Incident to the Embraer ERJ170
registered **F-HBXI**
operated by HOP!
on Saturday 11 May 2024
on Toulouse – Blagnac airport

Landing with left landing gear not locked indication

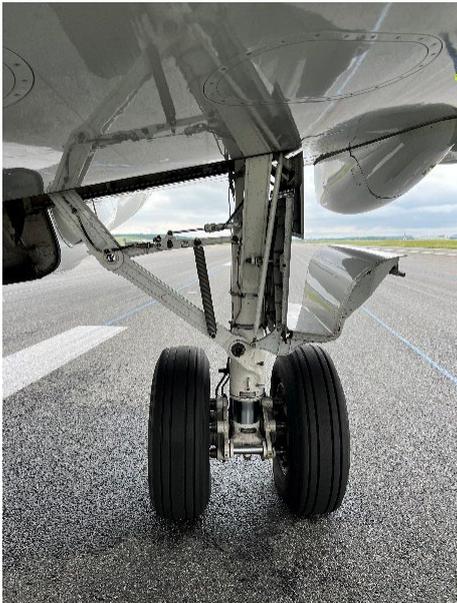
Figure 2: left main landing gear of F-HBXI after landing, view looking aftwards (source: BEA)

- the torque link actuating the left main landing gear was not aligned (see **Figure 2** and **Figure 3**)
- the locking-stay had separated from the landing gear shock strut (see **Figure 4** and **Figure 5**).

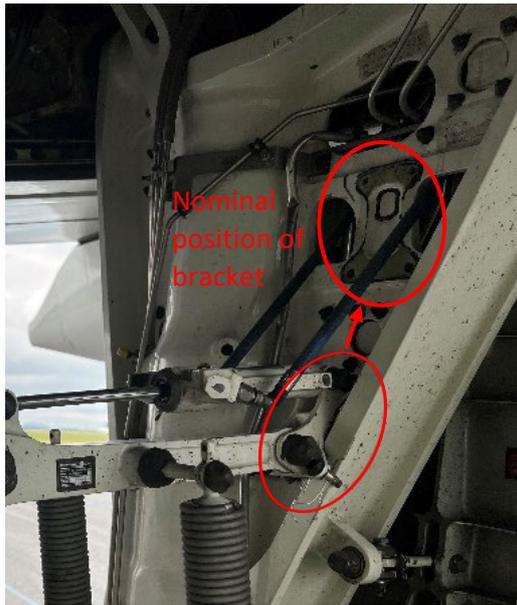
Figure 4: bracket separated from landing gear shock strut (source: BEA)

The bolts designed to connect the locking-stay bracket to the landing gear shock strut were found broken or incomplete (see paragraph 2.3.2).

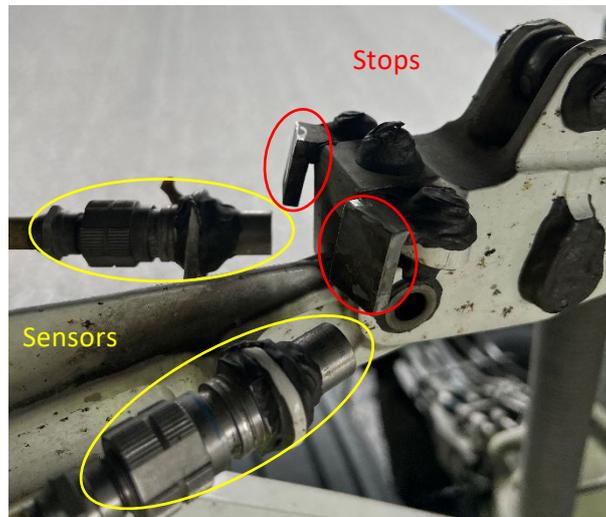
Figure 6: misaligned position sensor (source: BEA)

The bracket of the locking-stay was no longer attached to the landing gear and had moved resulting in the misalignment of the landing gear position sensors (see **Figure 6**). This misalignment explains why the aeroplane did not detect the landing gear locked position.

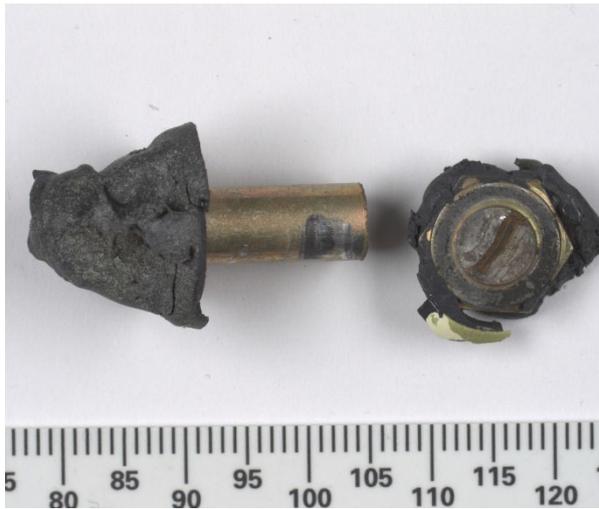
Figure 8: bolt in rear top position
(source: BEA)

- rear top position (see **Figure 8**): the screw was broken without deformation; all the components were recovered;
- forward top position (see **Figure 9**): the screw was broken and bent, the washer was missing;
- rear bottom position (see **Figure 10** and **Figure 11**): the screw was in good condition, the washer and nut were missing, a fragment of the cotter pin was still in place in the screw. Some metal debris was caught in the screw threads;
- forward bottom position: the screw was in good condition, the washer and nut were missing, a fragment of the cotter pin was still in place in the screw. Some metal debris was caught in the screw threads.

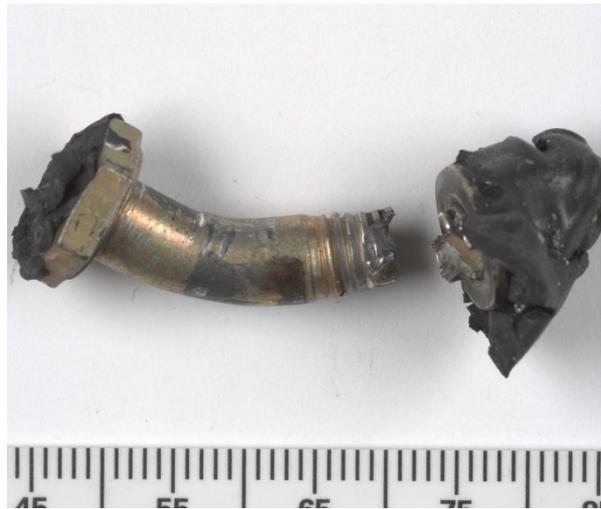
Figure 9: bolt in forward top position
(source: BEA)

The screw in the forward top position exhibited the characteristics of a sudden failure, due to bending overload. The nuts in the top position were type MS14145.

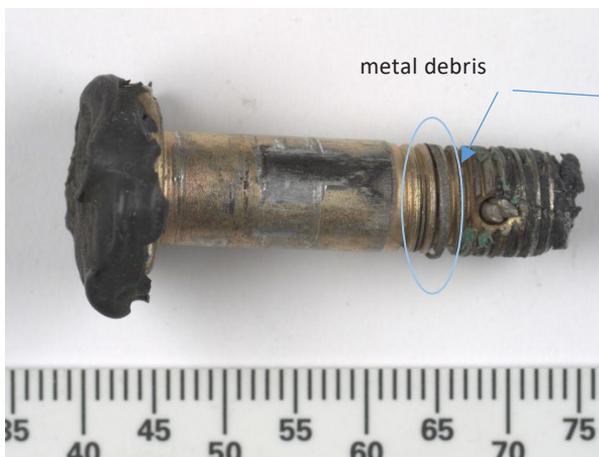
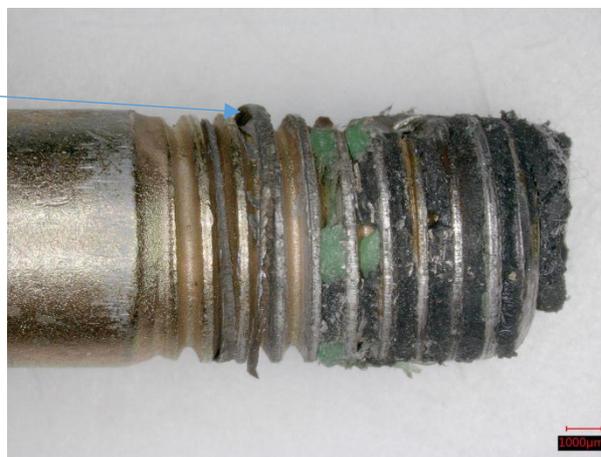
For each of the two screws in the bottom position, the presence of metal debris in one thread, a fragment of a cotter pin in the screw bore, and green product in several threads indicate that MS17826 nuts were installed on these screws.

It is very likely that the nuts of the two bottom bolts, being incorrectly sized, were damaged when torqued during their installation and subsequently tore off⁷. The forward bolt located in the top position then gradually cracked due to fatigue, until eventually breaking. As the bracket was then only held by the rear bolt, the latter suddenly broke due to overloading.

Following the incident, Embraer issued a mandatory *Alert Service Bulletin* (Alert SB170-32-A094) to inspect all landing gears in the fleet. By the end of 2024, the entire fleet had been inspected, with the following result: approximately 180 nuts replaced with type MS14145 models.

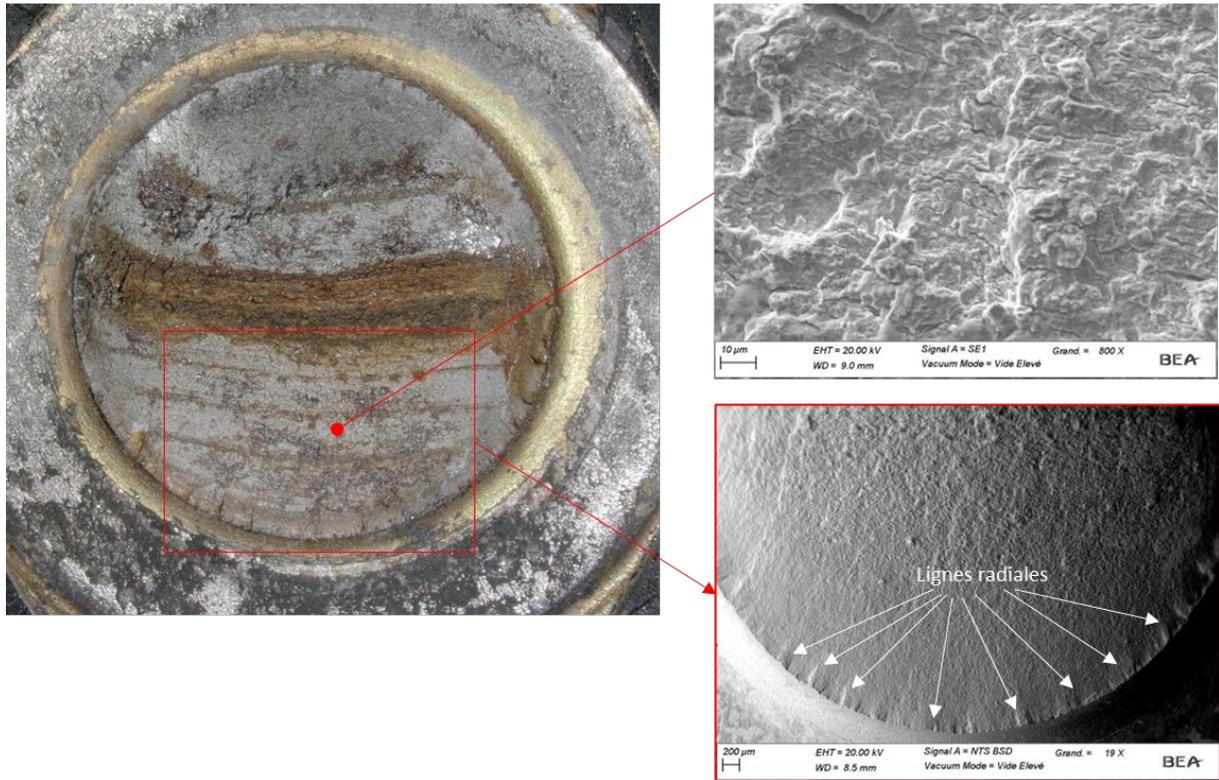
Figure 12: SEM view of fracture surface of screw in rear top position (source: BEA)

A scanning electron microscope (SEM) examination was performed on the fracture surface of the screw in the rear top position. The presence of micro-striations was brought to light, characteristic of a fatigue cracking process under repeated tensile loads. There were multiple incipient cracks on the surface of the screw shank, as evidenced by the presence of radial lines. The material conformed to the expected grade for this type of screw.

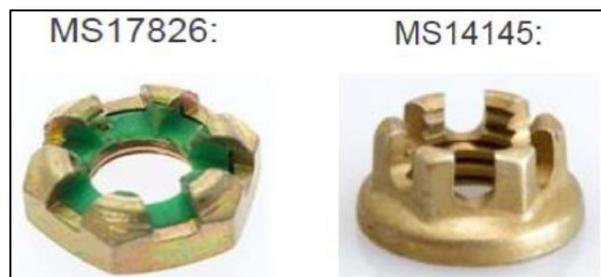
Figure 13: authorized retaining nuts in Liebherr documentation (pre SB 170-32-0089) (source: BEA)

The maximum tightening torque that can be borne by this type of nut is 8 Nm. The tightening torque indicated in Liebherr's documentation was 22 to 25 Nm.

- the use of nuts, recommended by the manufacturer, which were not designed to bear the torque values indicated in the documentation.
