**Accident** to the ELIXIR  
registered **F-HCDN**  
on Friday 2 May 2025  
at Amboise-Dierre aerodrome

**Runway veer-off during an emergency landing, rupture of  
nose gear fork, overturn**

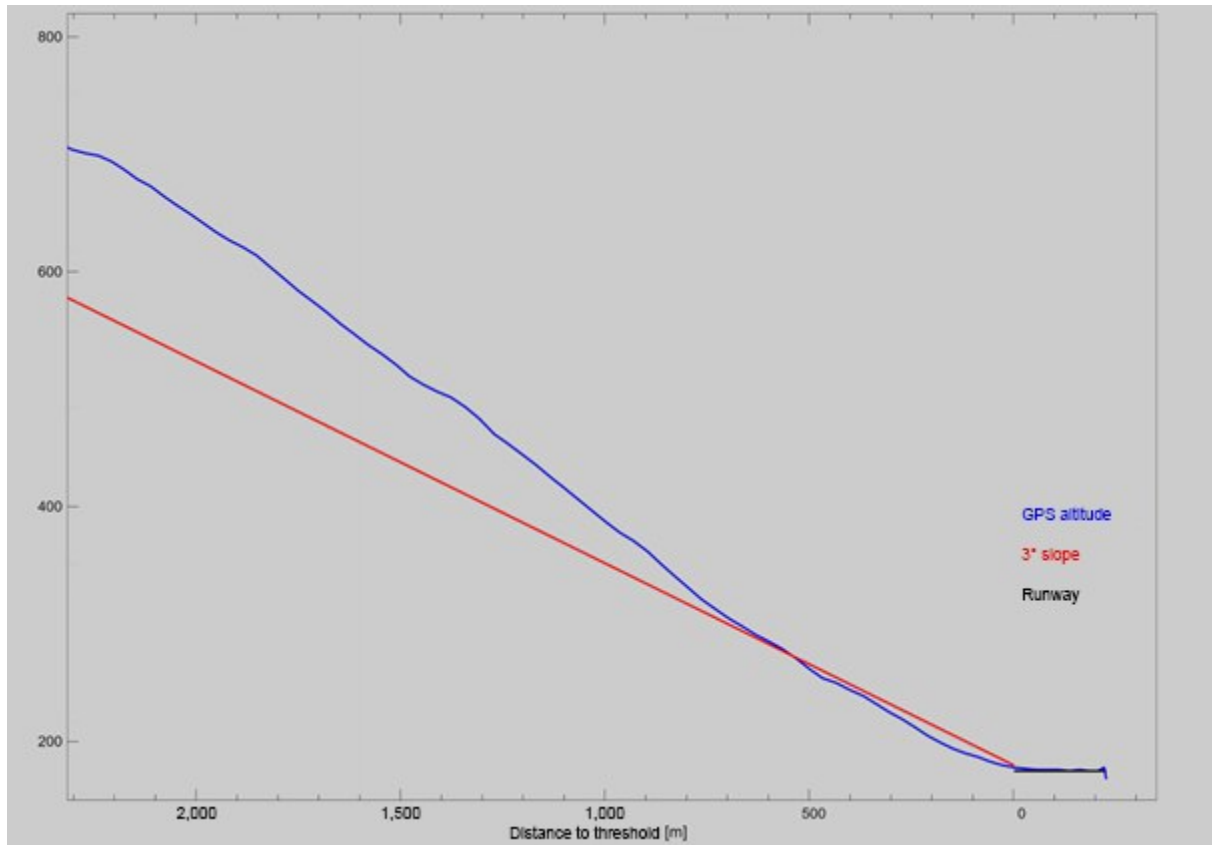
Figure 3: descent slope of F-HCDN compared to nominal descent slope (source: BEA)

The recorded data shows that the descent slope of F-HCDN was approximately 4°, i.e. above the standard slope. The elevator trim was set to 39% nose down.

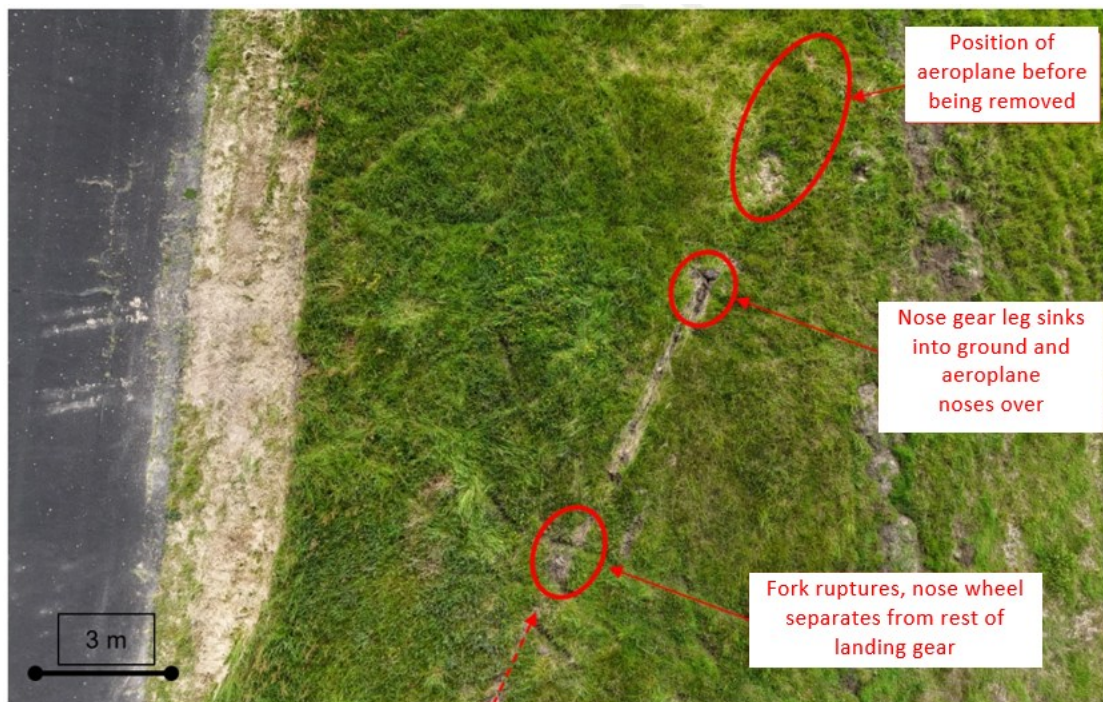
Figure 5: aerial view of accident site (source: BEA)

The damaged aeroplane was moved and placed in a hangar before the BEA arrived on site. However, the visible marks on the runway and in the grass were examined. They showed the aeroplane was in a continuous right-hand skid until it veered off the runway around 85 m after the threshold of paved runway 10.

Ruts were observed in the grass, due to agricultural machinery having passed through.

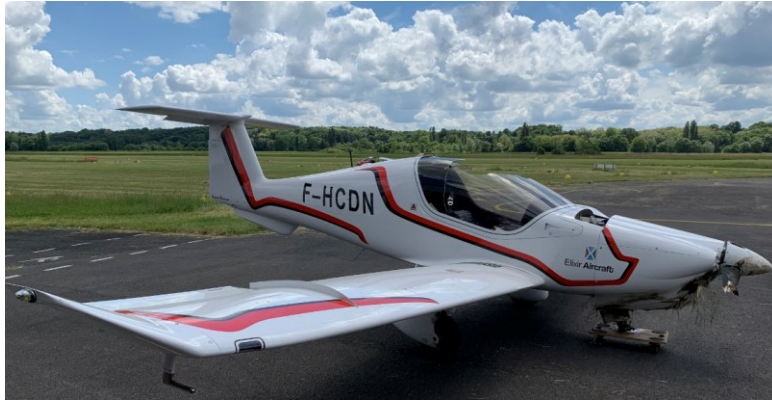
Figure 6: overall view of aeroplane after it was moved (source: BEA)

The damage observed on the tail plane, the propeller and its cone, the engine cowling and the wing tips was consistent with the aeroplane nosing over onto its back.

The nose gear had ruptured at the connection between the moving leg and the fork. Part of the fork was still integral with the nose wheel, found in the grass, upstream of the final position of the wreckage.

The examinations carried out on the wreckage in the presence of the manufacturer revealed a lack of lubrication of the nose gear legs, causing significant friction likely to affect the damping behaviour of the gear in abnormal operating conditions.

When F-HCDN was manufactured, the fixed leg of the nose gear should have been fully lubricated. However, given the total absence of grease observed during the examination, this operation was probably not carried out.

Elixir Aircraft has modified the Production Instruction Sheets to insist on the importance of the lubrication.

Furthermore, in the scope of an overall analysis of the nose gear, Elixir Aircraft is assessing the introduction of a new lubrication port so that this operation can be carried out without having to disassemble the gear.

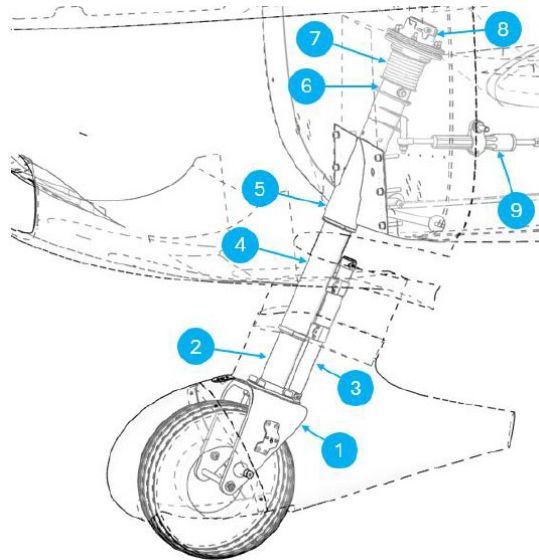
Figure 7: nose gear (source: Elixir Aircraft)

The fork (see **Figure 7** point ①) connects the nose wheel to the moving leg (point ②) and to the moving leg shaft (point ③) which ensures the alignment of the nose wheel with the fixed leg. The moving leg slides in the internally-lubricated fixed leg (point ④). The fixed leg can also slide in the lower fixation (point ⑤) which ensures the junction of the landing gear with the fuselage. The damping function of the nose gear is provided by the compression of polymer blocks between the bottom of the moving leg and the end of the fixed leg.

- new aluminium nose gear fork to replace the composite fork;
- installation of a canopy breaker tool on the aircraft which can be accessed by each occupant.

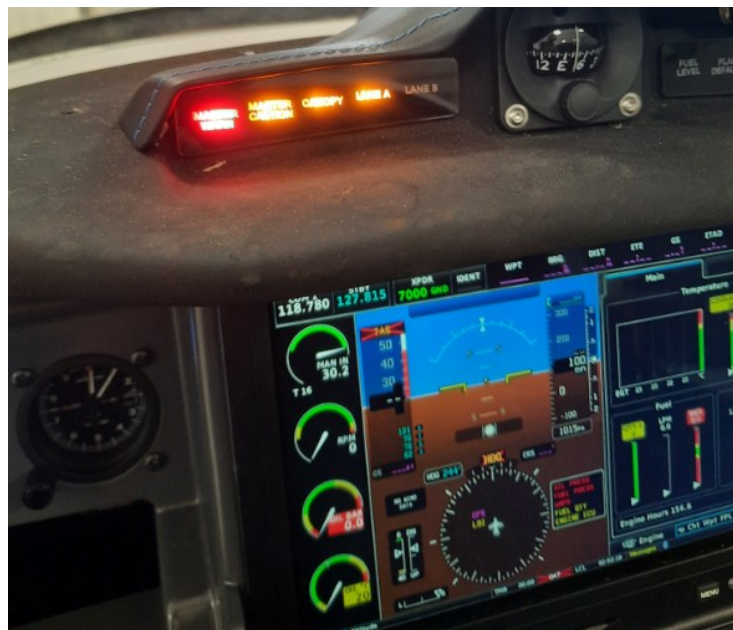
Figure 8: warning and caution panel on F-HCDN (source: BEA)

The preliminary examinations of the engine identified substantial play between the manifold air temperature sensor of lane A of the ECU, and its wiring harness. A fault on this sensor or its wiring is consistent with the steady illumination of the “LANE A” caution light based on the data recorded by the on-board avionic systems.

In the centre of the instrument panel, above the MFD, a warning and caution panel includes the “MASTER WARN” red light and the “MASTER CAUTION”, “CANOPY”, “LANE A” and “LANE B” amber lights (see **Figure 8**).

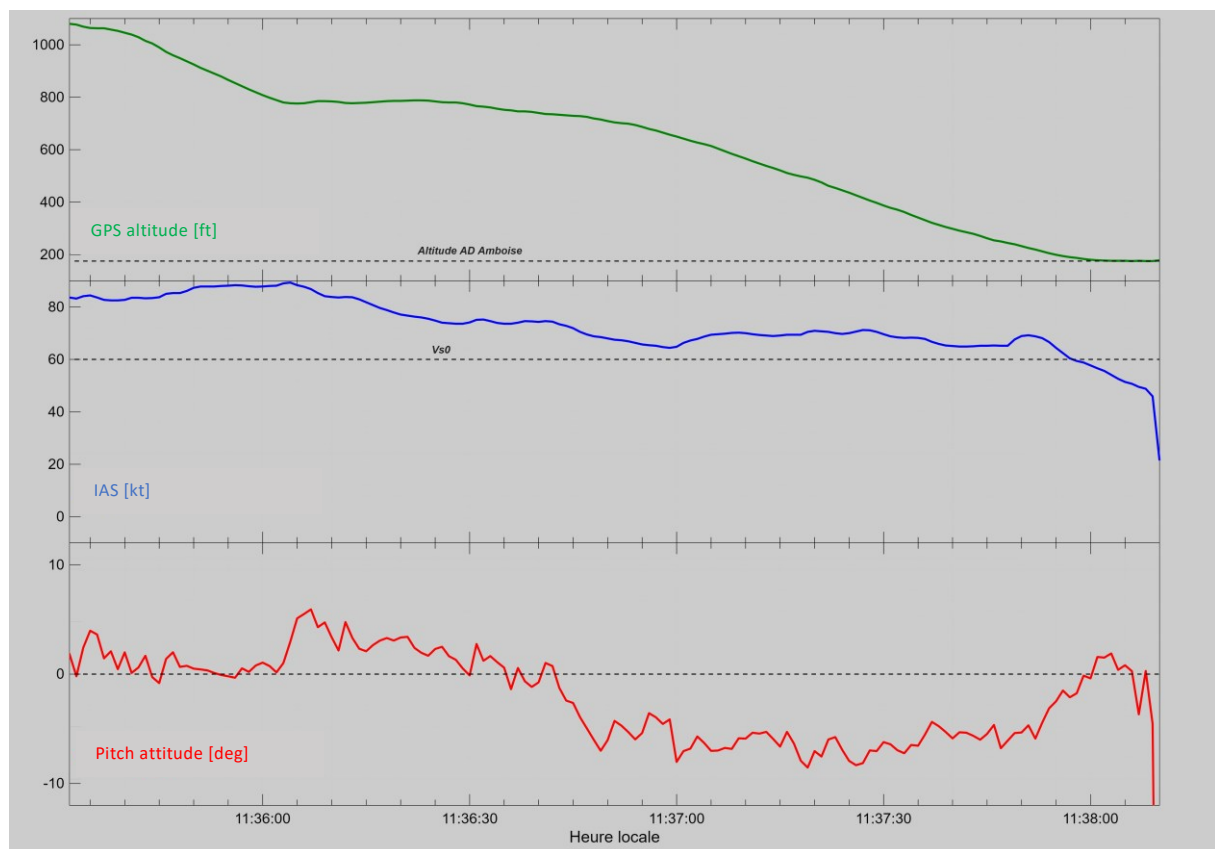
Figure 9: recorded altitude, speed and pitch attitude parameters during final

The recorded data indicates that the aeroplane had a negative pitch attitude on short final until reaching the aerodrome’s altitude at which point the pitch attitude became positive. At this point, at what seems to correspond to a flare, the indicated airspeed was around 58 kt.
