Accident to the LINDSTRAND 180A
registered **F-HCMP**
on Tuesday 4 March 2025
at Castelnau-la-Chapelle

Collision with trees, during cruise

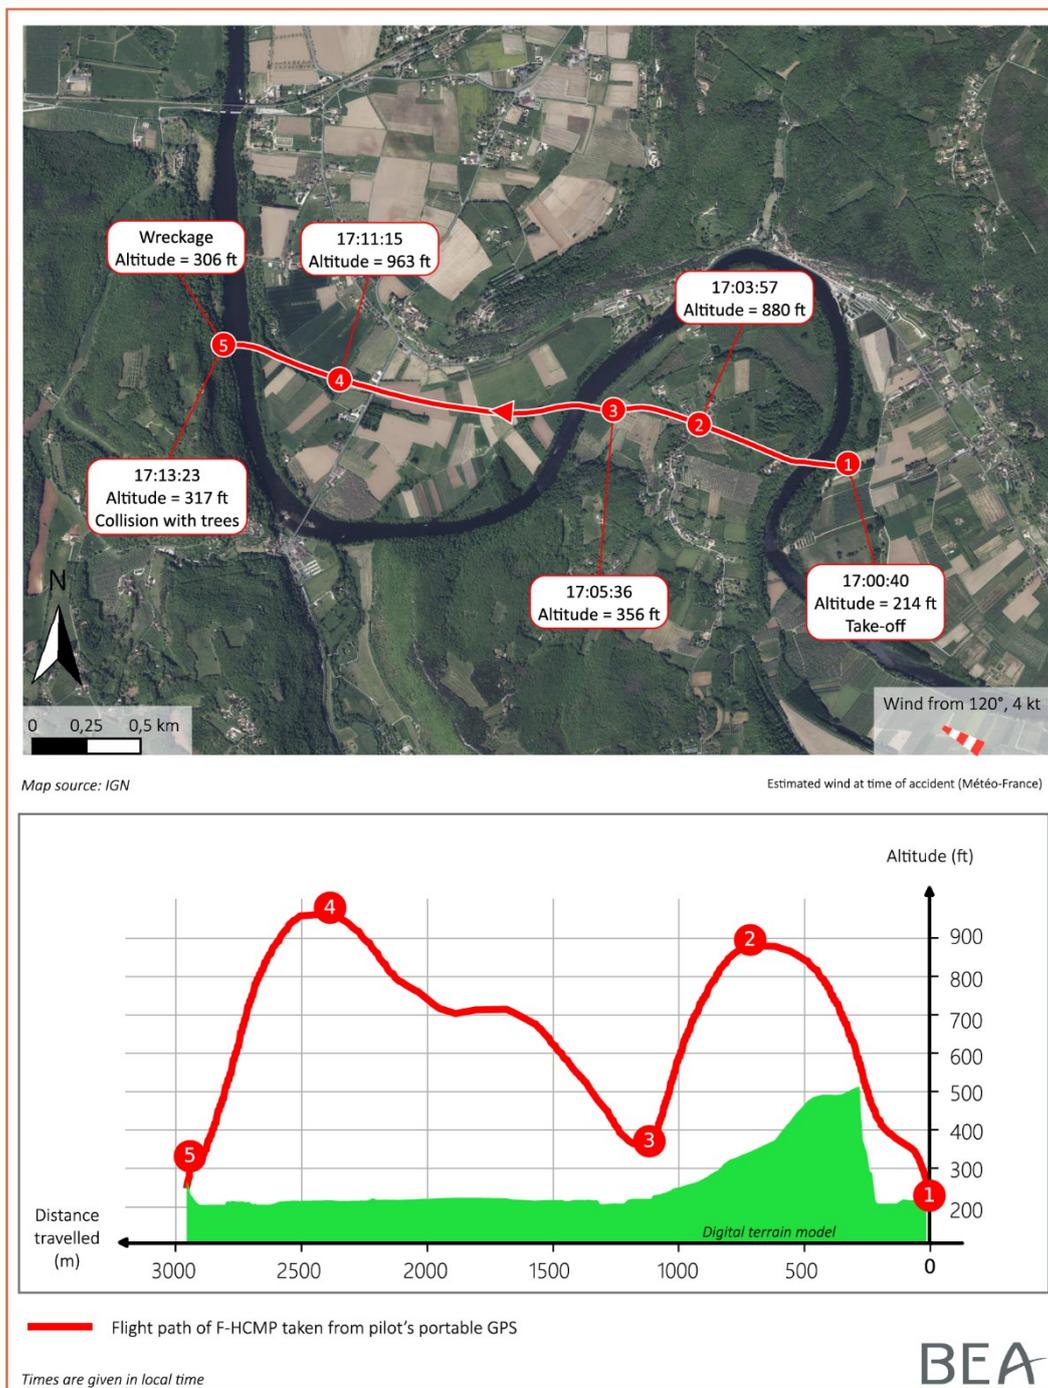
The pilot, accompanied by seven passengers, took off at around 17:00 from a take-off site at La Roque-Gageac (see Figure 1, point ①). The balloon headed westwards and climbed to a height of around 600 ft² (point ②). The pilot descended to a height of around 100 ft to fly over the Dordogne (point ③) and then rose again. On approaching a second branch of the Dordogne, with the cliff ahead of him, he descended once more. The pilot then activated the burners again to fly over the cliff. The balloon took time to gain height and the envelope caught on trees (point ⑤). The basket came to a stop on a bank, on the side of the cliff. The pilot closed the fuel tanks, extinguished the pilot lights, bled the systems and closed the valves.

Figure 1. flight path of balloon (source: BEA)
