**Accident** to the PIPER PA28  
registered **F-HDYN**  
on Saturday 8 July 2023  
on Lognes - Émerainville aerodrome

<b>Time</b>	Around 15:10 <sup>1</sup>
<b>Operator</b>	Club Air Pilot
<b>Type of flight</b>	Sightseeing flight, commercial
<b>Persons on board</b>	Pilot and two passengers
<b>Consequences and damage</b>	Passengers slightly injured, aeroplane destroyed

**Balked landing, flight on the backside of the power curve,  
collision with obstacles situated after the end of the  
runway, during a local flight for remuneration**

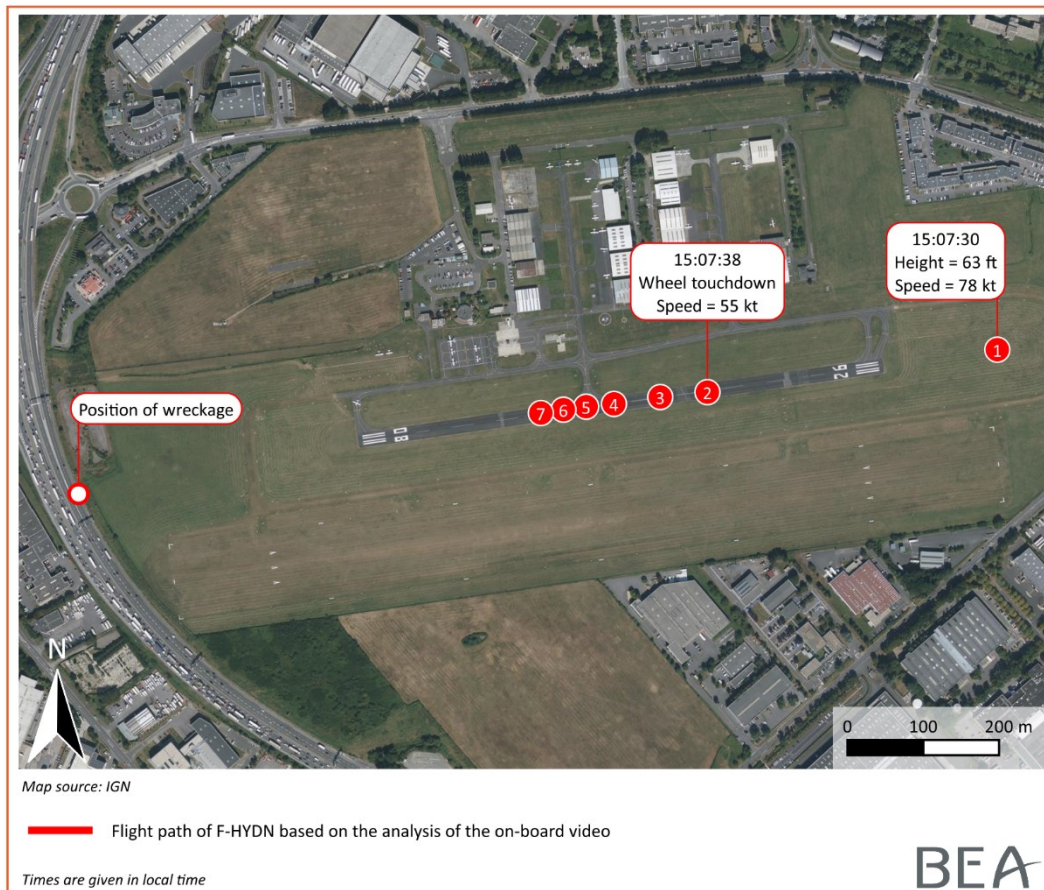
During the final approach, the pilot extended the flaps to the landing position (40°). On short final, at point ① on Figure 1, the speed was 78 kt. The pilot explained that she chose an aiming point slightly before the runway so as to touch down at the beginning of the runway.

Figure 1: flight path of aeroplane

The aeroplane touched down on the runway at point ②, 230 m after the runway threshold and bounced. The flare was not very pronounced. The aeroplane bounced five times between points ② and ⑦, without the pilot making a nose-up or nose-down input on the wheel.

Just after point ⑦, at around 250 m from the end of the runway, when the video taken by the passenger stopped, the aeroplane was on the ground and the pilot retracted the flaps by two detents to the take-off position (10°) in order to, she explained, adhere to the runway and have better braking.

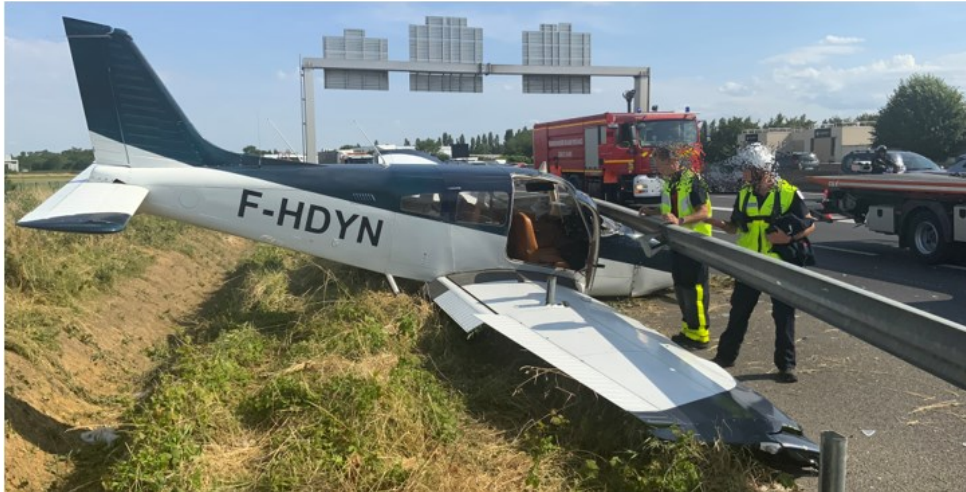
A few seconds later, the pilot decided to carry out a balked landing as she was worried about a runway excursion. She increased power and made a nose-up input. The carburettor heat was left switched ON. A high nose-up pitch was held according to a witness in an aeroplane on the ground. On board, the stall warning was triggered. The aeroplane reached no more than a height of two metres when it passed over the end of the runway. It then struck the aerodrome's perimeter fence which slowed it down. It finally touched down just before finishing its path under the crash barrier of the main road, N104<sup>3</sup>, adjacent to the aerodrome, 375 m after the end of the runway.

Figure 2: wreckage (Source: BEA)
