**Accident** to the helicopter AIRBUS Dauphin EC155B1  
registered **F-HEGT**  
and  
the plane NORD N1203 registered **F-AYVV**  
on Thursday 8 February 2024  
at Cozy

## Mid-air collision

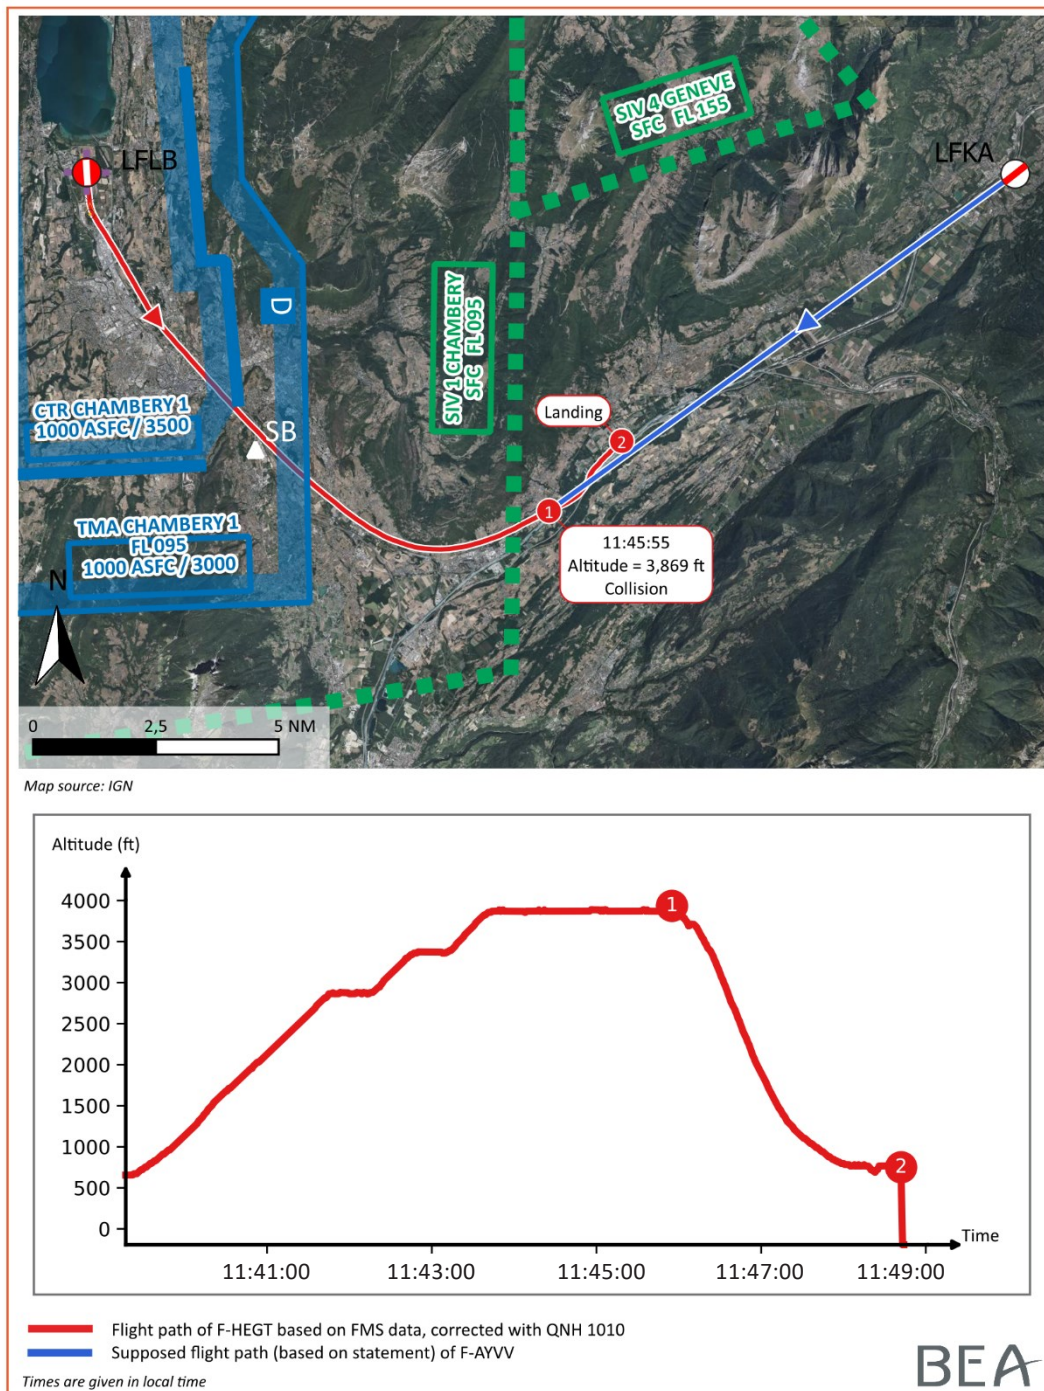
Figure 1: flight paths taken by both aircraft

At 11:45:55, the tips of the helicopter's main rotor blades came into contact with the aeroplane's left fairing and made a cut in the root of the left wing, between the leading edge and the main spar (see **Figure 1**, point ①).

The helicopter pilot started an emergency descent, reducing the speed to 80 kt. While searching for an obstacle-free area for landing, he transmitted a distress message by radio and activated the emergency locator transmitter. He landed in a field less than three minutes later (point ②).

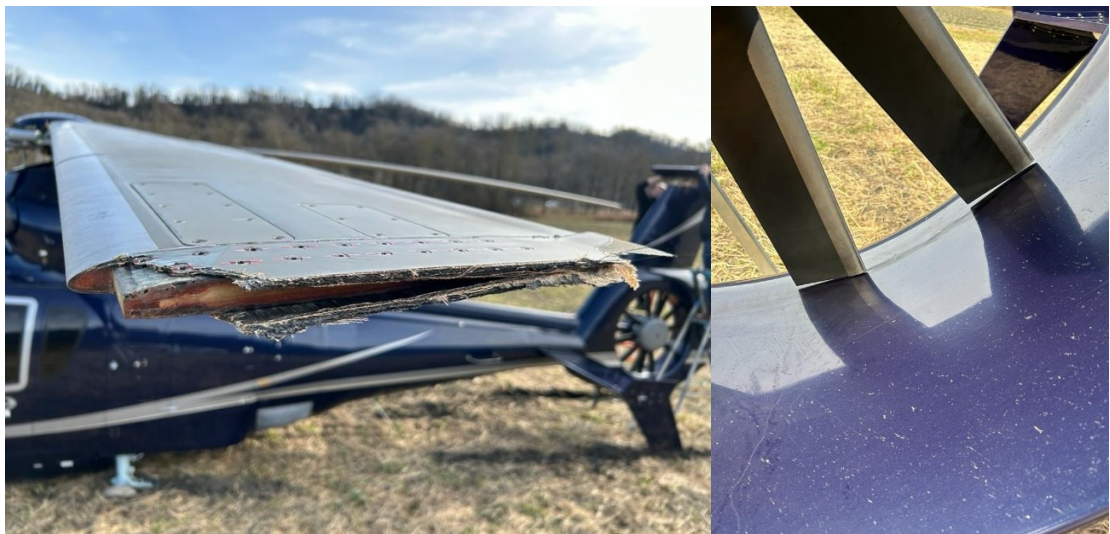
Figure 2: damage to helicopter (source: BEA)

The helicopter pilot landed in a field close to where the mid-air collision had occurred. The helicopter was resting on its landing gear. During the landing, the landing gear sunk into the soft ground by roughly ten centimetres. The keel under the fenestron had also slightly penetrated the ground.

The damage observed was limited to:

- the tip of two of the five blades, due to contact with the aircraft wing during the evasive manoeuvre, and a notch on the trailing edge of one of the blades;
- the fenestron fairing, which showed blade rubbing marks that probably occurred during landing and the keel coming into contact with the ground.

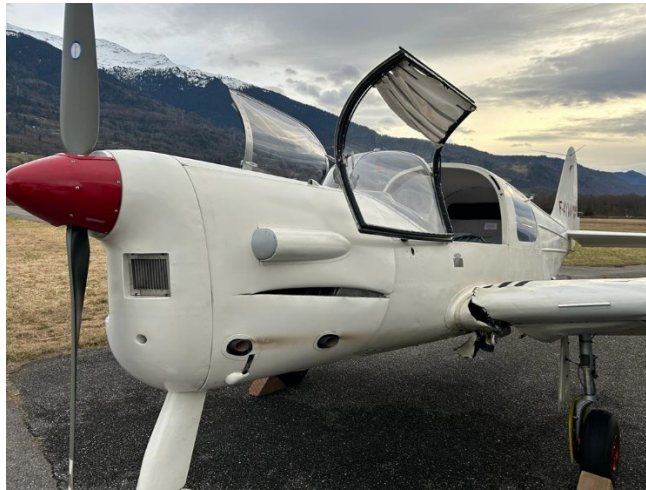
*Figure 3: photo of aeroplane and location of damage  
(Source: BEA)*

The damage observed on the aeroplane was located on the left-hand side, close to the wing root. There was a cut on the left-hand side of the engine cowling. The left-hand wing was also cut from the leading edge to the spar, which was not damaged.

The left-hand wing fuel tank situated forward of the spar was torn. The left-hand aileron control rod was severed. This rupture did not cause the aileron control system to jam. The aeroplane's pilot was still able to turn.
