Incident to the AIRBUS A320
registered **F-HEPB**
on 11 February 2022
at Pointe-à-Pitre - Le Raizet (Guadeloupe)

**Loss of visual references during a night visual approach²,
activation of MSAW warning in base leg, off-centred final
approach, missed approach**

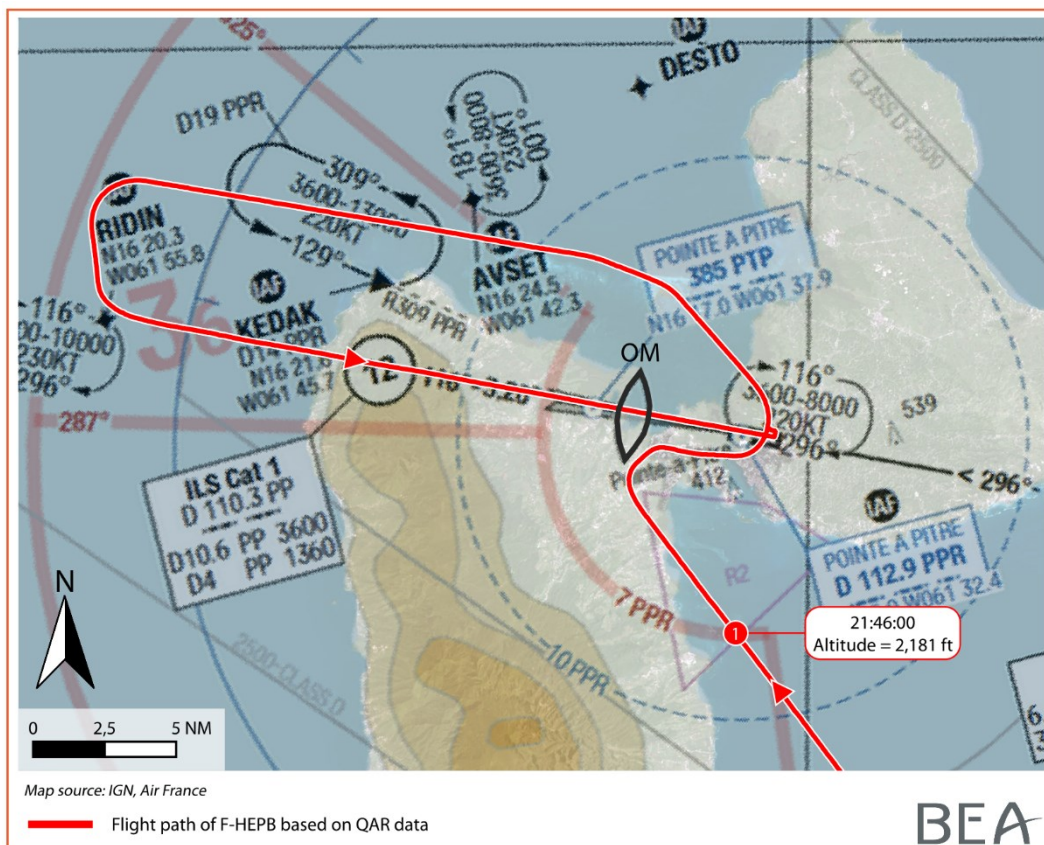
Figure 1: path of F-HEPB

At 21:48:34, the crew noticed that the aeroplane was not aligned with the centreline of runway 12 and aborted the approach. The aeroplane was then 2.5 NM from the threshold of runway 12, on a path parallel to the runway centreline, 1 NM south of this centreline.

The minimum height of the aeroplane⁶ was 460 ft and the minimum speed recorded during the go-around was 128 kt for an approach speed of 138 kt.
