Serious incident to the MUDRY – CAP 232
registered **F-HERA**
on Wednesday 7 June 2023
at Montluçon - Guéret

Shattering of canopy during aerobatic manoeuvres

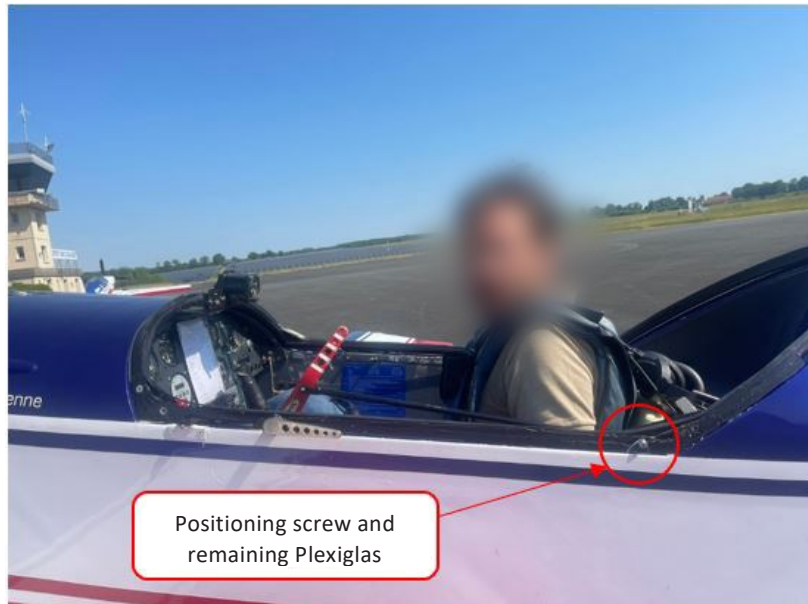
Nearly all of the Plexiglas bubble canopy shattered when the aeroplane started climbing. Around ten fragments were found on the ground. Only two pieces of Plexiglas remained integral with the frame around three positioning screws which were still screwed in place. The five other screws were not found. The airframe of the aeroplane was not damaged by the Plexiglas shards.

Figure 1: photo of F-HERA after the event (Source: pilot)

The visual examination of the frame carried out by the BEA found that the adhesive used to bond the Plexiglas bubble canopy to the frame had an aged appearance. The analysis of the surface identified that the rupture between the adhesive seal and the Plexiglas was an adhesive failure.

An examination of the canopy frame carried out by CETIM⁴ identified that this adhesive (TECNITE MSP15) has a skin formation time of 10 min. According to CETIM, as the bonding surface was 900 cm², it is probable that the parts were not joined together within the restricted time.

In order to have optimal adhesive characteristics for bonding the canopy, the adhesive has to be applied to a prepared Plexiglas. This preparation implies lightly sanding the Plexiglas surface with grit-1200 sandpaper. The examination carried out by CETIM found that the edges of the Plexiglas canopy in contact with the adhesive had not been prepared.

The almost total loss of the properties of the adhesive between the canopy and the frame junction, which went undetected, resulted in the adhesive failing. During an aerobatic training flight, the canopy separated from the frame and shattered. After quickly checking that the controls were effective and the condition of the elevator, the pilot flew an adapted circuit and landed.

- no preparation of the Plexiglas surface before the installation of the canopy;
- use of an adhesive with a shorter application time than the adhesives usually recommended for this type of bonding and this not being specified;
- exceeding, when bonding, the skin formation times of the adhesive used;
- the lack of information made available to the maintenance workshop concerning the type of adhesive to be used;
- not taking into account the loosening of positioning screws on several occasions, likely to indicate the adhesive failure between the Plexiglas and the frame.
