**Accident** to the Issoire Aviation APM 30  
registered **F-HFIK**  
on Saturday 17 June 2023  
at Pignans

<b>Time</b>	Around 13:00 <sup>1</sup>
<b>Operator</b>	Aéroclub du Var
<b>Type of flight</b>	Local
<b>Persons on board</b>	Pilot and two passengers
<b>Consequences and damage</b>	Pilot and passengers fatally injured, aeroplane destroyed
This is a courtesy translation by the BEA of the Final Report on the Safety Investigation. As accurate as the translation may be, the original text in French is the work of reference.

## **Asymmetric stall, spin, post-impact fire**

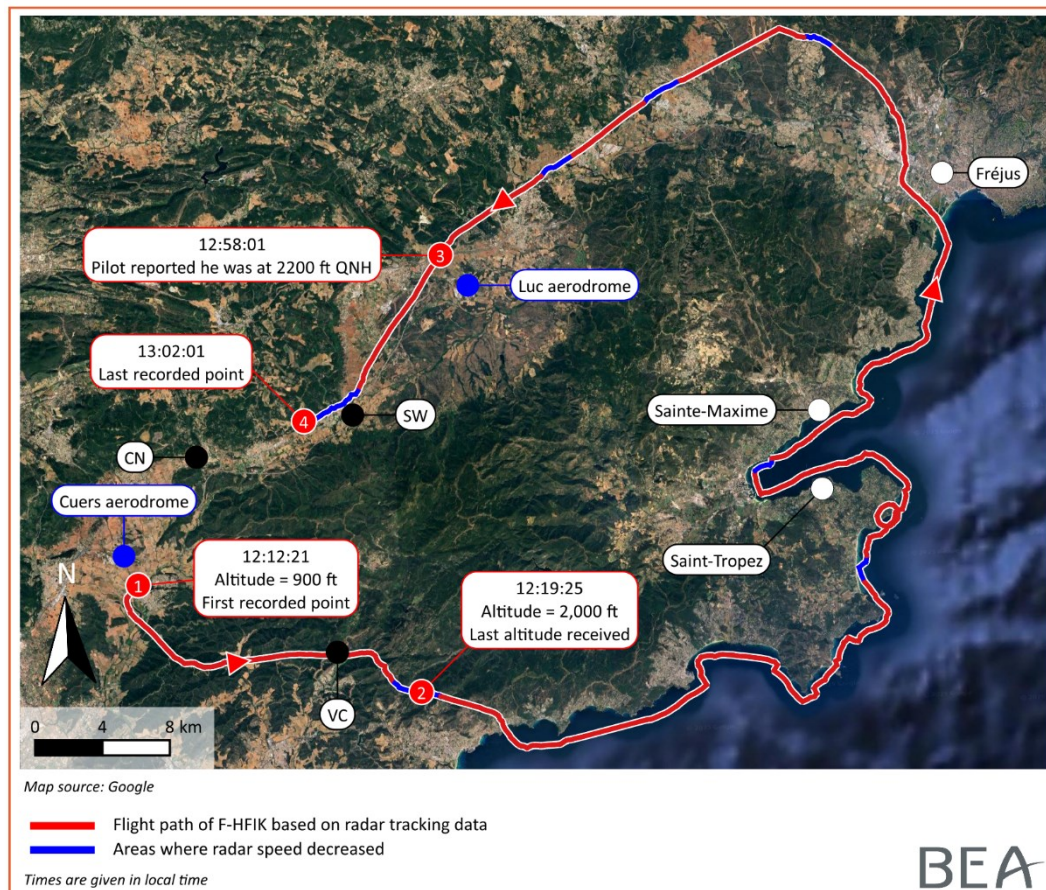
Figure 1: flight path of F-HFIK based on radar tracking data

- flight on 11 June 2023: the altitude information was received by the radar processing system for the first thirty-three minutes of the flight, the altitude information was then no longer received for the fourteen minutes up to the end of the flight;
- accident flight on 17 June 2023: the altitude information was received by the radar processing system for the first seven minutes of the flight, the altitude information was then no longer received for the forty-three minutes leading up to the accident (see **Figure 1**).

The analysis of the flight data from the south-east ACC secondary radar found that a similar decrease in the radar speed of F-HFIK (assimilated with the ground speed) observed in the seconds preceding the accident occurred six times during the flight (see **Figure 1**).

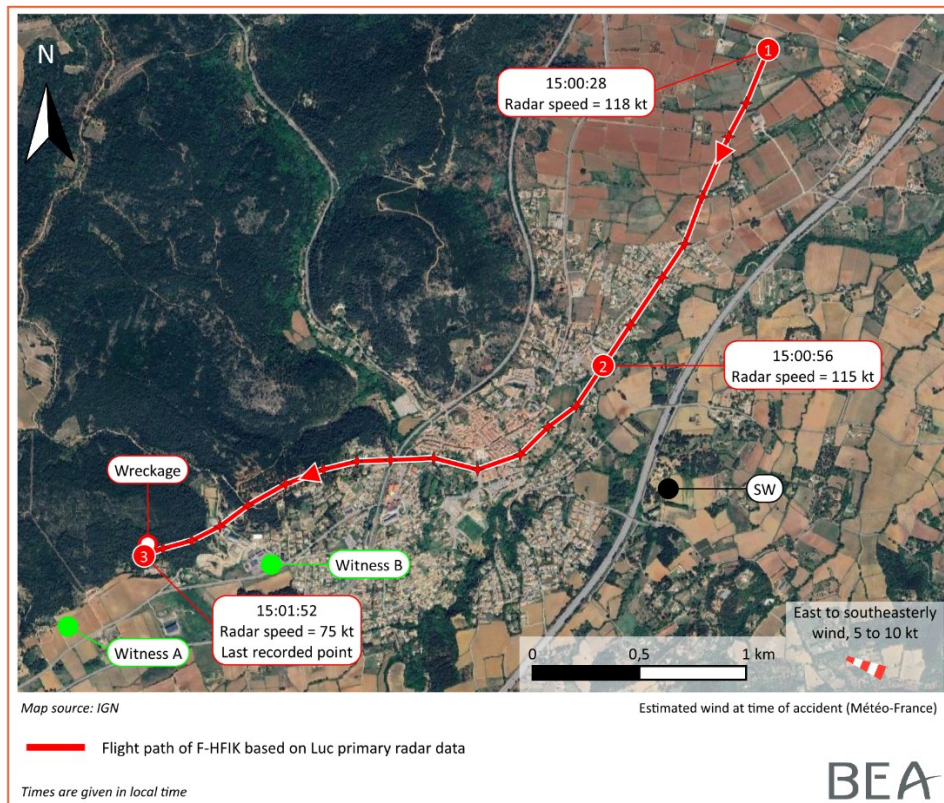
Figure 2: flight path of F-HFIK

At 13:00:28 (see **Figure 2** and **Figure 3**, point ①), the aeroplane was flying in a straight line at a constant horizontal speed of 118 kt. At 13:00:56 (point ②), the aeroplane's track started to veer right and the horizontal speed decreased<sup>4</sup> to around 88 kt. At 13:01:20, the track heading in a westerly direction started to veer left and the horizontal speed continued to decrease. At 13:01:52, (point ③), the last recorded radar point was situated close to where the wreckage was found, the horizontal speed was around 70 kt.

Eyewitness A (see **Figure 2**), close to the accident site, saw the aeroplane make a RH turn and then track from left to right<sup>6</sup>. The aeroplane then banked to the LH side and entered into what seemed to be a LH spin. Its flight path was nearly vertical, nose down in a LH rotation. Eyewitness A indicated that the aeroplane made at least one complete spin turn.

Eyewitness B (see **Figure 2**) observed the aeroplane tracking from right to left. He believed that he saw the aeroplane make a LH banked turn, its nose slightly tip down, the canopy facing the ground, then its nose completely tip down. He then saw the aeroplane turn around itself once on the longitudinal axis before disappearing behind a building. During the descent, he heard a noise similar to what the engine would make if the pilot applied a lot of throttle.

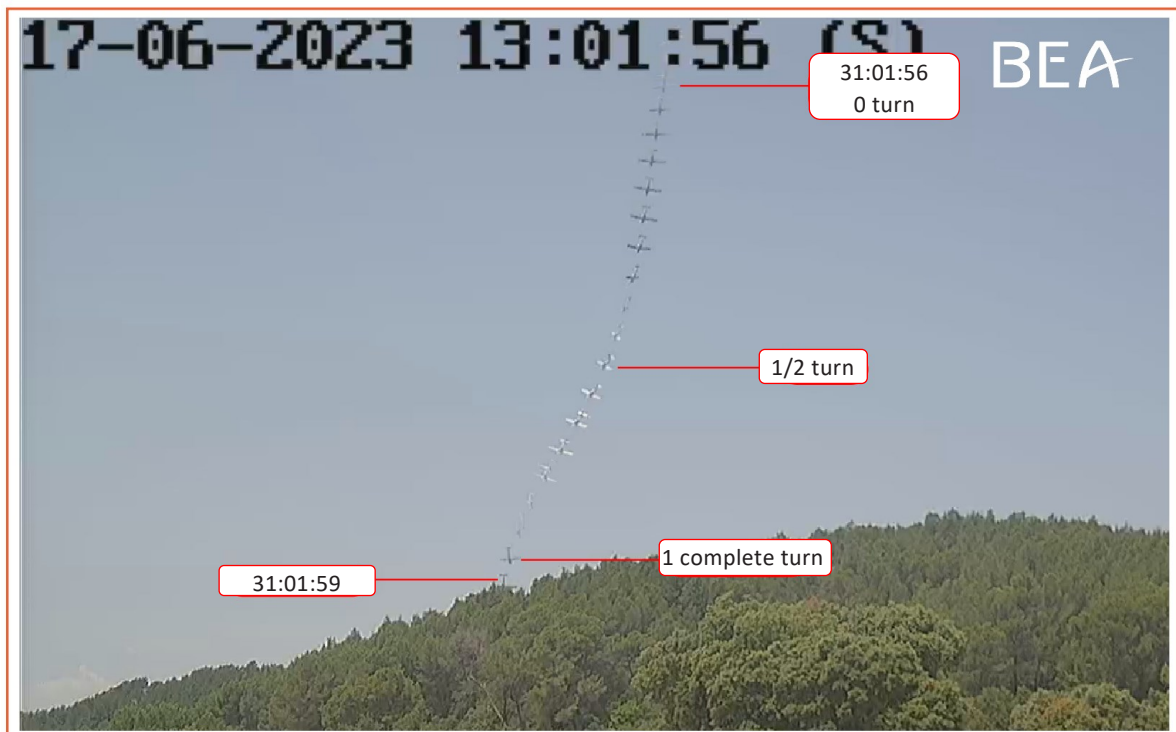
*Figure 4: photo-sequence using surveillance camera video (source: BEA)*

From 13:01:55 to 13:02, a surveillance camera filmed the last complete turn which was akin to a spin up to the disappearance of the aeroplane behind the trees (see **Figure 4**).

The average rotation rate calculated using the photo-sequence was one turn in three seconds. It increased at the end of the sequence to reach one turn in two seconds.
