Accident to the TECNAM P2010
registered **F-HFMO**
on Monday 31 May 2021
at Tours - Val de Loire

Loss of control during an engine failure exercise at take-off, at low height, collision with runway, in instruction

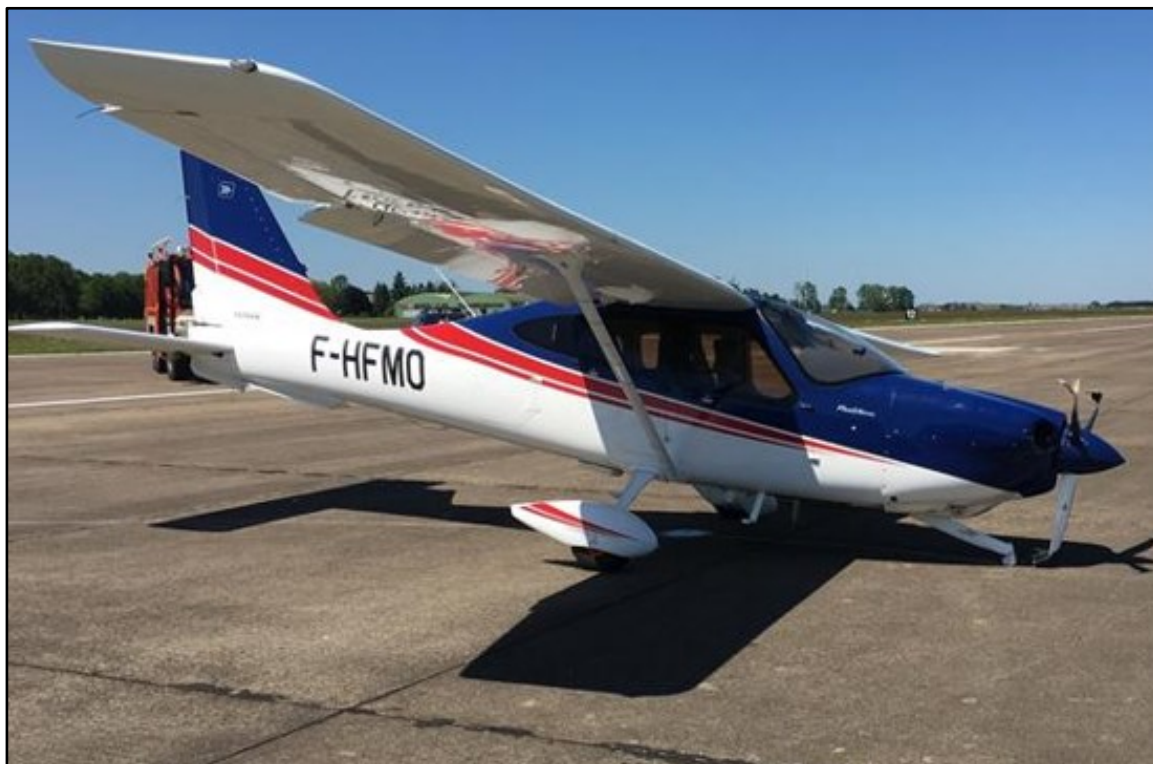
The LH strut, the LH main landing gear and the nose gear collapsed. The LH wing came into contact with the ground. The aeroplane slid along the runway, pivoted 90° to the RH Side and then came to a stop on the edge of the runway. The occupants evacuated the damaged aeroplane unaided.

Figure 1: photo of damaged aeroplane

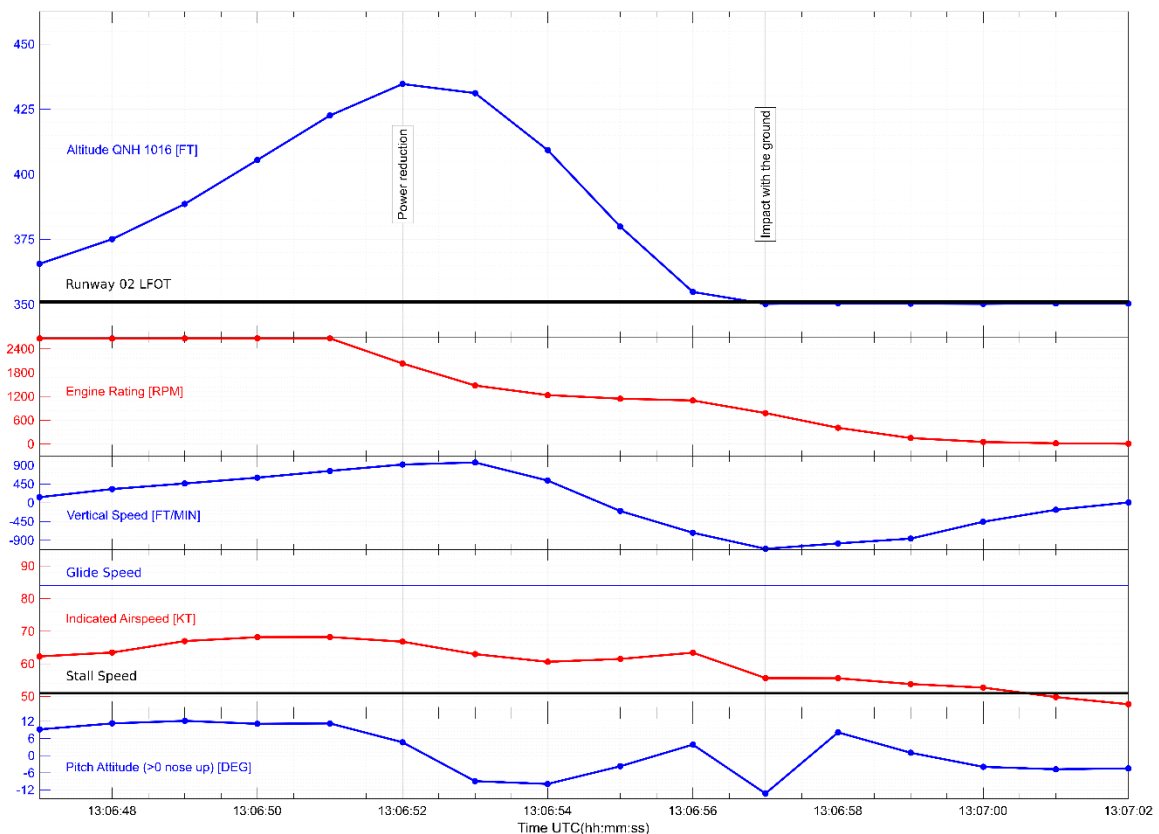
Figure 2: recorded parameters

- the engine power reduction, marking the start of the engine failure on take-off exercise, was carried out at a height of 80 ft and an indicated airspeed of 67 kt;
- the collision with the runway occurred between five and six seconds after the start of the exercise;
- between the reduction in power and the collision with the runway, the indicated airspeed decreased overall;
- the indicated airspeed remained above the stall speed in the take-off configuration (52 kt) and below the glide speed V_{glide} (84 kt) and climb speed (86 kt).
