Accident to the CHAIZE - JZ - 25 F24
registered **F-HGMV**
on 3 May 2021
at Locqueltas

This is a courtesy translation by the BEA of the Final Report on the Safety Investigation published in May 2022. As accurate as the translation may be, the original text in French is the work of reference.

**Balloon taking-off again on landing,
collision with a power line, during a revenue flight**

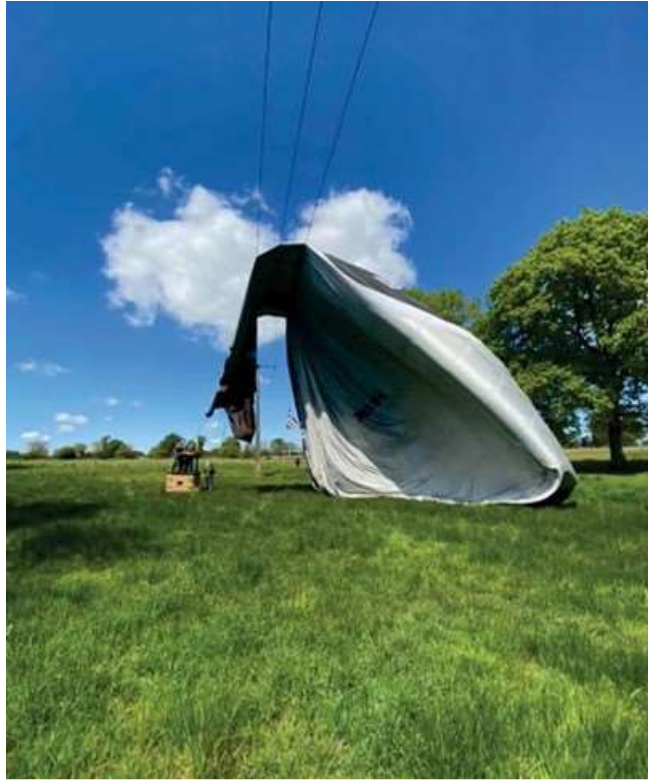
The pilot, accompanied by two passengers, took off at approximately 09:00 for a revenue flight from private land west of Vannes (Morbihan). The wind was southwesterly not exceeding around 10 km/h. After around one hour and fifteen minutes of flight, the pilot chose to land in the northern part of a ploughed field that was not planted, because of a power line in its southern part. The pilot indicated that the approach had taken place normally and that he had turned off the pilot lights before landing. According to the pilot, a gust of westerly wind of more than 20 km/h made the balloon take off again. The pilot tried to pull the cord to open the manoeuvring vent and indicated that his action had been hindered by the tilt of the envelope caused by the gust of wind. The balloon rose to a height of around 10 m and passed over a line of trees. The basket touched the tops of the trees before making contact with the ground, approximately 150 m from the first point of contact in the field. The envelope fell over a high-voltage power line located north of the field selected for landing (see illustration).

Figure 1: balloon and power line (source: BGTA)

During the landing in a field, the pilot was probably confronted with an increase in wind strength, while he experienced difficulties pulling the vent cord and thus deflating the envelope. The balloon took off again, and flew over and touched a line of trees about 10 m high before landing in another field. In this context, the pilot could not prevent the envelope from coming into contact with the cables of a power line.

- Insufficient force applied to pull the vent cord on first contact with the ground, possibly due to partial detachment of the hook and loop fastener tapes between the vent and the envelope as well as physical capacity limitations related to the age of the pilot. This input did not empty the balloon sufficiently to prevent it from taking off again.
- The lack of use of the fast deflation system during the first landing, which meant that the balloon was not deflated quickly before the gust made it take off again.
- The pilot's lack of recent experience and lack of recent flight with an instructor.
