**Serious incident** to the MOONEY M20J  
registered **F-HGPR**  
on Tuesday 6 August 2024  
at La Rochelle - Île de Ré airport

**Continuation of a non-stabilised approach, bounced landing, loss of control, go-around, runway veer-off, near collision with obstacles**

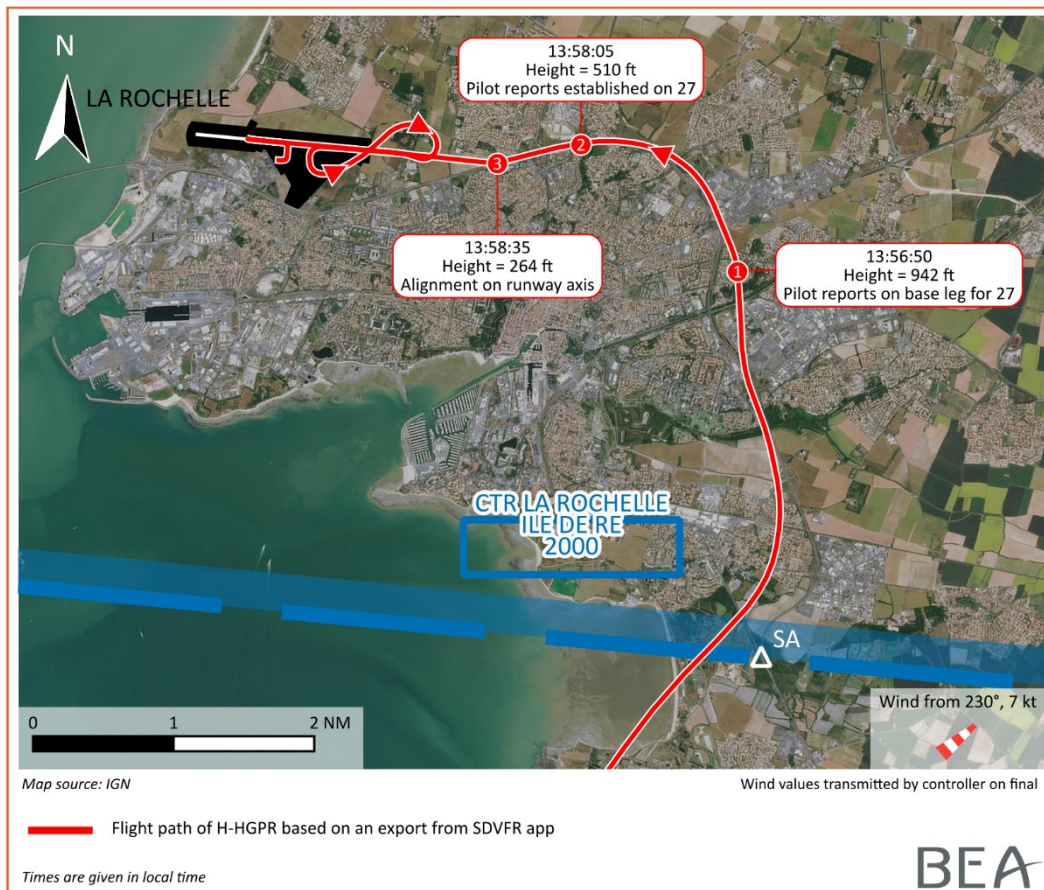
Figure 1: path based on SDVFR data

The pilot took off from runway 27 at Biarritz airport at around 12:35 and then flew along the coast at an altitude of 1,500 ft<sup>2</sup>. After flying over Île d'Oléron, he entered the La Rochelle CTR via the SA reporting point. The controller then asked him to call back in left-hand base leg. The pilot flew along the ring road, then started the descent and intercepted the centreline of runway 27<sup>3</sup> about 1.1 NM from the displaced threshold. The aeroplane was then at a height of around 300 ft (see **Figure 1**, point **3**). The pilot, alone in the runway circuit, was cleared to land.

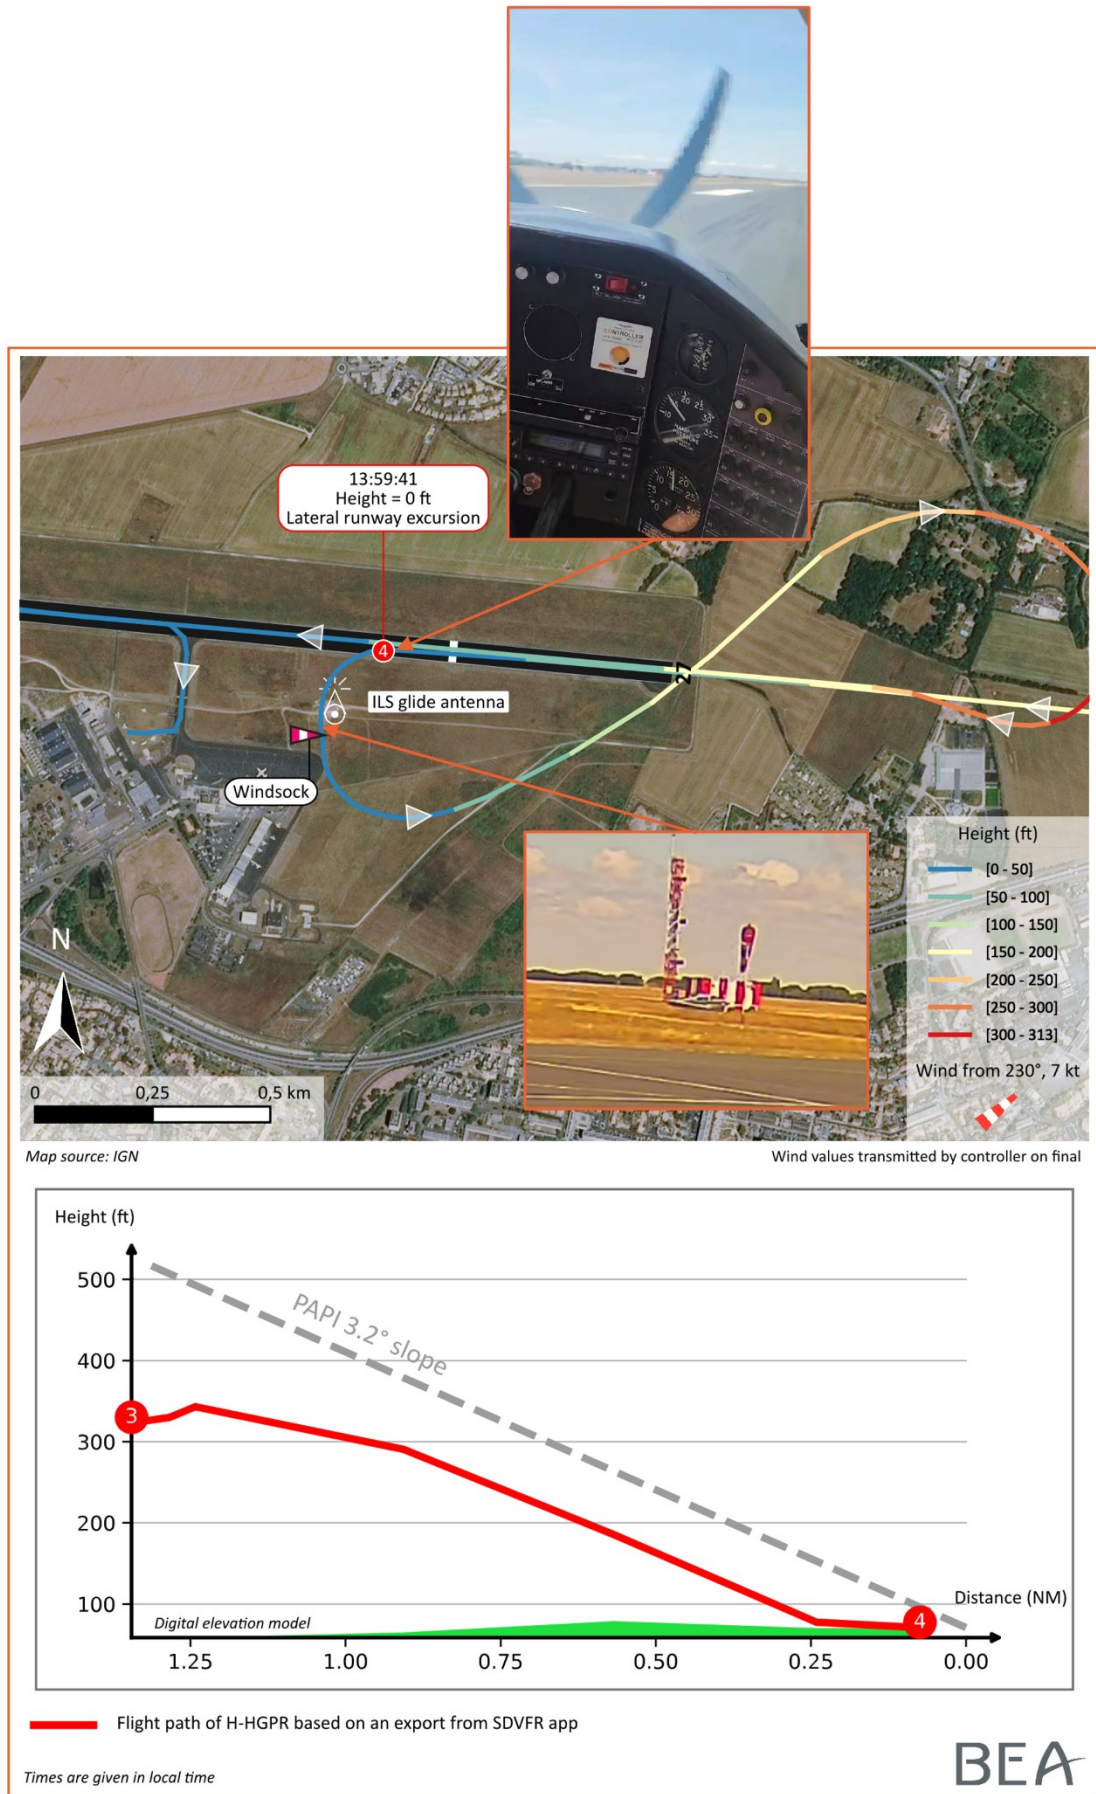
Figure 2: path based on SDVFR data

During the final, he realised that he was below the approach slope by observing four red lights on the PAPI. Nevertheless, he continued his approach. The aeroplane touched down on the runway around 50 m before the displaced threshold and bounced. When the aeroplane touched down on the runway again, it deviated slightly to the left. The pilot, afraid that he could exit the runway, went around. The aeroplane veered off the runway along a path almost perpendicular to the runway and passed close to the ILS Glide antenna and the windsock<sup>4</sup>. The aircraft then took off, adopted a bank angle to the left in climb, and passed close to the commercial aviation parking area at low height.

<sup>4</sup> Based on the path established using the SDVFR data, the aeroplane passed within 30 m of these obstacles.

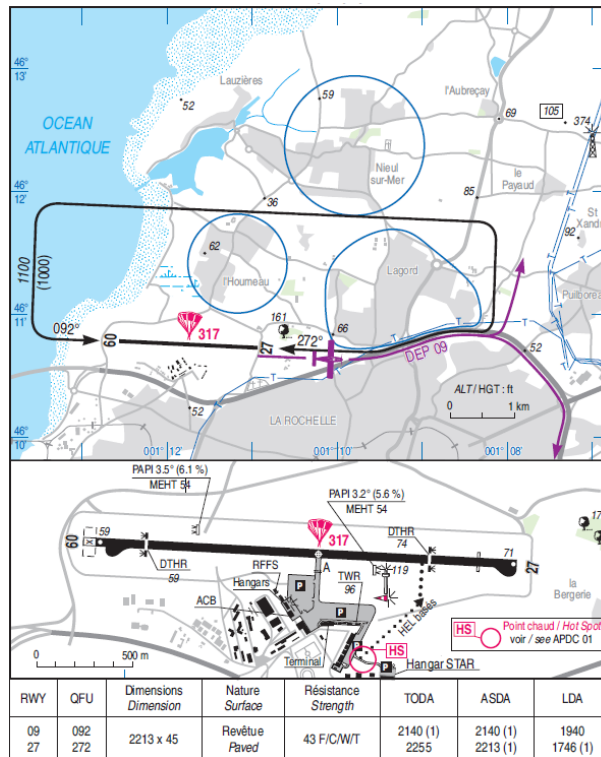
Figure 3: excerpt from the visual approach chart (Source: AIS)

In the special instructions of the approach chart, the following is specified for landing on runway 27: “Make final turn to intercept and follow ring road to RWY centre-line. PAPI is mandatory.” The PAPI for runway 27 is calibrated for a slope of 3.2° (5.6%).
