**Accident** to the SONACA S200  
registered **F-HGRA**  
on Saturday 5 October 2024  
at Espira-de-l'Agly

**Engine failure in initial climb, forced landing, during an instruction flight**

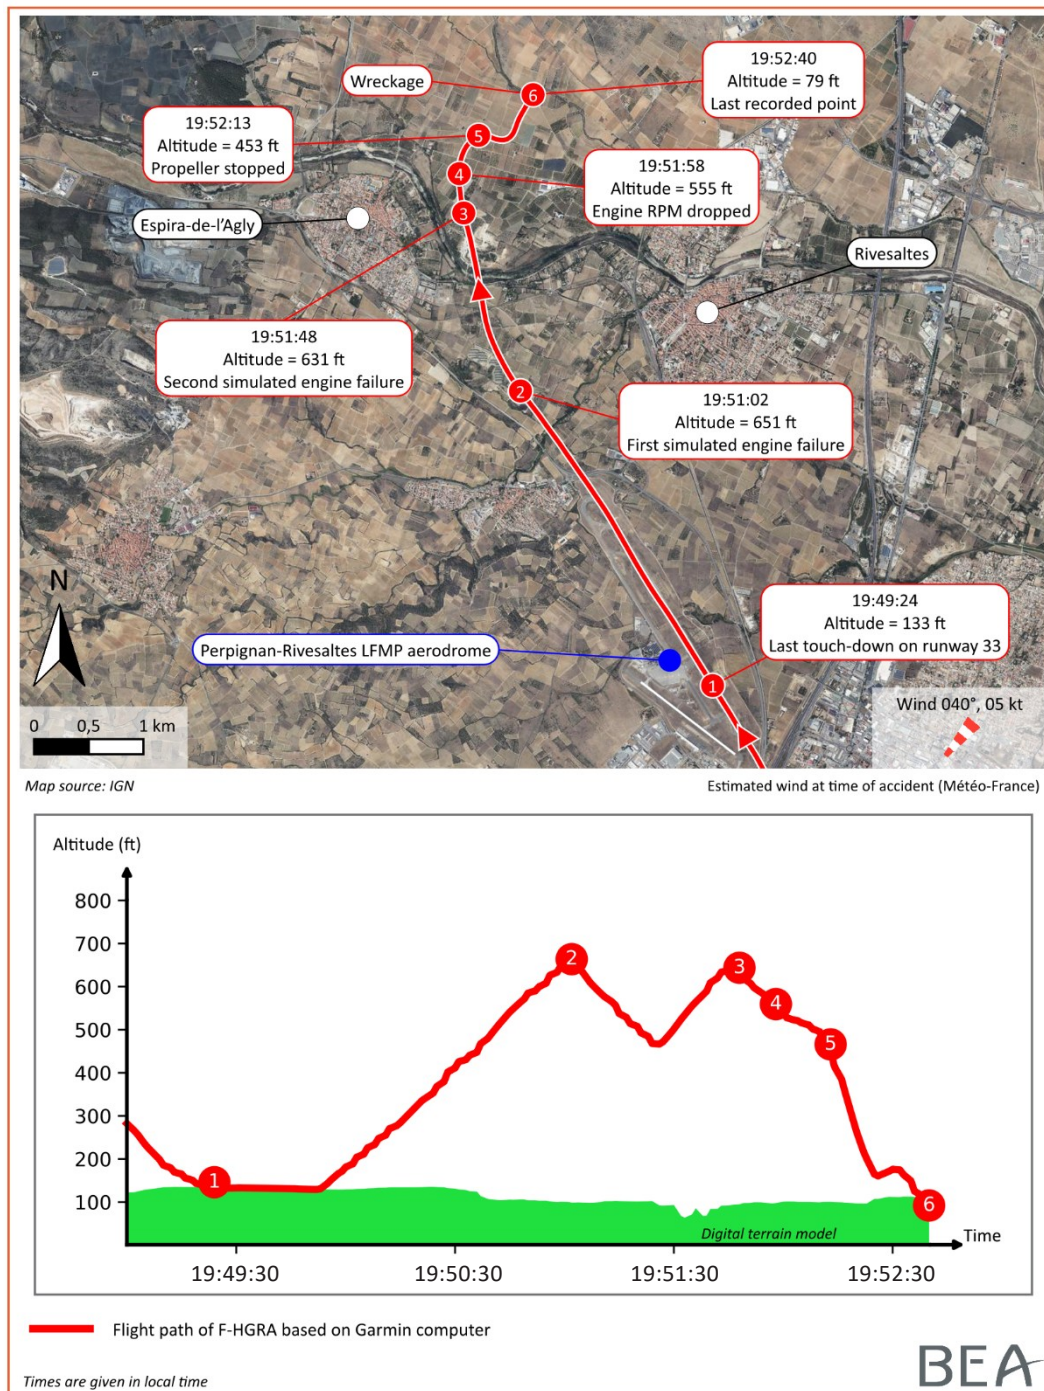
The student pilot started carrying out the expected actions but the instructor cut short the exercise in order to improve the sequence. After gaining some altitude, the instructor started the exercise again. The student pilot reduced the pitch attitude of the aeroplane and directed the flight path towards an obstacle-free area. At a height that he thought to be 300 ft, the instructor indicated that they had arrived at the end of the exercise and took the controls. Despite power control inputs, he was unable to increase the engine speed. He changed the fuel tank selection and activated the electric auxiliary pump. A short time later, the propeller stopped. The instructor carried out a forced landing. During the landing, the wing struck a pine tree and the aeroplane came to a stop in a ditch.

Figure 1: flight path of F-HGRA

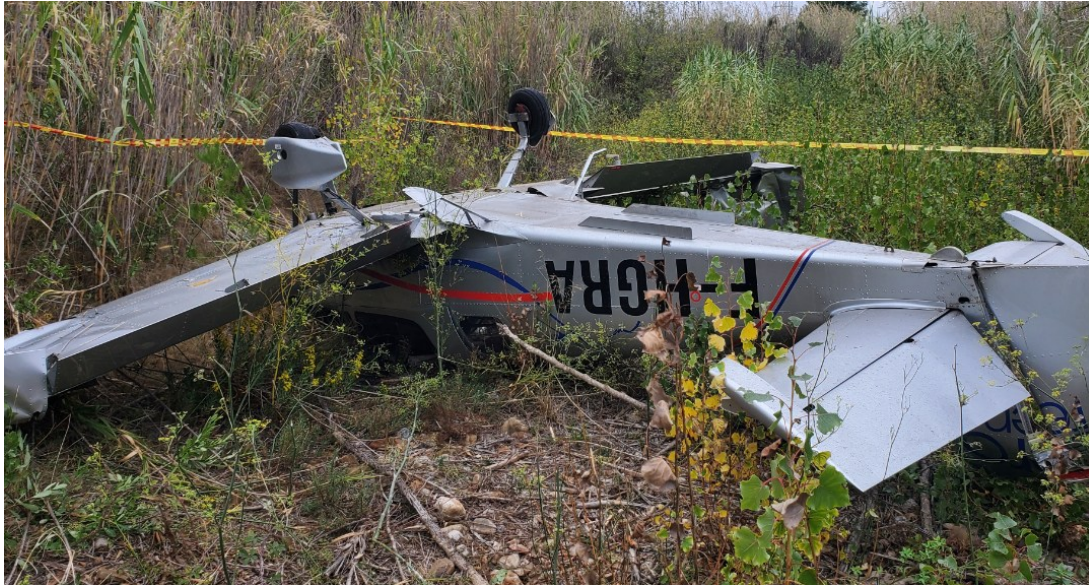
The aeroplane was lying on its back in a dry river bed. It had struck several trees before turning over in the river bed.

The damage observed on the wreckage was the result of the impact with the vegetation and the aeroplane turning over onto its back.

The flaps were extended to the landing position. The auxiliary pump switch was set to ON.

*Figure 2: wreckage of F- HGRA on accident site (source: BEA)*

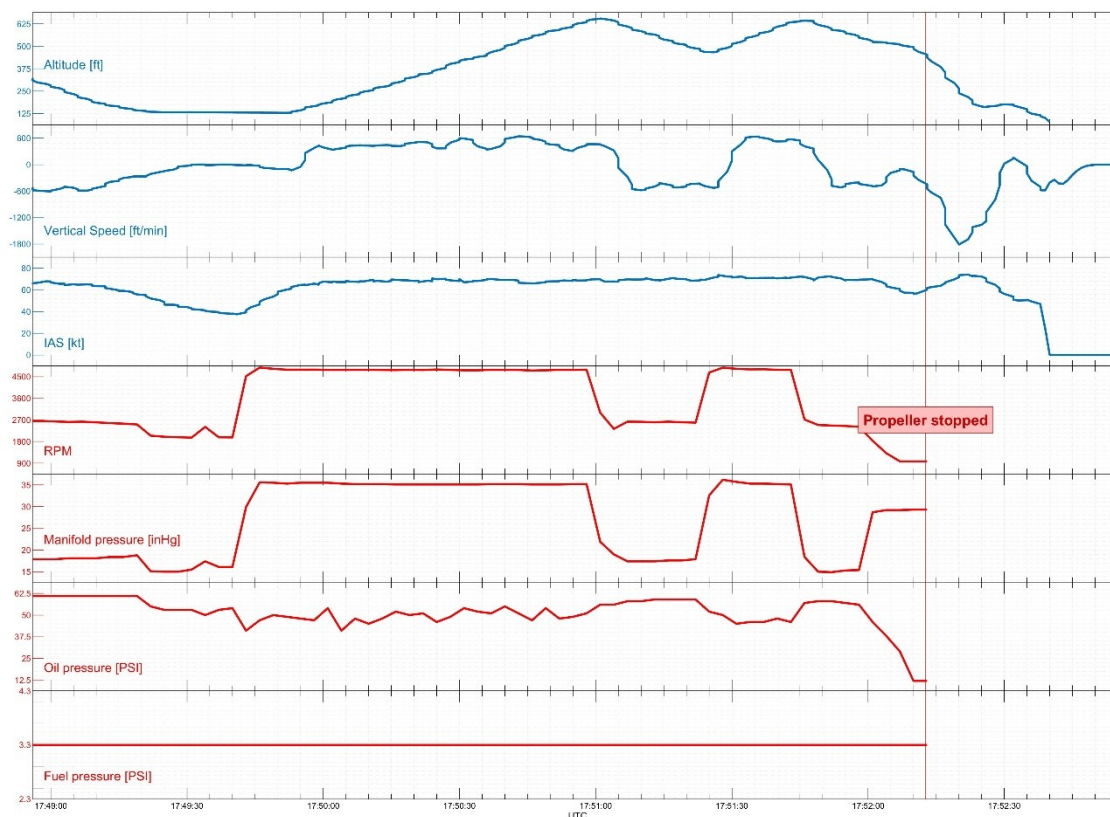
Figure 3: flight and engine parameters of F-HGRA

The analysis of the engine data recorded by the Engine Data Monitor (EDM) indicated nominal and stable fuel pressure and flow rates until the recording stopped. This finding rules out the hypothesis of the fuel system having dried out.

The Manifold Absolute Pressure (MAP) and engine speed (RPM) curves show a consistent trend until a gradual decrease in speed. After the final take-off, the data suggests an initial power reduction, followed by a power increase with climb, and then a second reduction. This data is consistent with the execution of the two successive failure exercises.

Several seconds after the second reduction, the decrease in engine speed below idle, correlating with the manifold pressure rising towards the atmospheric pressure, indicates that the engine was no longer delivering power.

A windmilling<sup>4</sup> phenomenon is identifiable for several seconds, until the Indicated AirSpeed (IAS) decreases, causing the propeller to stall and, consequently, the EDM recording to stop.
