Serious incident to the Beechcraft C90A “King Air”
registered **F-HHAM**
on Monday 23 May 2022
on approach to Paris - Le Bourget airport

**Subtle incapacitation, path deviation on approach,
temporary loss of control, proximity with an aeroplane on
approach to Paris - Charles de Gaulle airport**

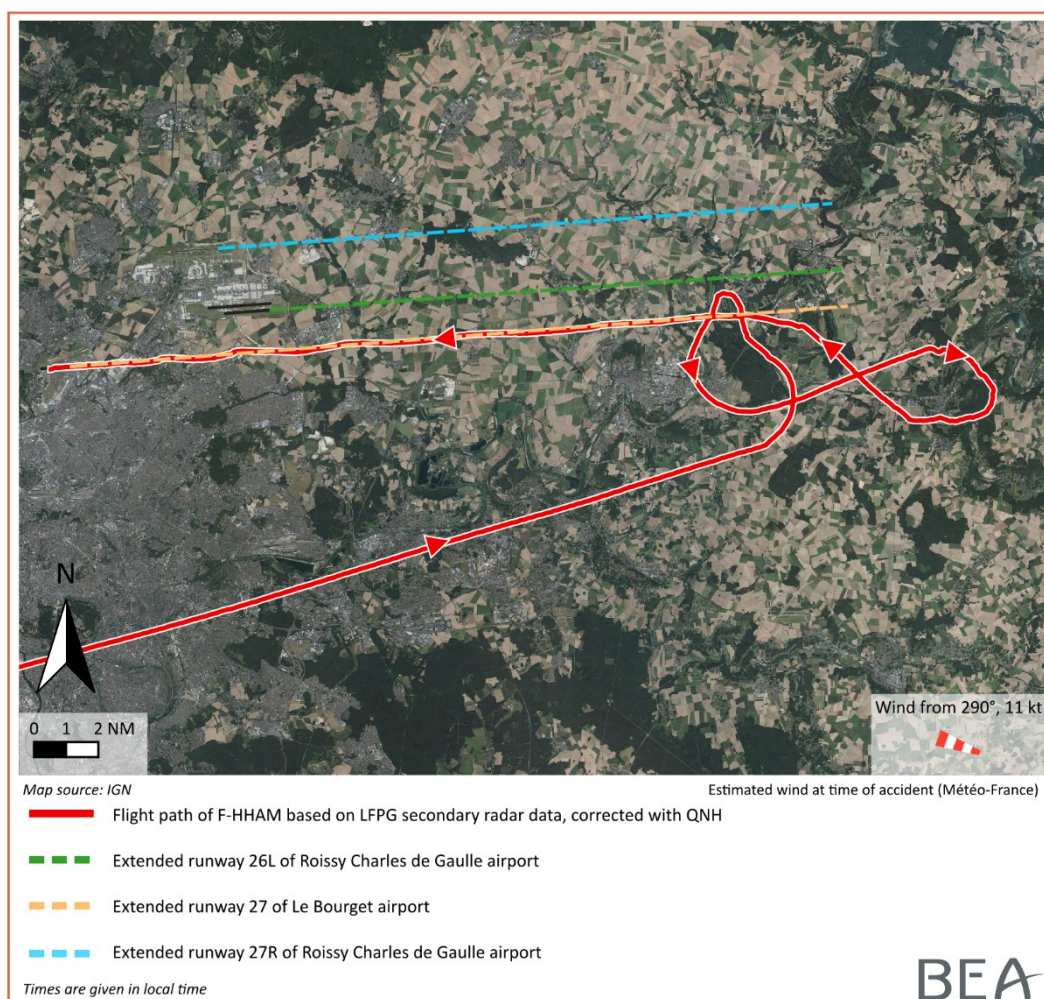
Figure 1: path of F-HHAM based on radar data

On arriving in the Paris - Charles de Gaulle (CDG) approach sector, the pilot was radar-vectored on a heading of 073°, at an altitude of 5,000 ft. The pilot then used the AutoPilot (AP) in HDG mode. The controller then asked the pilot to turn left onto a heading of 300° and cleared him for an ILS approach to runway 27 at Paris-Le Bourget airport. The pilot selected a heading of 300° on the AP. Shortly before intercepting the centreline, the aeroplane stopped following the 300° heading by turning right and crossed the centreline on a path roughly north.

After moving away to the south of the approach path and after discussions with the controller, the pilot indicated that he was continuing the approach based on the indications of the instruments on the right side. With radar vectoring, the pilot intercepted the centreline of ILS 27 in manual flight, then he flew the final approach and landed without further difficulty.

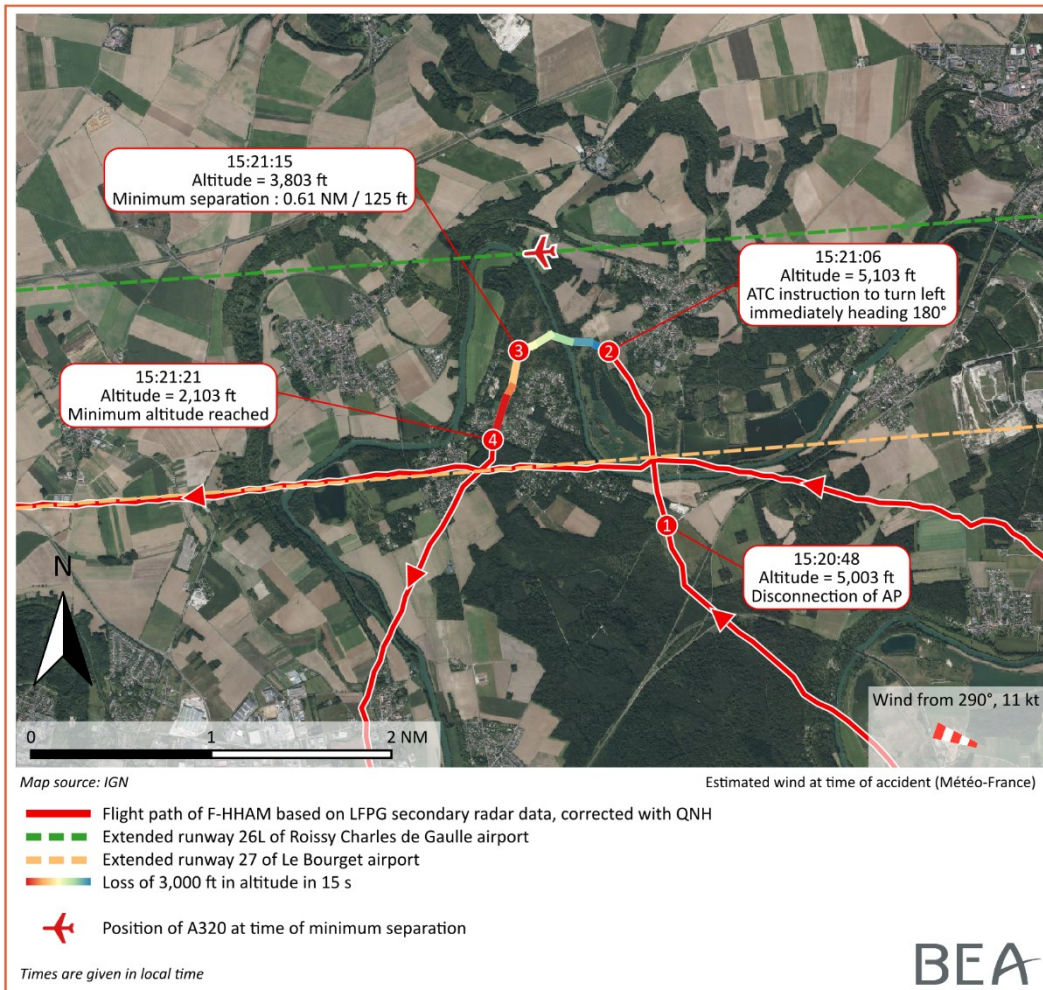
Figure 2: path of F-HHAM based on radar data (in green, the path of the second A320 nearby)

The controller immediately ordered the pilot to turn left onto a heading of 180° (see **Figure 2** point **2**), and the crew of an Airbus A320, on approach to runway 27R at CDG and at the same altitude as F-HHAM, to turn right onto a heading of 360°. The pilot of F-HHAM read back the message and turned left. During the manoeuvre, he lost control of the aeroplane, which descended by around 3,000 ft in 15 seconds. The pilot regained control of the aircraft, announced over the radio that there was a problem with the artificial horizon and then climbed back to 5,000 ft.

During the loss of control, the aeroplane came close to a second Airbus A320 established on the approach path to runway 26L at Paris-Charles de Gaulle, initially 1,000 ft below F-HHAM. The crew of the A320 indicated that the TCAS issued a traffic advisory immediately followed by a resolution advisory. The A320, equipped with the AP/FD TCAS mode⁴, descended automatically. After a descent of 200 ft, the AP levelled off the aeroplane. The minimum separation estimated by air navigation services was approximately 0.6 NM and 125 ft (point 3). This proximity triggered an alert from the air traffic control's conflict detection system (STCA) for a few seconds.

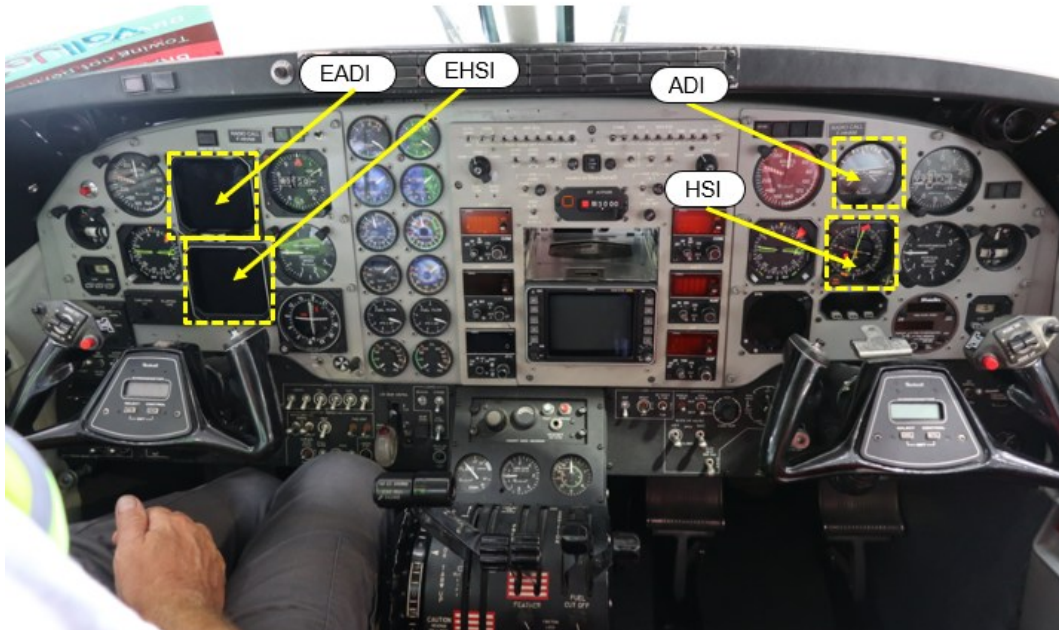
Figure 3: instrument panel of F-HHAM (Source: BEA)

F-HHAM features avionics incorporating digital systems, albeit with a predominantly analogue display. Flight parameters are not recorded.

After regaining control of the aeroplane, he noticed a discrepancy between the horizon indication on the left side and that on the right side, as well as between the EHSI and the HSI. He made the end of the flight manually, relying on the instruments on the right side. He specified that shortly before landing, the indications on the right side and on the left side became consistent with each other again.

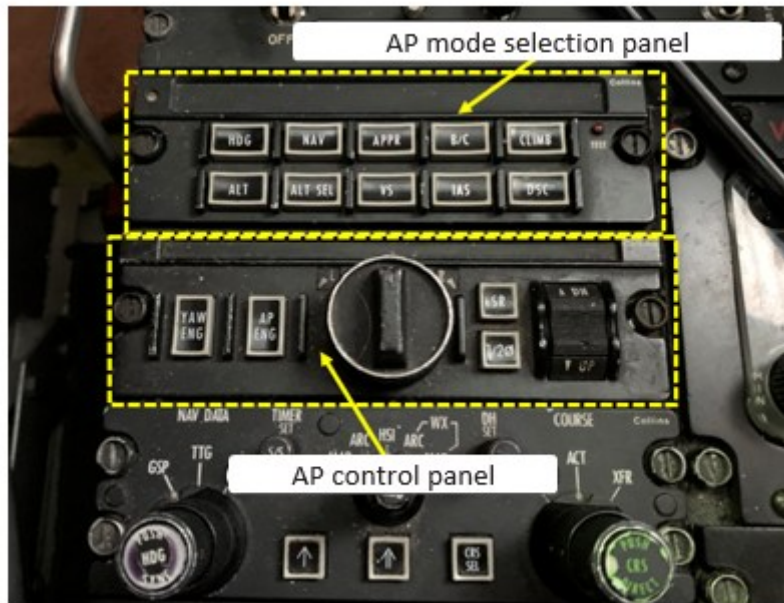
Figure 4: F-HHAM's AP control and mode selection panels (Source: BEA)

During these tests, the heading displayed on the EHSI was found to be correct and the flux valve slaving system was found to be functional. The AP also performed as expected during all the ground tests, which included using the APPR mode with a cut-off box simulating an ILS signal. Still using the cut-off box on the ground, simulations of an ILS path acquisition (with HDG mode engaged, and APPR mode armed) did not show any anomalies.

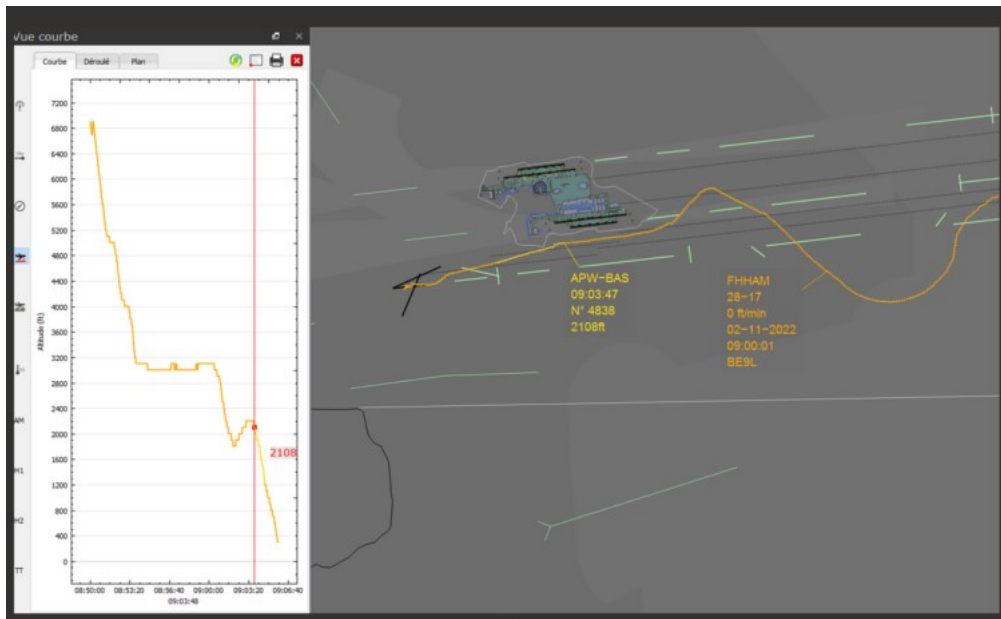
Figure 5: ELVIRA screenshot (Source: DSNA)

The BEA was notified by the air navigation services of a similar incident to F-HHAM on 2 November 2022 during an approach to Paris - Le Bourget airport. During this incident, the pilot⁸ had difficulty intercepting the approach path to runway 27 at Paris-Le Bourget airport. On several occasions, the pilot crossed the approach path without managing to intercept it. The controller regularly provided the pilot with headings and gave him his position in relation to Paris - Le Bourget airport on several occasions. When questioned by the controller, the pilot reported that he had a "GPS flickering problem". After landing, the pilot announced to the controller that he had experienced AP problems. He recorded an AP cut-off problem on approach in the aeroplane's Technical Log Book.

The pilot at the controls during this incident indicated that this was an own-account flight with three passengers seated in the rear seat. During the first interception of LOC 27 at Le Bourget, he engaged APPR mode. He specified that he had checked the selected frequency as well as the heading. He then noticed that the LOC and Glide information had disappeared from the EADI, and the AP disconnected without any input from him. He engaged the HDG mode and tried to manage the fault. He specified that he focused on the fault and may have lacked concentration in conducting the flight. Once he had sight of runway 27 at Le Bourget, he did not manage to engage APPR mode and did not recover the LOC and Glide information. He therefore continued the visual approach, without encountering any particular difficulties. He specified that, during the approach and landing, the weather conditions were VMC. The pilot added that he did not observe any discrepancy between the instrument indications on the left side and on the right side.
