Accident to the CAMERON - A300
registered **F-HHLC**
on 16 September 2022
at Le Liège

This is a courtesy translation by the BEA of the Final Report on the Safety Investigation. As accurate as the translation may be, the original text in French is the work of reference.

**Hard landing, injury to passengers,
during a sightseeing flight**

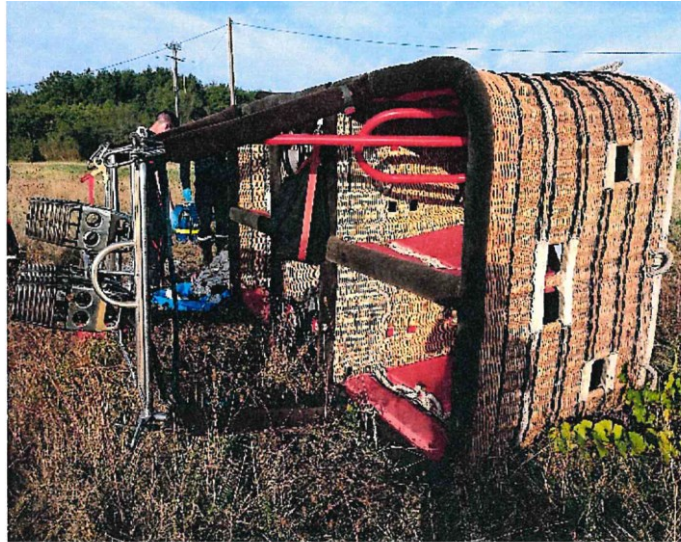
After approximately 50 minutes of flight in nominal conditions, the pilot initiated the procedure to land in a field located in the commune of Le Liège (Indre-et-Loire). The pilot stabilized his approach five metres above the ground at approximately 15 km/h (i.e. approximately 4 m/s)² and asked the passengers to adopt the safety position that he had demonstrated to them before the flight. He then flew over a low voltage line and a telephone line and repeated instructions to the passengers asking them to hold on tight. The basket touched down with a vertical speed that he estimated to be approximately 1 m/s, tipped onto its long side and dragged along the ground for approximately four metres before coming to a stop.

Figure 1: basket after the accident (Source: GTA)

She indicated that the balloon “*crashed to the ground*” just as it was about to land. According to her, it bounced two or three times before tipping onto its side. She specified that she was then sat in the corner of the basket that made contact with the ground first.

On landing, the basket tipped over and one of the passengers, probably taken by surprise, was unable to maintain the safety position and was thrown onto her friend, resulting in injuries to two people.
