Accident to the ISSOIRE AVIATION - APM30
registered **F-HHOP**
on Sunday, 2 August 2020
at Arras-Roclincourt (Pas-de-Calais)

Rupture of left flap control, loss of control during approach, collision with ground

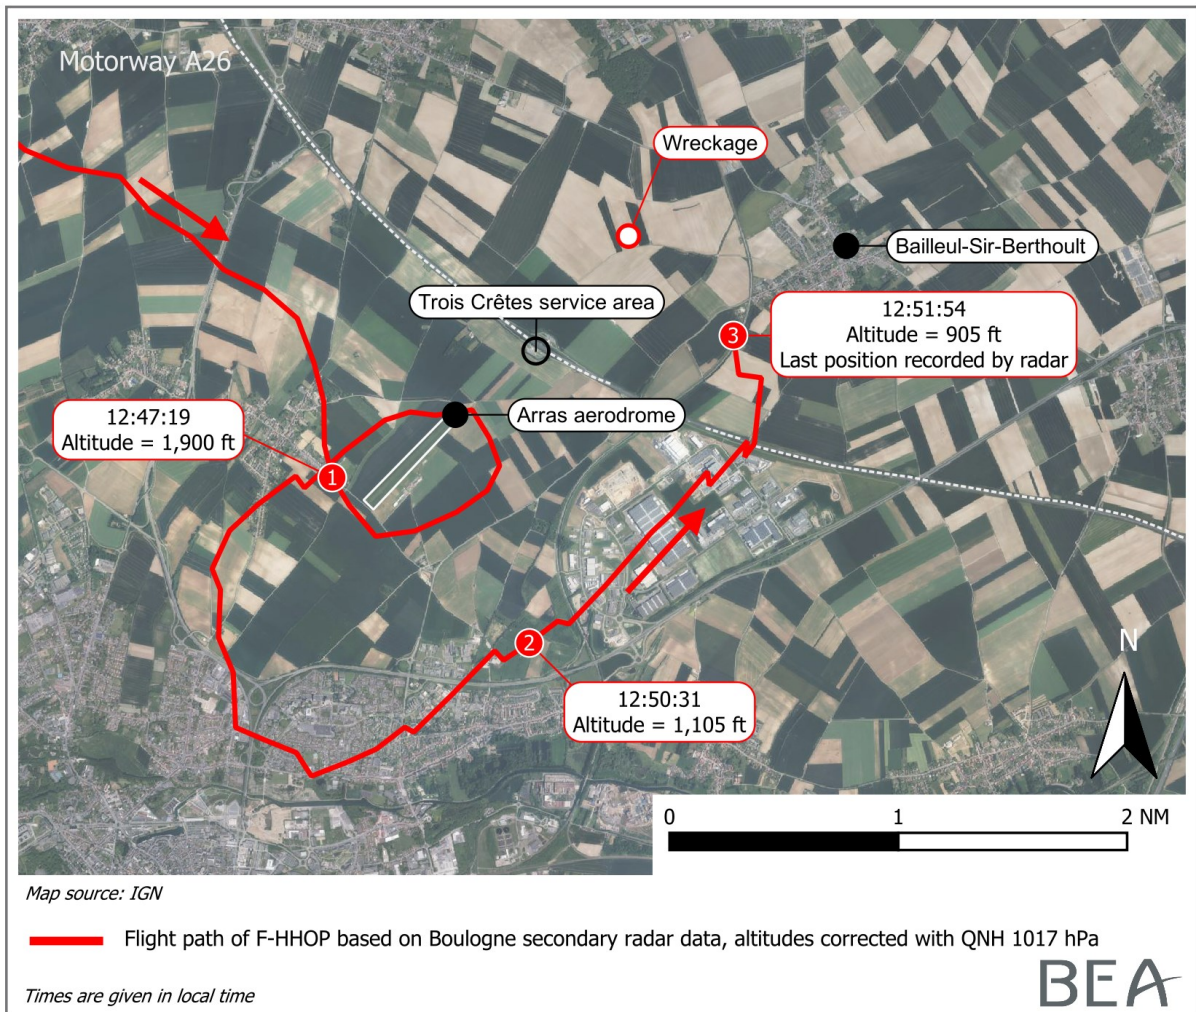
On his return, the pilot flew overhead Arras-Roclincourt aerodrome (see **Figure 1**, point ①) and after turning for a reconnaissance, he headed towards the downwind leg of the aerodrome circuit for runway 22 (point ②). At 12:51, the pilot started the descent. At 12:53, the aeroplane collided with the ground on the axis of the runway and came to a stop in a field of tall corn.

Figure 1: end of flight path of F-HHOP

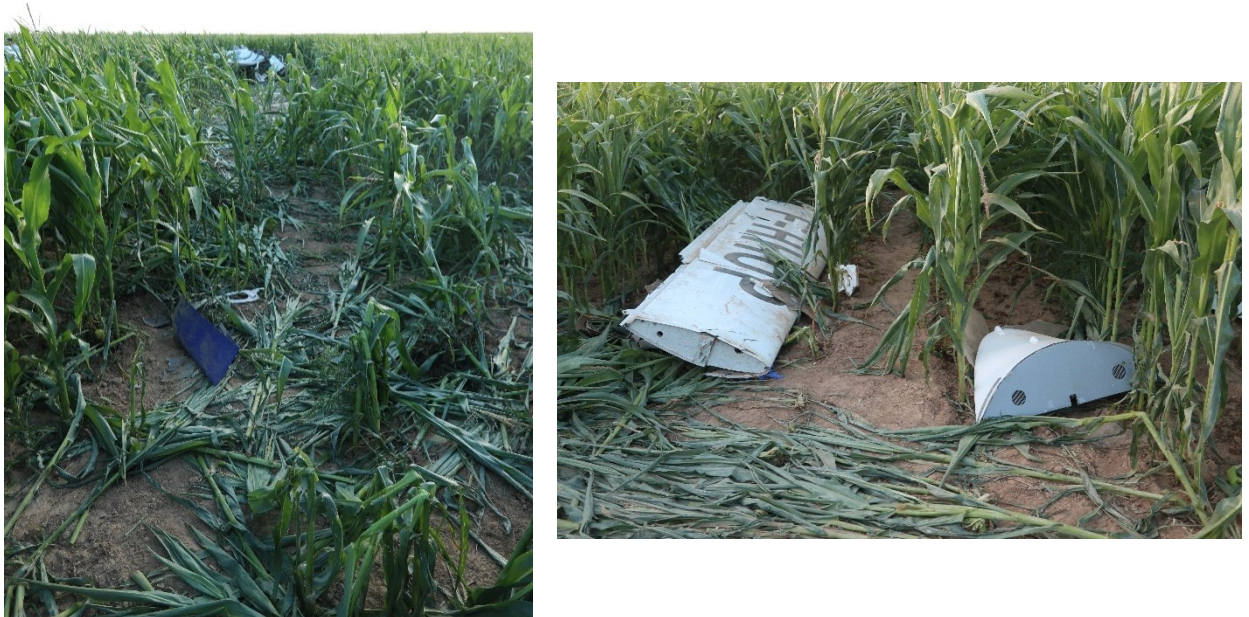
A first impact mark was located around 50 m north-east of the position of the main wreckage. The observation of the site and wreckage found that the aeroplane's left wing had struck the ground and then torn off (see **Figure 3**). The energy at the time of the collision with the ground was moderate.

Figure 3: views of wreckage from initial impact point (on left), and left wing found between the first point of impact and the main wreckage (on right) (source: BEA)

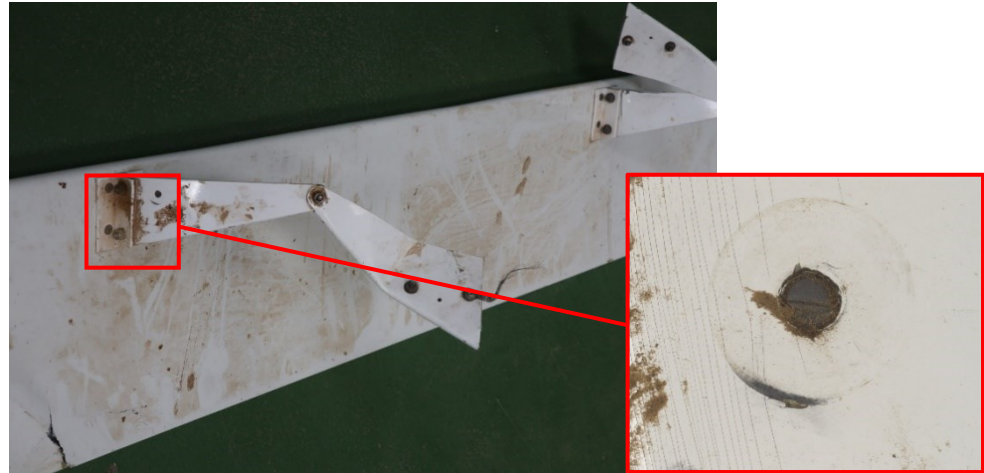
The screw which fastened the left flap actuating rod to the flap itself had failed (see **Figure 6**, item 41). One end of this screw was still in place in the flap attachment (see **Figure 4**), the other end was found on the site between the area of the first impact and the position of the wreckage. The conical washer (see **Figure 6**, item 40) was not found. Detailed information about the results of the laboratory examination of the ruptured screw are given in paragraph 2.2.3.

Figure 4: left flap arm and end of rod attaching screw in position in bore hole (source: BEA)

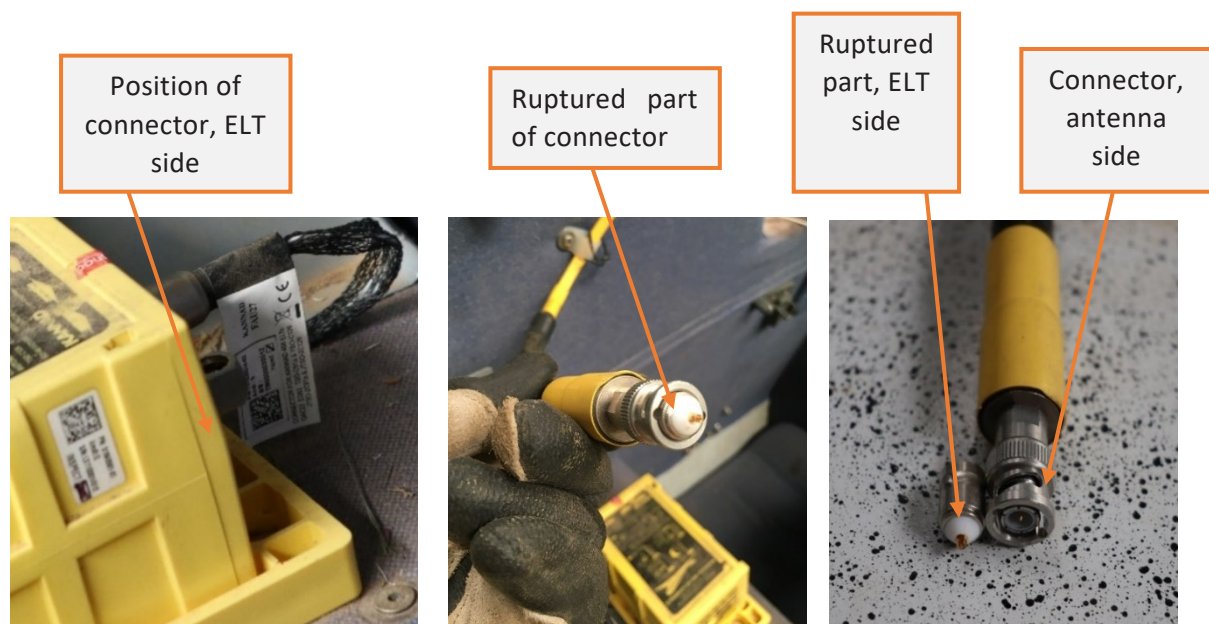
The emergency locator transmitter (ELT) and the antenna were found attached to their respective mounts in the aeroplane. However, the connector connecting the ELT to the antenna was found broken (see **Figure 5**).

Figure 5: ruptured elbow connector between the ELT and the antenna (source: BEA)

The emergency locator transmitter (ELT) was effectively activated on impact. However, the distress signal was not emitted due to the connector linking the ELT to the interior antenna, fixed to the back of the pilot's seat, having ruptured. This meant that the associated search procedures were not launched. While it is probable that the accidental rupture of the connector was prior to the accident flight, the BEA cannot rule out the possibility that the connector ruptured on impact with the ground.

The investigation found that the connector linking the ELT to the antenna was ruptured on F-HHOP. The connector was probably damaged before the accident flight when a passenger took the rear seat or on positioning an object on the seat or from a harness shoulder strap, although it is not possible to rule out the possibility of the connector having ruptured on impact.

The rupture of the ELT-antenna connector which prevented the distress signal from being transmitted correctly, could probably have been avoided by protecting the ELT and its accessories.

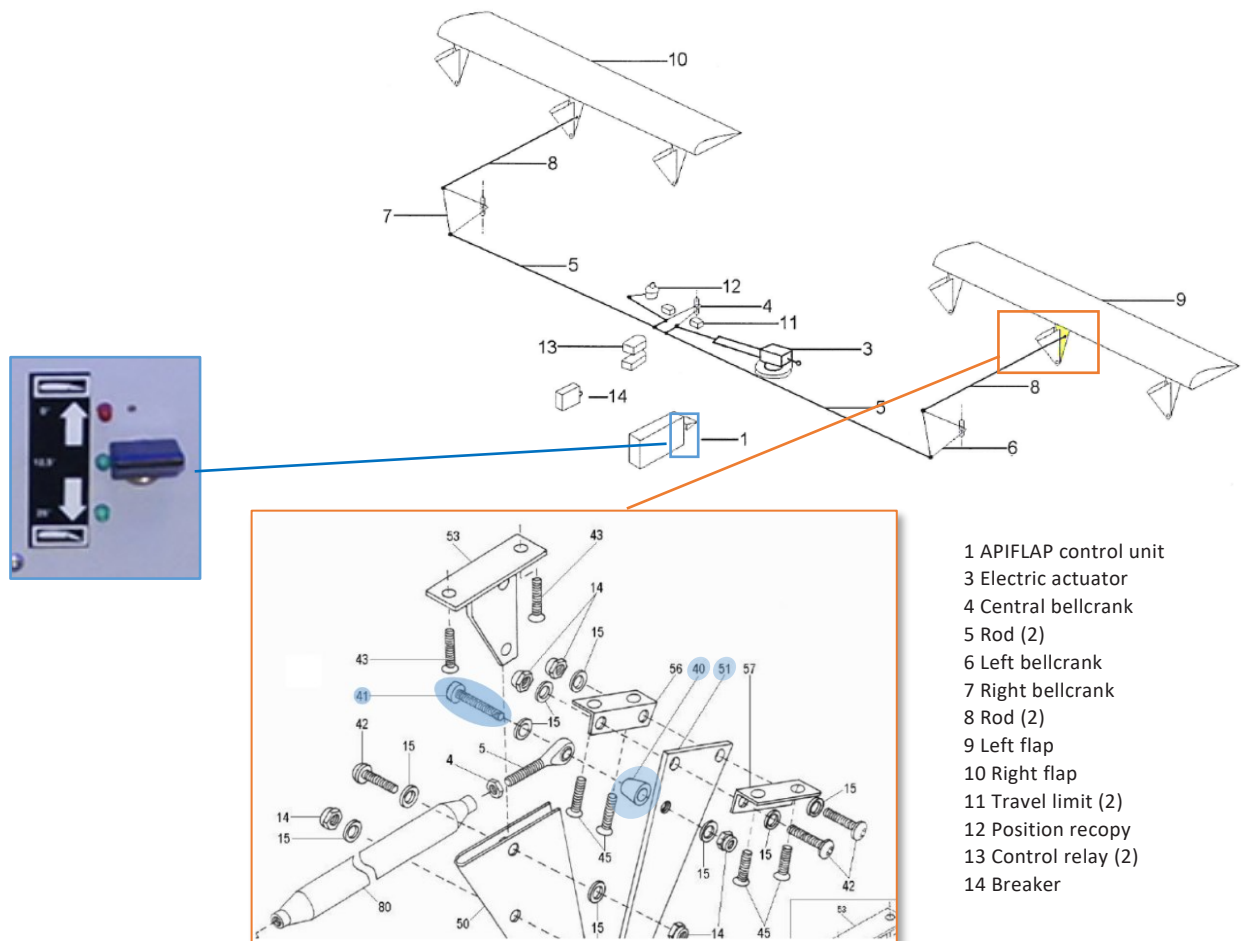
The flap selector (see **Figure 6**, item 1) has three positions: 0, 12.5° (take-off) and 25° (landing). The flaps are controlled by a multi-function unit which actions the electrical control actuator (item 3) and are mechanically interconnected by a system of metal rods and composite bellcranks as described in **Figure 6** below.

Figure 6: diagram of wing flap actuating mechanism on the APM30
(source: Isoire Aviation, annotated by the BEA)

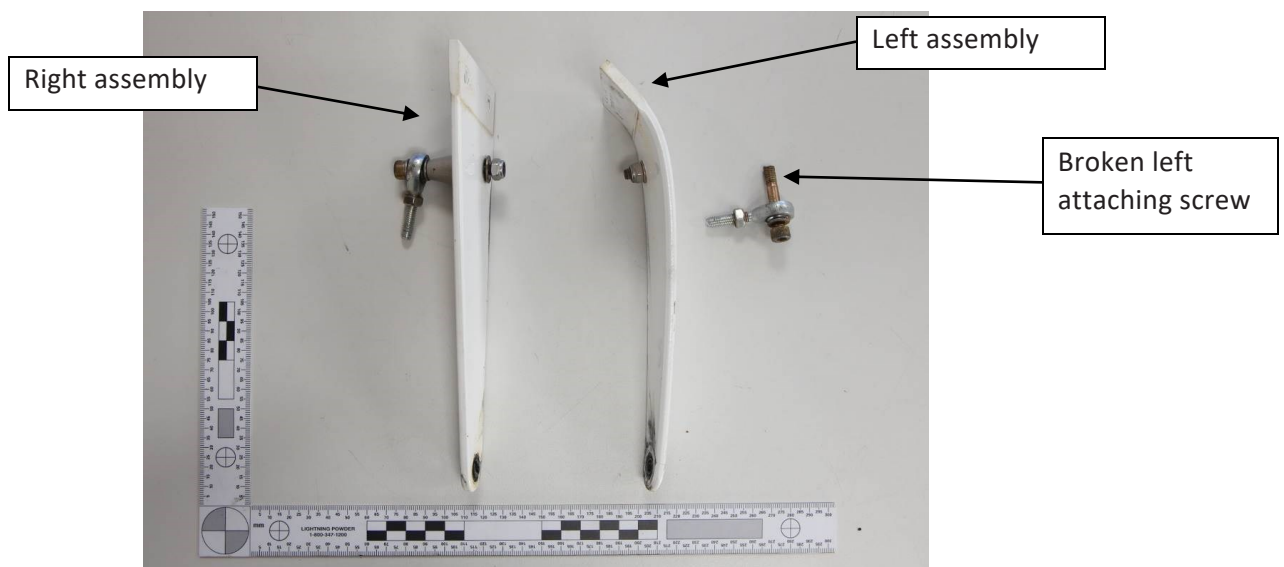
The left flap arm (see **Figure 6**, item 51) and the screw attaching it to the control rod (item 41) were removed for detailed examination in the BEA laboratory. The equivalent system on the right side of the aircraft was also removed (see **Figure 7**).

Figure 7: examined flap arms of F-HHOP (source: BEA)

The left attaching screw had failed in the root of the thread, 35 mm below the screw head. There was no visible deformation of the screw along its length. The material used, its microstructure and its hardness complied with the expected requirements for a screw of this type⁶.

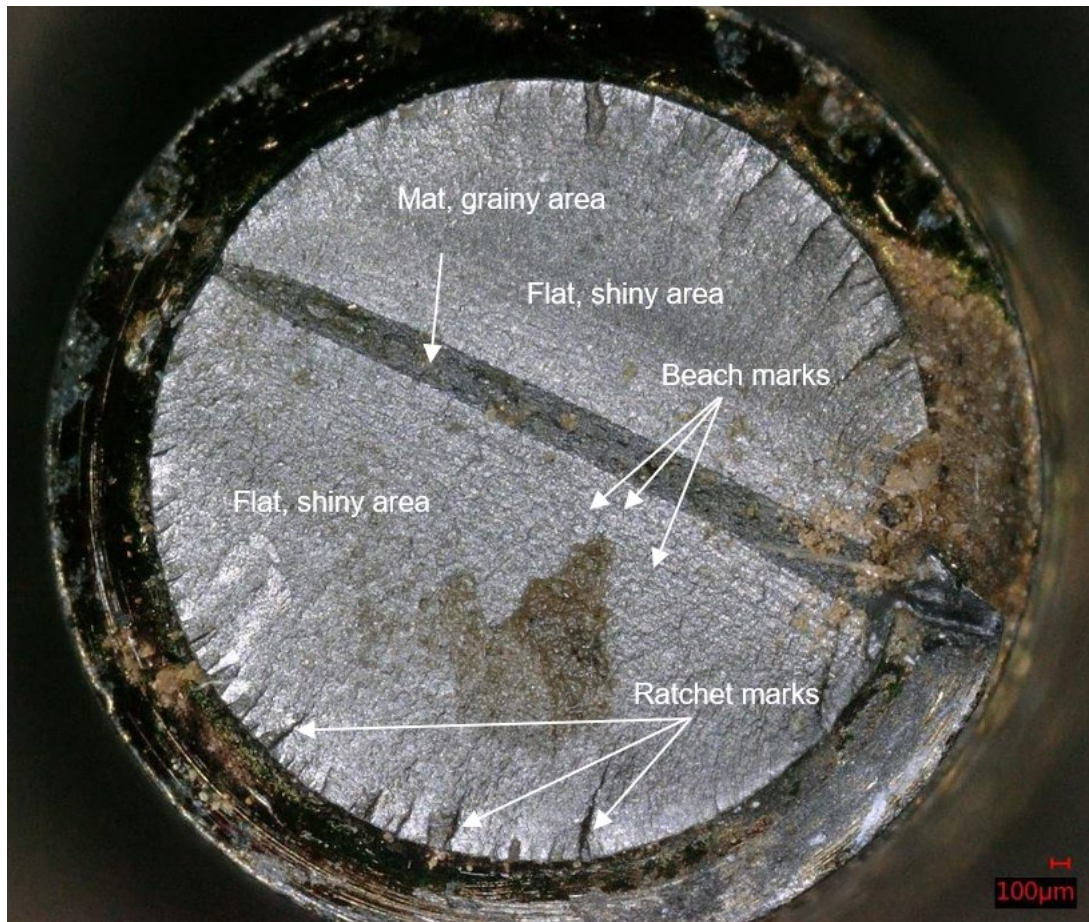
All of the characteristics observed during the visual examination (see **Figure 8**) and under the scanning electron microscope (SEM) indicate that the screw had failed as a result of a fatigue cracking process under alternating bending loads.

A multitude of micro-cracks had begun in the root of the thread, joining to form ratchet marks and eventually forming two main cracks, diametrically opposed. They continued to propagate until the remaining stressed section of the screw was no longer sufficient to withstand the in-service loads, leading to its complete failure (matt and grainy area characteristic of a sudden overload failure).

Figure 8: fracture face of broken left attaching screw (source: BEA)

The scanning electron microscope (SEM) analyses of screw (41) on the left side of F-HHOP, carried out at the BEA, found that it had failed as a result of a fatigue cracking process under alternating bending loads. The failure of this screw is liable to result in the asymmetric extension of the flaps, the aerodynamic effects of which might compromise the controllability of the aeroplane. The asymmetric marks left by the conical washers on the left arm are consistent with a tightness fault of the screwed assembly without it being possible to determine the exact cause of this. A tightness fault can contribute to the development of a fatigue cracking process.

EASA ensure that Issoire Aviation carry out the relevant examinations of the collected screws, and analyses of the results in order to determine whether or not the risk of failure persists, and impose new preventive measures if these prove necessary. [Recommendation FRAN-2024-004].

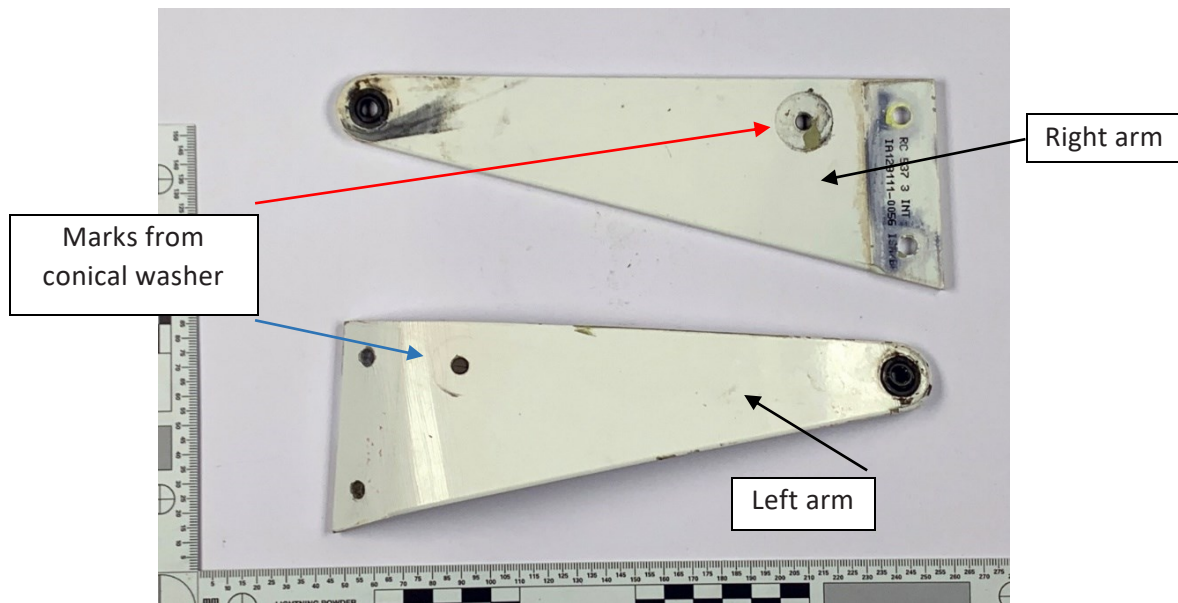
The right and left arms of F-HHOP were also examined (see **Figure 9**). A deformation of the left arm was observed, characteristic of abnormally high loads probably following the separation of the left wing when the aircraft collided with the ground. After removing the screwed assemblies,

it was observed that the conical washer had only left a mark in one sector on the left arm (blue arrow) whereas the mark on the right side was clearer with a more homogeneous circumference (red arrow). The asymmetric mark on the left arm corresponded to the direction of application of the bending forces of the screw/conical washer assembly. This finding was consistent with incorrect tightening of the screwed assembly, leading to the introduction of abnormally high bending forces within the left attaching screw.

Figure 9: right and left arms of F-HHOP (source: BEA)

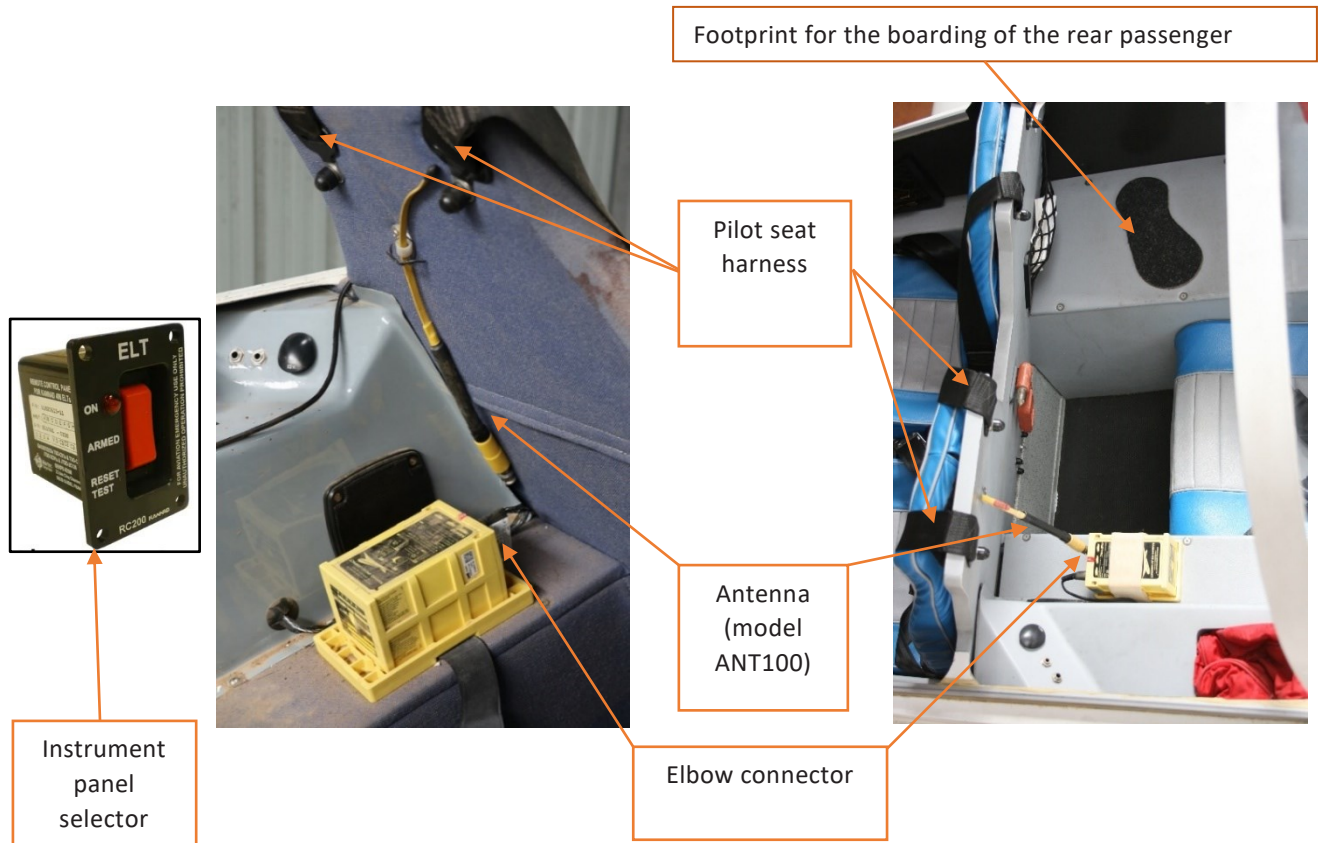
The ELT installed in F-HHOP was a Kannad 406 AF Compact. It was fixed on a mount attached to the aeroplane structure (ledge on left side of rear passenger seat). The ELT was connected via an elbow connector to an interior antenna Kannad ANT 100 fixed to the rear of the pilot's seat. The Kannad 406 AF Compact models were not equipped with a built-in GPS antenna. According to the serial numbers of the APM30s, the ELT antenna was fixed in different ways to the back of the pilot's seat.

Figure 10: installation of ELT in F-HHOP
(source: BEA)

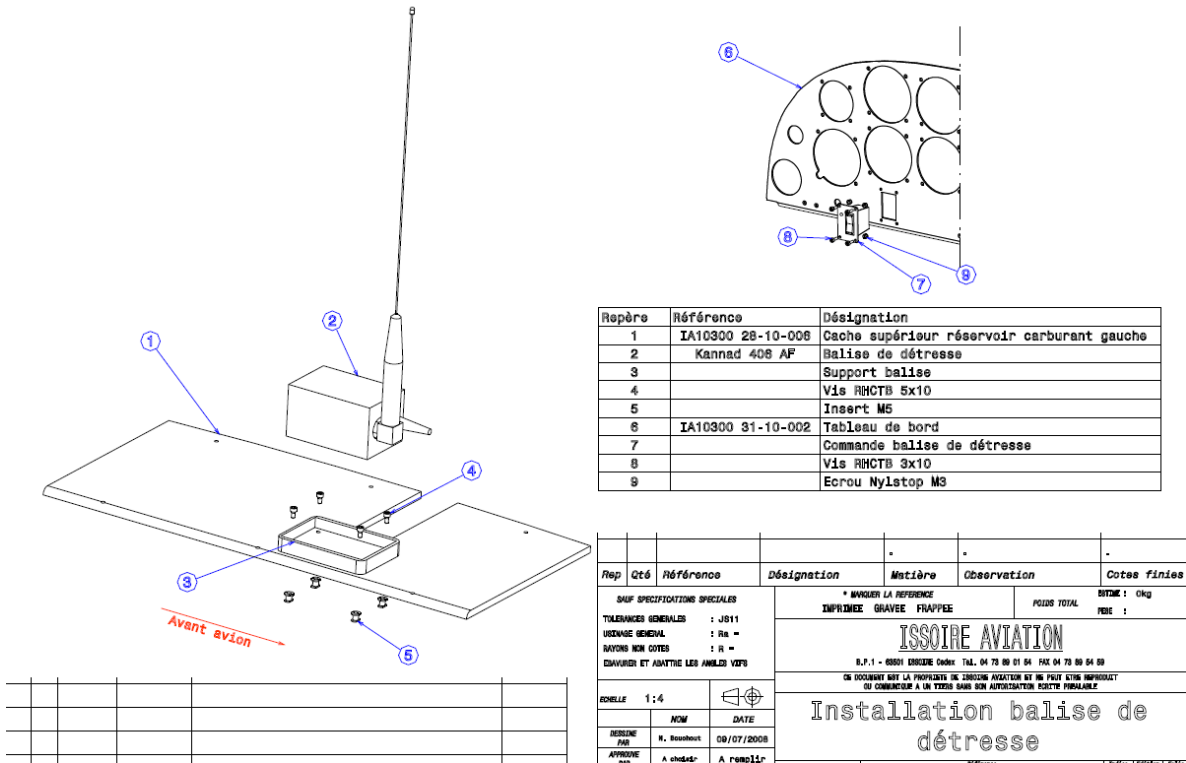
Furthermore, it could be understood from the diagram in the appendix of the file (see **Figure 12**) that this was an approved external antenna model and that the antenna was joined to the ELT and not attached to the back of the pilot's seat. This modification file was approved by EASA on 21 July 2008 by a "Minor change approval" referenced EASA.A.C10413.

Figure 12: diagram in the ELT modification file (source: Issoire Aviation)
