Accident to the Cameron Z180
registered **F-HIII** operated by Montgolfières d'Anjou
on Wednesday 19 July 2023
at Longué-Jumelles

Power line strike during landing, incipient basket fire

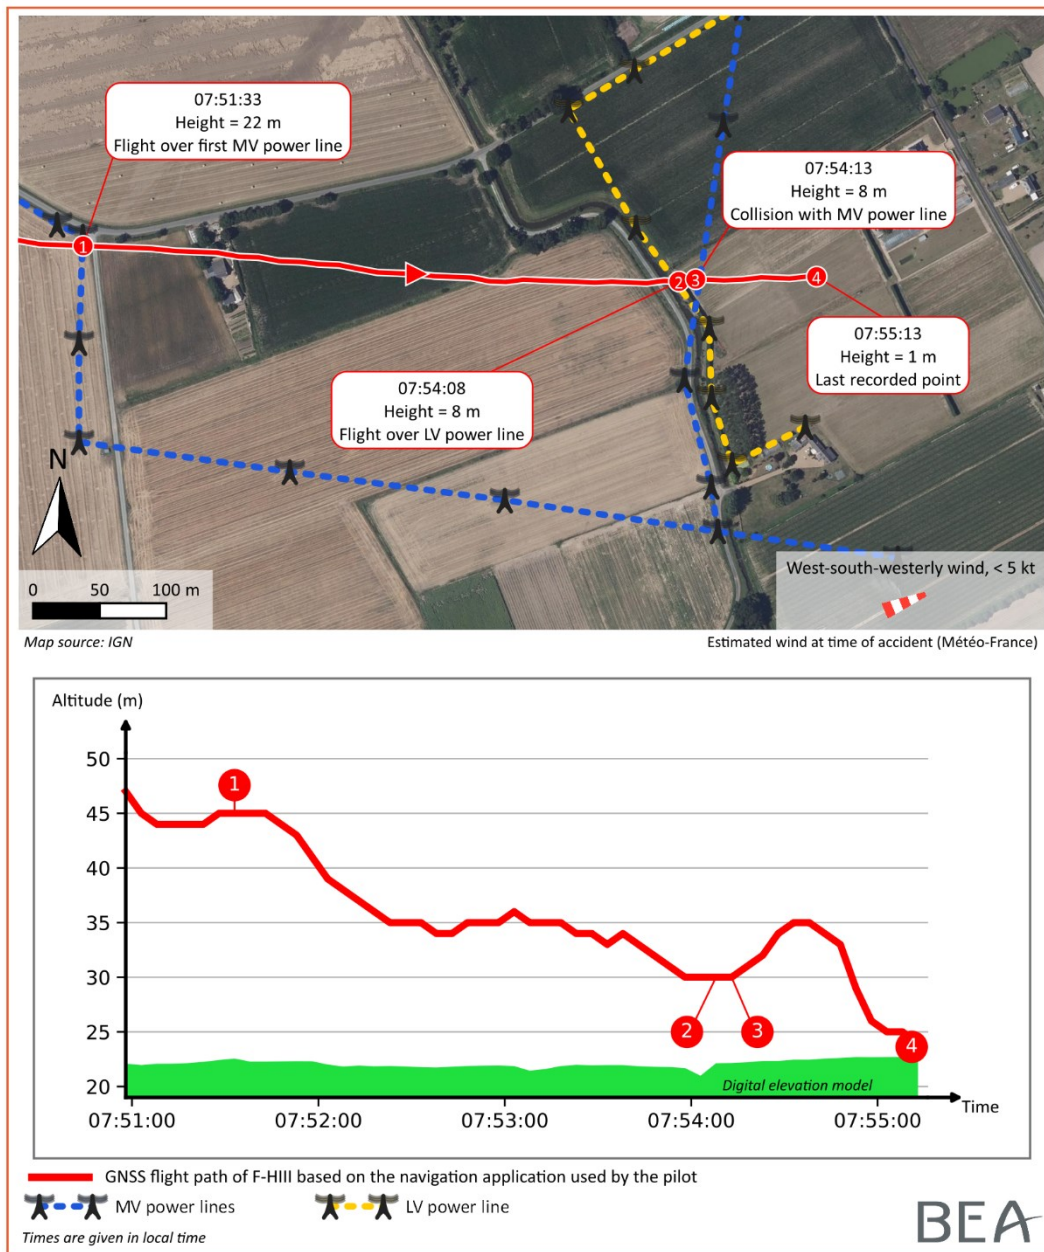
After a flight time of around 45 min, the pilot started to look for a landing site and reminded the passengers of the safety instructions who took up their landing positions in the basket. The pilot identified a field for landing, close to a farm allowing access for picking up the passengers and material. He detected two power lines, a 20,000 MV³ line (see **Figure 1**, point **1**) and a LV⁴ line (point **2**), nearly perpendicular to the flight path. In descent towards the field, he saw that behind the LV line that he was about to fly over, there were cables from another MV line that were higher than the LV line and with poles spaced further apart. He immediately made an input on the two burners. The balloon did not sufficiently climb and the lower part of the pilot's compartment came into contact with the cables of the power line (point **3**), at a height of around 8 m. The three cables of the line were severed. The pilot saw an electric arc in his compartment. The balloon continued its flight path and the pilot landed in the field a few seconds later less than 100 m after the line, with the basket and envelope vertical (point **4**). The pilot had the passengers exit the basket; this was done without any particular difficulty.

Figure 1: flight path of F-HIII
