Accident to the DIAMOND - DA42 - NG
registered **F-HIMY**
on 16 June 2022
at Courchevel

**Runway overrun, collision with a bank, in mountain flight,
in instruction**

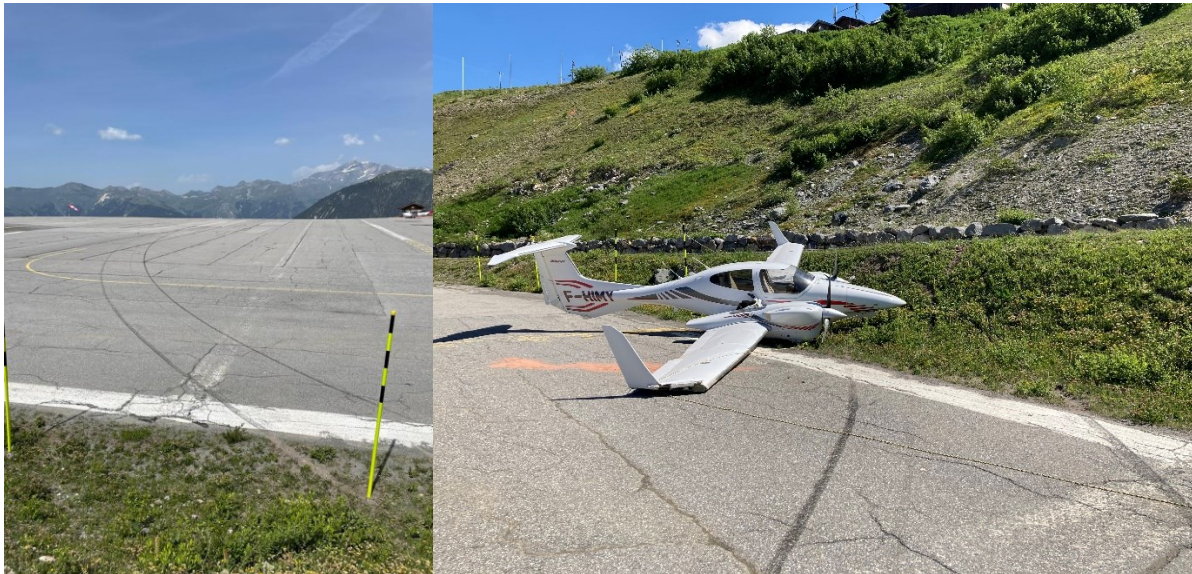
Braking marks started in the last meters of the slope at 18.66% and continued to the wreckage. Their direction and spacing showed that the aeroplane had slipped on turning left and continued its run until it struck the bank. It spun around before coming to rest at the bottom of the bank. The flaps were retracted at the time of the collision with the bank.

No anomaly which could have contributed to the accident was identified on the aeroplane.

Figure 3: photo of braking marks (on left) and of aeroplane (on right) (source: BEA)

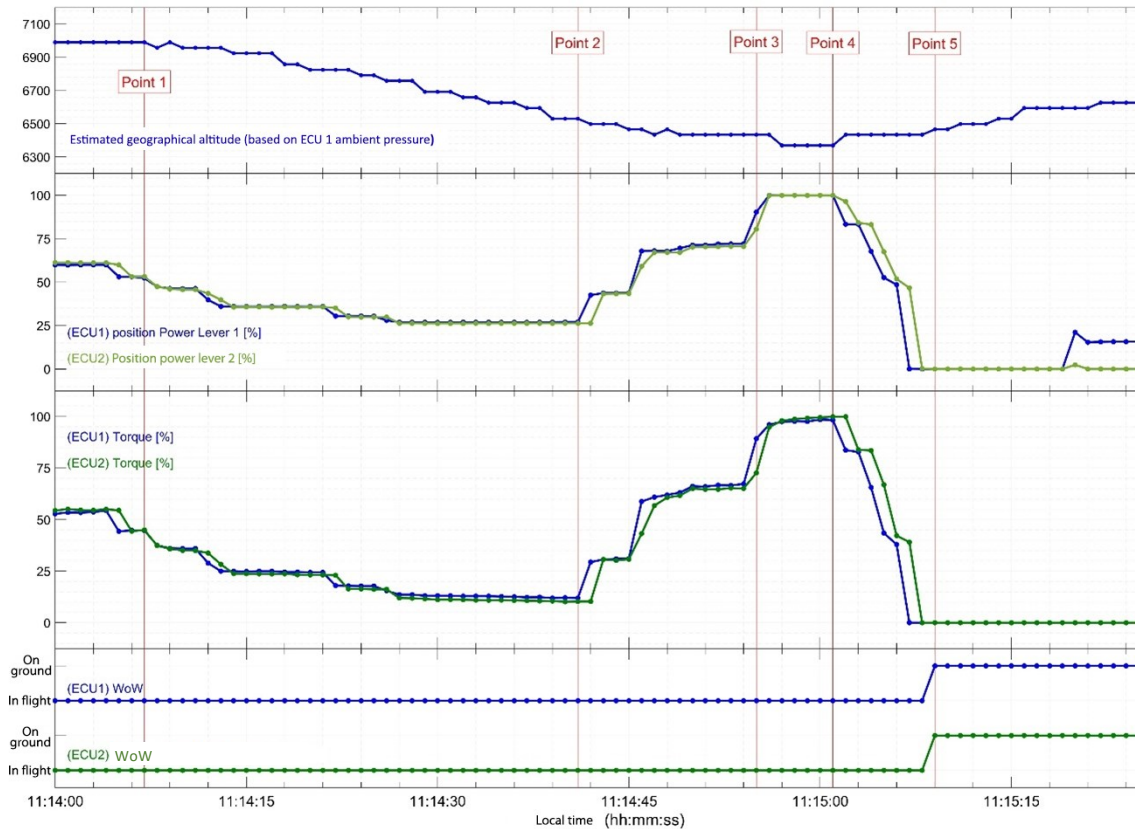
Figure 4: evolution of parameters recorded by ECUs

- At 11:14:07 (see Figure 4, Point 1), at an estimated altitude of 7,000 ft, the aeroplane was on the final approach and the pilot started the descent. In the following 20 s, the pilot continued to reduce power (position of power levers moved from 48% to 27%).
- Between 11:14:12 and 11:14:45, the aeroplane’s average vertical speed was stable, estimated at -920 ft/min.
- From 11:14:40 (Point 2), the engine power increased.
- The aeroplane’s altitude stabilized at around 6,400 ft from 11:14:45.
- From 11:14:55 (Point 3) to 11:15:01 (Point 4), the power levers were fully forward.
- From 11:15:01 (Point 4) to 11:15:07, the engine power was completely reduced.
- At 11:15:08 (Point 5), the aeroplane touched down on the runway at an estimated altitude of 6,470 ft.

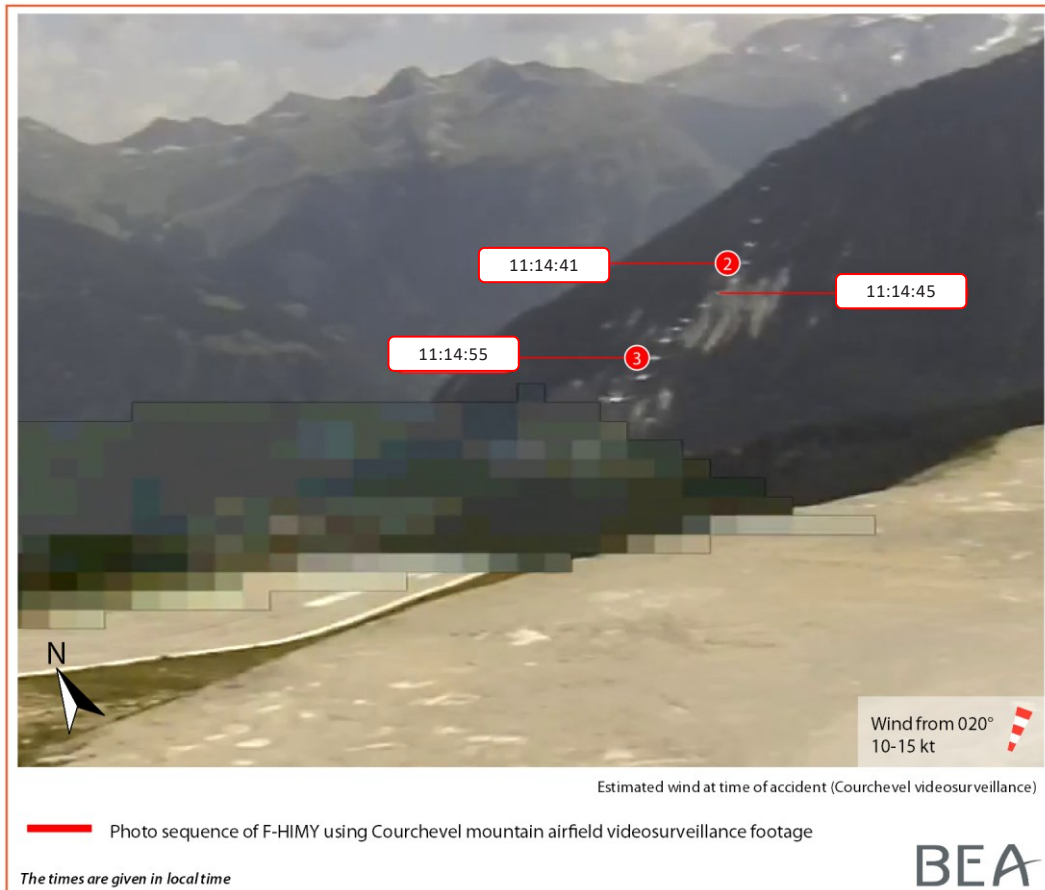
The analysis of the video recording from the surveillance camera installed at the edge of the aerodrome revealed part of the final approach (see Figure 5).

Figure 5: photomontage of end of flight

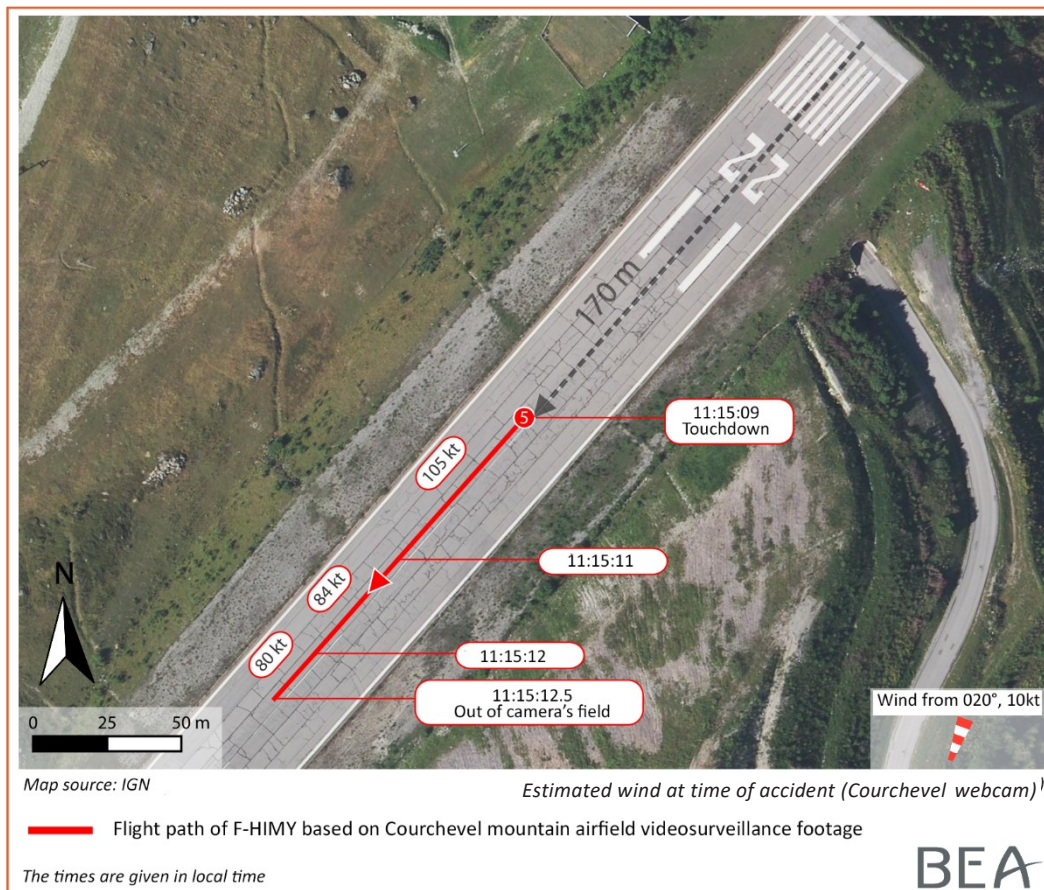
Figure 6: evolution of average ground speed during deceleration phase

The wheels touched down at an estimated distance of 170 m from the runway threshold, on the slope at 18.66%. The remaining runway distance at this point was approximately 360 m.

The average ground speed in the first two seconds after wheel touchdown is estimated at 105 kt⁴. Taking a tailwind component of 9 kt, this speed corresponds to an average airspeed for the aeroplane of 96 kt, i.e. an indicated airspeed of 85 kt in the altitude and temperature conditions at the time of the accident⁵.

The analysis of the video shows that the flaps were not in the landing configuration on touchdown on the runway. The quality of the recording is such that it is not possible to determine if they are in the approach configuration or retracted. It is however certain that they were retracted from three seconds after wheel touchdown.
