Accident to the AIRBUS - EC135- T1
registered **F-HJAF** operated by SAF HELICOPTERES
on 8 December 2020 at Bonvillard (Savoie)

Time	Around 17:15 ¹
Operator	SAF HELICOPTERES (France)
Type of flight	Instruction flight
Persons on board	2 pilots, 2 hoist operators, 2 rescuers
Consequences and damage	5 persons fatally injured, 1 person severely injured, helicopter destroyed

**Collision with vegetation during an instruction flight in
helicopter hoist operations, at night**

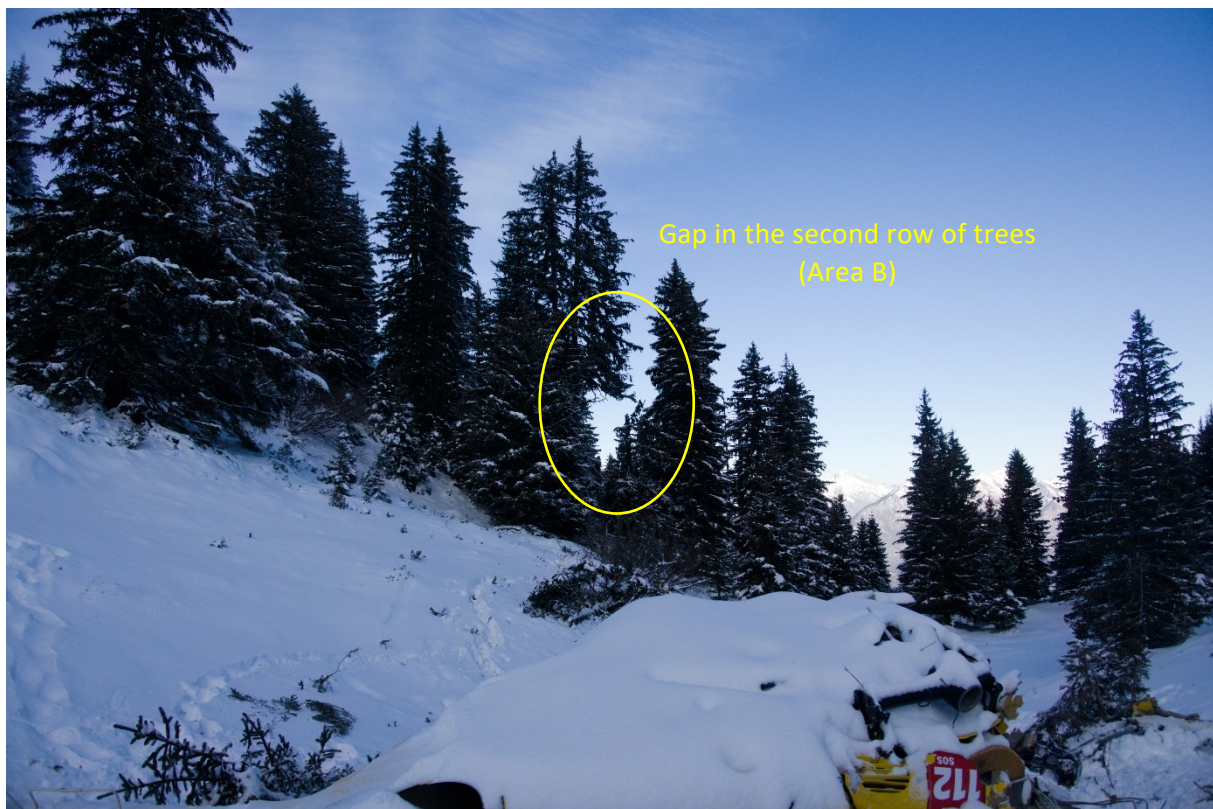
Figure 7: gap in row of trees (source: BEA)

The wreckage was located in an area of low vegetation, surrounded by several groups of conifers standing at a height of up to around 30 m. To the north-west of the position of the main wreckage and about 50 m from the latter in the direction of the valley, a row of trees was damaged at mid-height. This gap was recent. A large number of branches as well as a lot of debris from the helicopter were found in the gap and on the ground, between this group of trees and the main wreckage.

Another 50 m upstream on the aircraft's path, there was another row of trees. Two of these trees had had their heads lopped off by a few tens of centimetres (Area A).

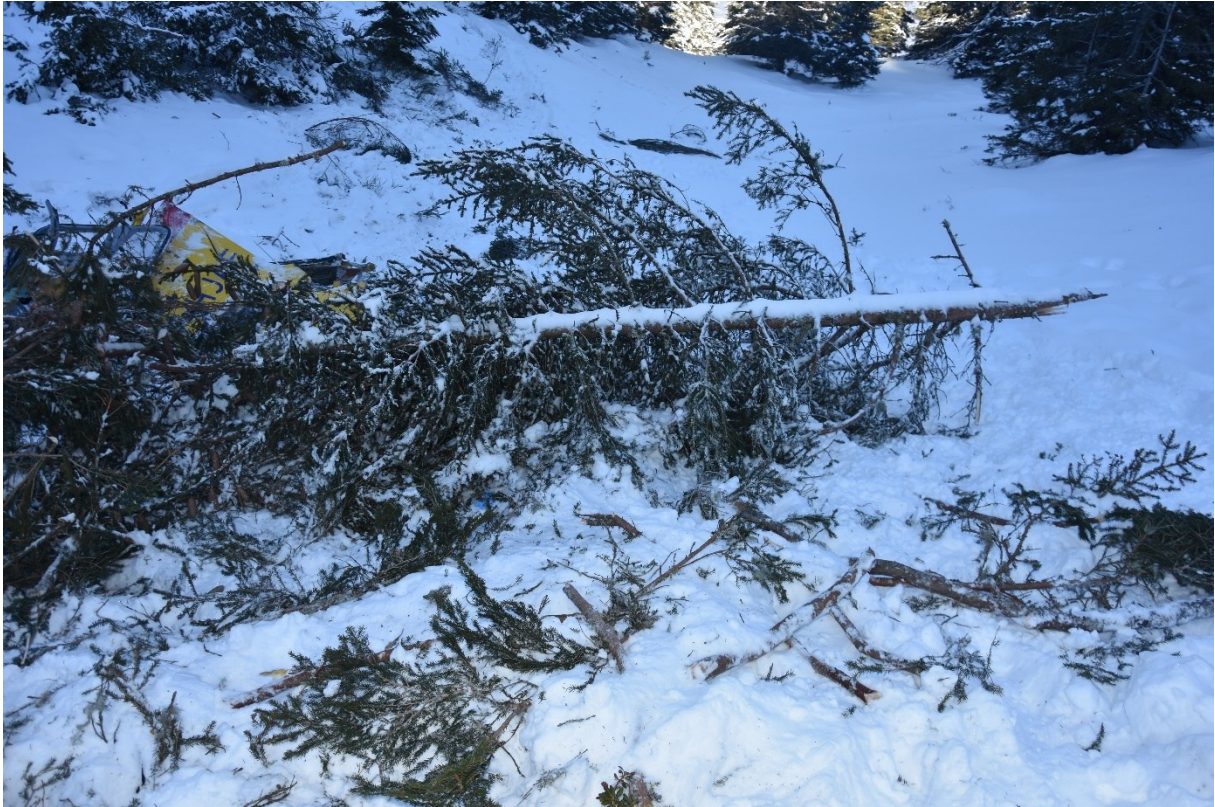
Figure 8: piece of tree 15 cm in diameter found at site (source: BEA)

A first limited examination of the wreckage was carried out at the accident site. The helicopter was destroyed. The wreckage was dispersed. A collection of small debris – mainly foam from the helicopter's main rotor blades and small pieces of windshield/windows – were found on the ground in Area A. Numerous branch pieces of all sizes (up to 15 cm in diameter) were found at the base of the trees in Area B, as well as along the path between Areas B and C.

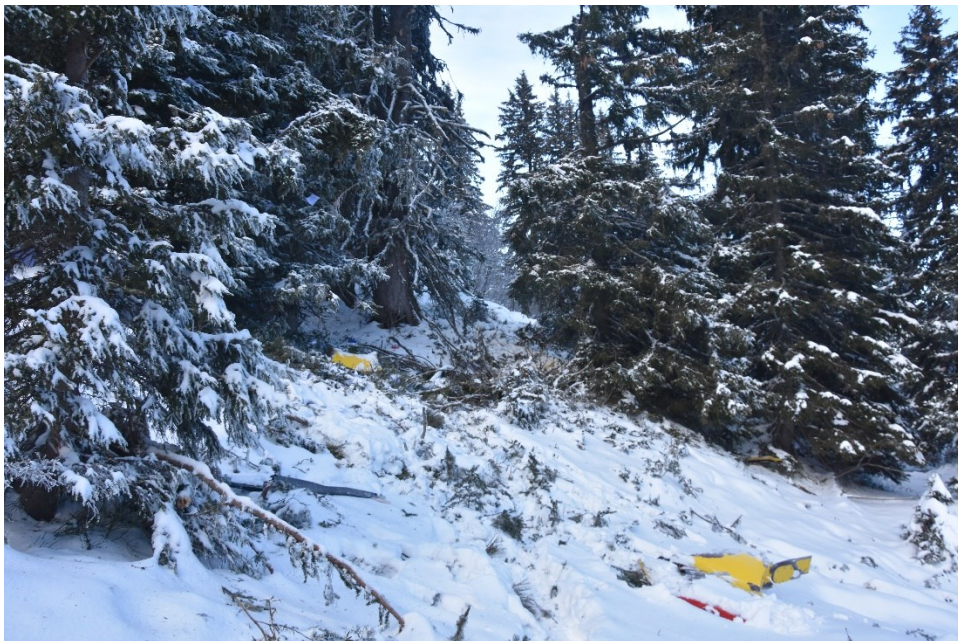
Figure 9: snow-covered helicopter debris (source: BEA)

- The front right and left doors, the right sliding door and pieces of the tail surface were found at the base of the trees (Area B), as well as elements of the main rotor blades and cabin structure.

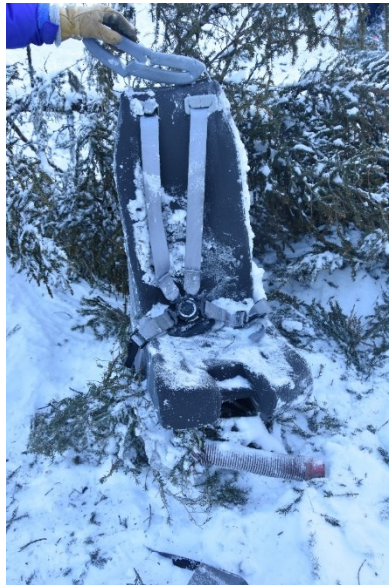
Figure 10: front left seat (source: BEA)

- The front left seat (instructor's position), parts of the right and left landing skids, elements of the hoist, the front section of the fuselage and the fenestron fairing were found between Area B and the main part of the wreckage (Area C).

The front left seat was damaged. It was found just after the row of trees (Area B). The four-point harness was found fastened. The marks observed on the right shoulder strap appeared to be consistent with a person in the seat with the harness fastened.

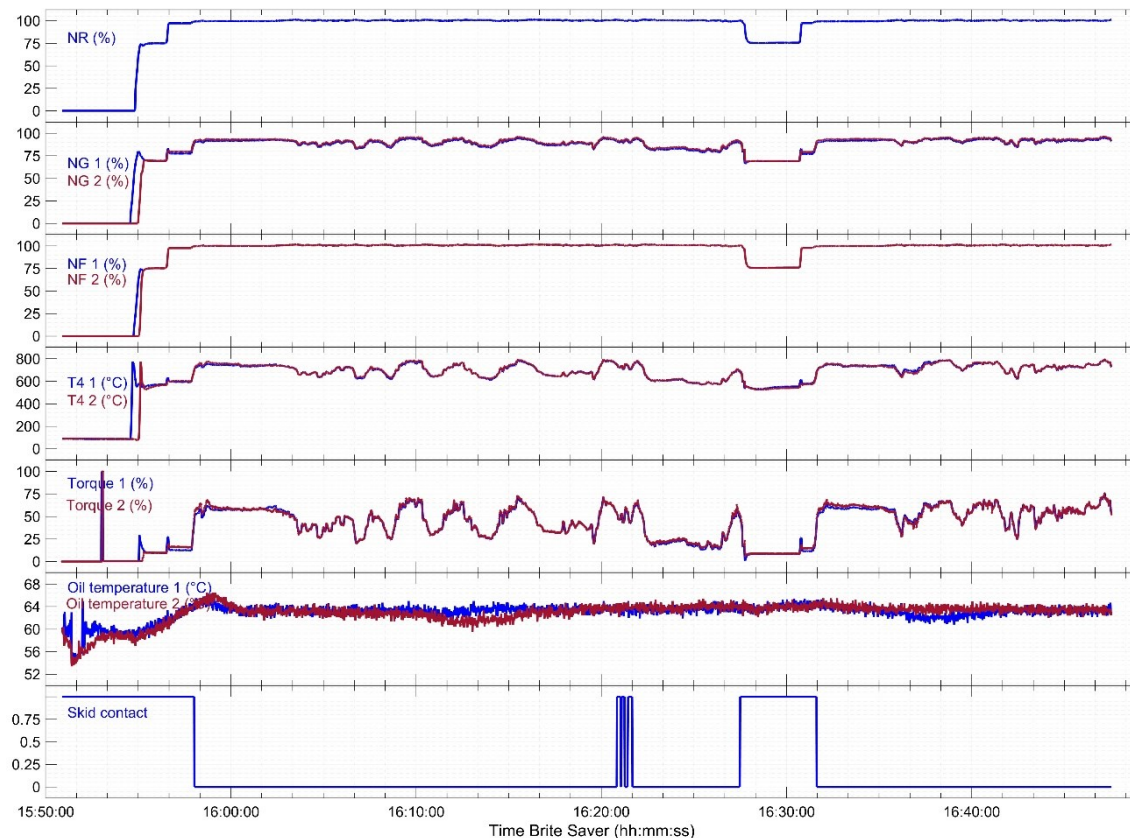
Figure 16: parameters recorded during accident flight and previous flight (source: BEA)

The “skid contact” parameter enabled the two flights to be identified and confirmed the landing at Marret refuge during the first flight. The “NR”, “NG”, “NF”, “T4”, “Torque” and “Oil Temp” parameters did not show any engine operating anomaly.

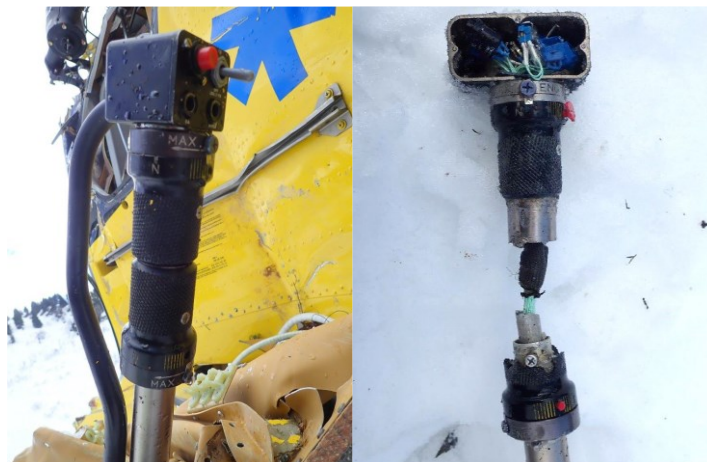
Figure 29 : poignées tournantes

Les deux leviers de commande de pas collectif ont été retrouvés séparés de la cellule. La poignée tournante sur l'un des leviers est sur la position « flight », la position de la seconde poignée tournante n'a pas pu être déterminée, cette dernière étant rompue.

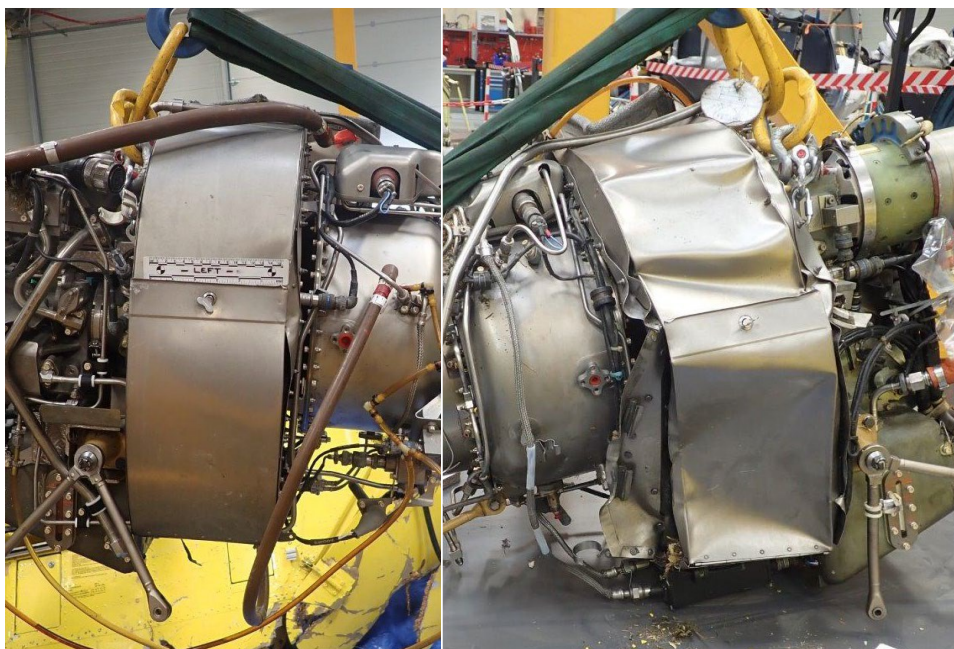
Figure 30 : plénums des moteurs gauche et droit

Les plénums des deux moteurs sont en place. Celui du moteur gauche est peu endommagé. Celui du moteur droit, bien que complet, est très déformé.

Les deux plénums ne sont pas obstrués mais contiennent de petits débris provenant de l'hélicoptère ainsi que de nombreux branchages d'arbres résineux (sapins).

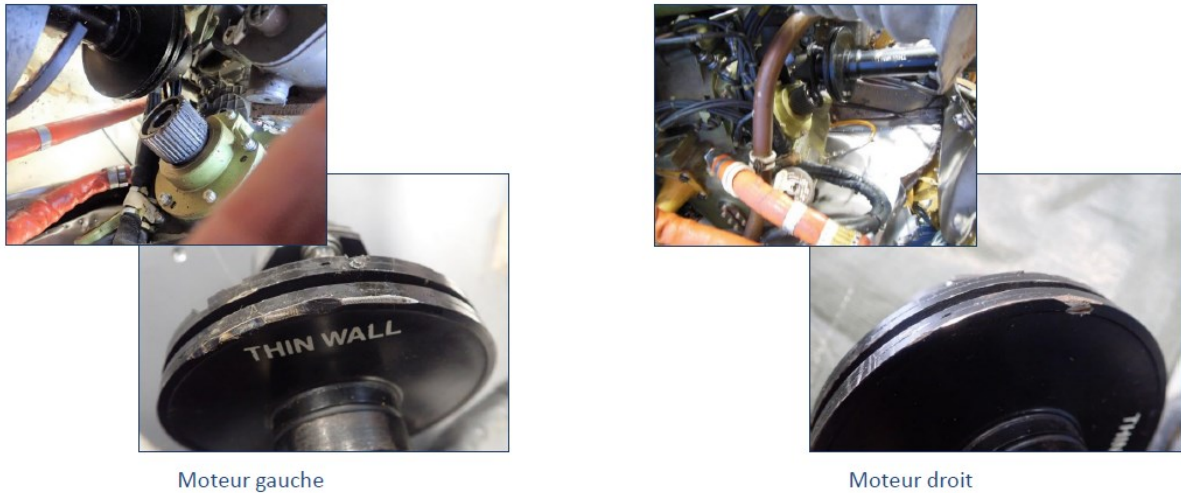
Les arbres de transmission de puissance entre les deux moteurs et la BTP sont connectés en entrée de la BTP mais sont désengagés des arbres cannelés en sortie des moteurs. Le désengagement des deux arbres de transmission indique un écartement important entre les deux moteurs et la BTP et sont liés à la collision avec le sol. Après leur désengagement, les arbres de transmission sont venus en contact avec les carter moteurs et avec les arbres cannelés de sortie de puissance moteur. Les traces de frottements sur les arbres de transmission de puissance sont de faible amplitude (secteur angulaire) ce qui indique une absence de rotation de ces derniers.

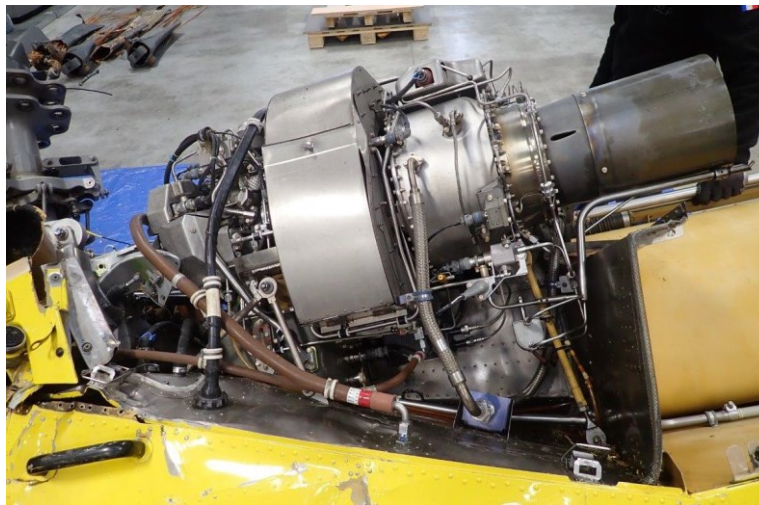
Figure 34 : vue d'ensemble du moteur gauche

Le moteur ne présente pas de dommage significatif visible.

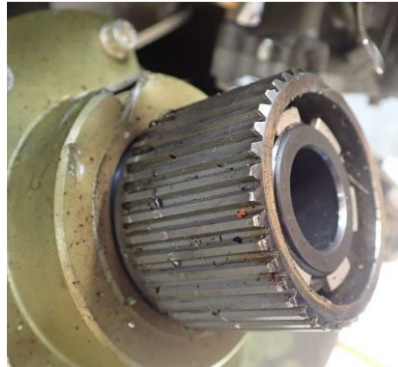
Figure 35 : arbre cannelé et flasque

largeur formant des trajectoires hélicoïdales, ce qui indique que l'arbre de sortie moteur tournait lors du désaccouplement de l'arbre de transmission. L'absence d'arrachement de matière en extrémité des cannelures indique un faible couple lors du désaccouplement.

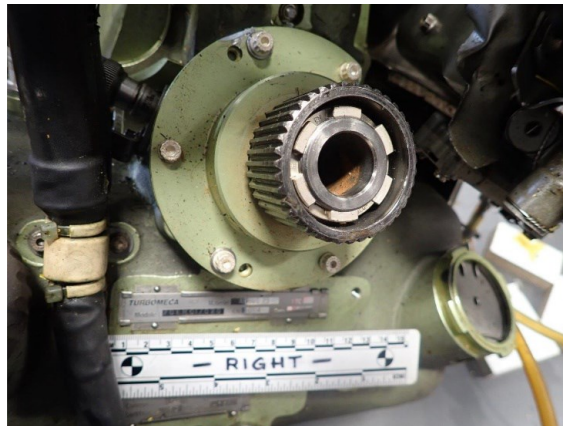
Figure 37 : arbre cannelé et flasque

Le flasque situé entre le carter et l'arbre de sortie cannelé a reçu un impact en partie supérieure. La position de cet impact est en cohérence avec la position de l'arbre de transmission de puissance qui a été constatée sur l'épave. Les cannelures de l'arbre de sortie montrent deux traces de contacts de faible profondeur et de faible largeur formant des trajectoires hélicoïdales, ce qui indique que l'arbre de sortie moteur tournait lors du désaccouplement de l'arbre de transmission. L'absence d'arrachement de matière en extrémité des cannelures indique un faible couple lors du désaccouplement.
