Preliminary report

concerning the **Serious incident**
to the CESSNA Citation 525 CJ1
registered **F-HJAV**
on Friday 14 March 2025
en route

Failure of an air data system, undetected altitude deviation, activation of a TAWS³ warning during approach

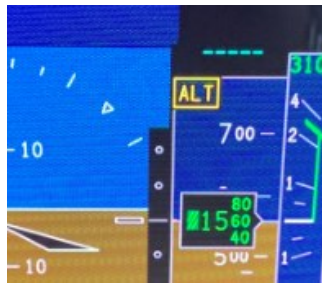
The crew reported that when flying through FL 100, the **ALT** indication (or “Amber ALT”) appeared on their PFDs indicating an altitude inconsistency between the captain's PFD and the co-pilot's PFD (see **Figure 1**).

*Figure 1: photo of PFD with **ALT** indication visible at the top of the altitude tape (Source: BEA)*

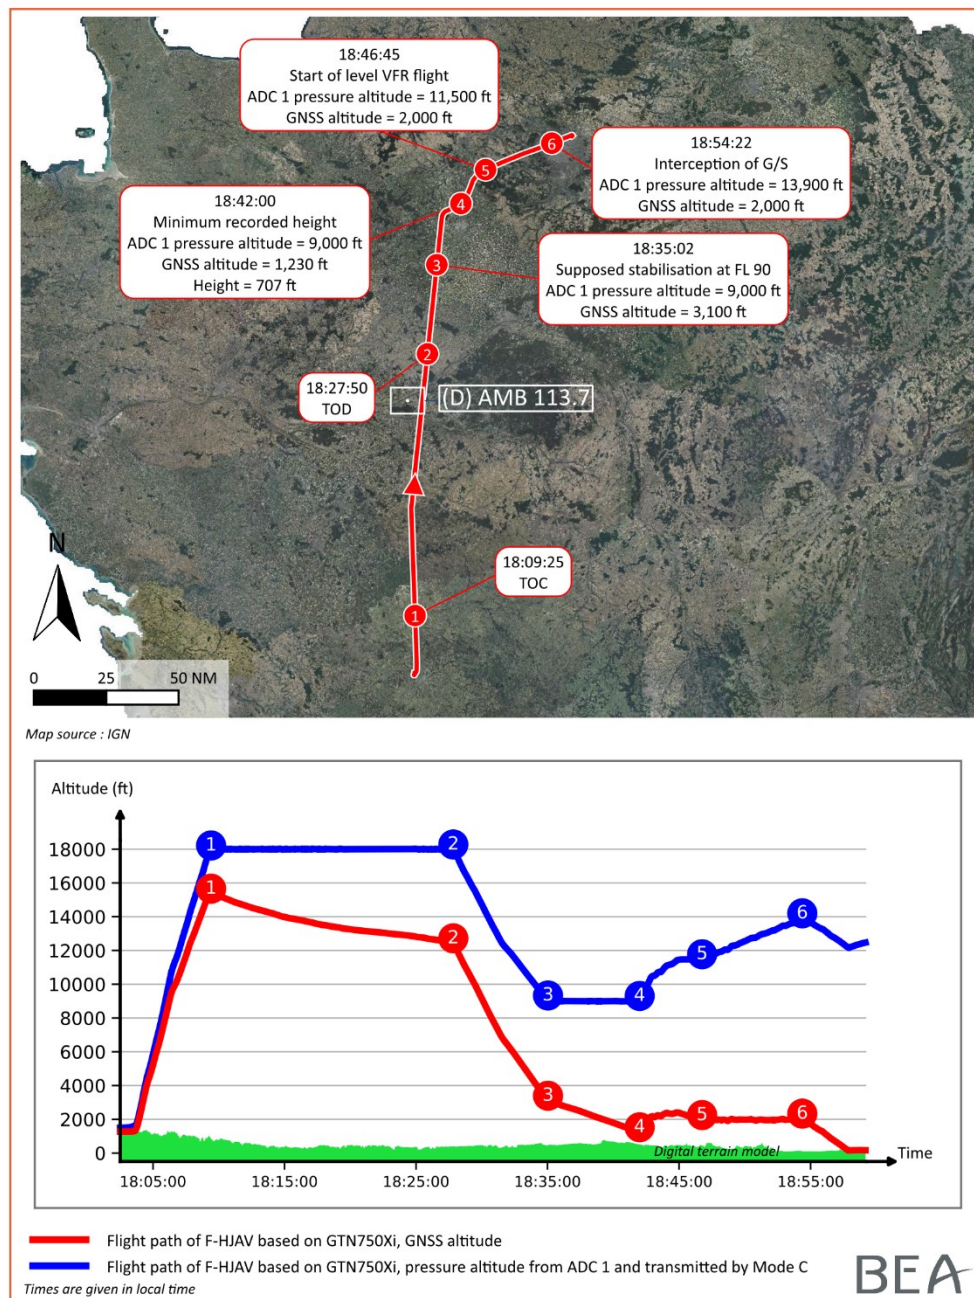
Between 18:09 (point **1**) and 18:28 (point **2**), although the autopilot was engaged and the information sent by ADC 1 indicated that the flight level was stable at FL 180, the GNSS altitude of the aeroplane progressively decreased from 15,300 ft to 12,600 ft.

Figure 2: flight path of F-HJAV, based on GTN750x data⁹

This difference in altitude was 2,500 ft at the start of cruise flight, 7,800 ft when the TAWS warning was activated, and reached 13,500 ft after landing (see **Figure 2**).

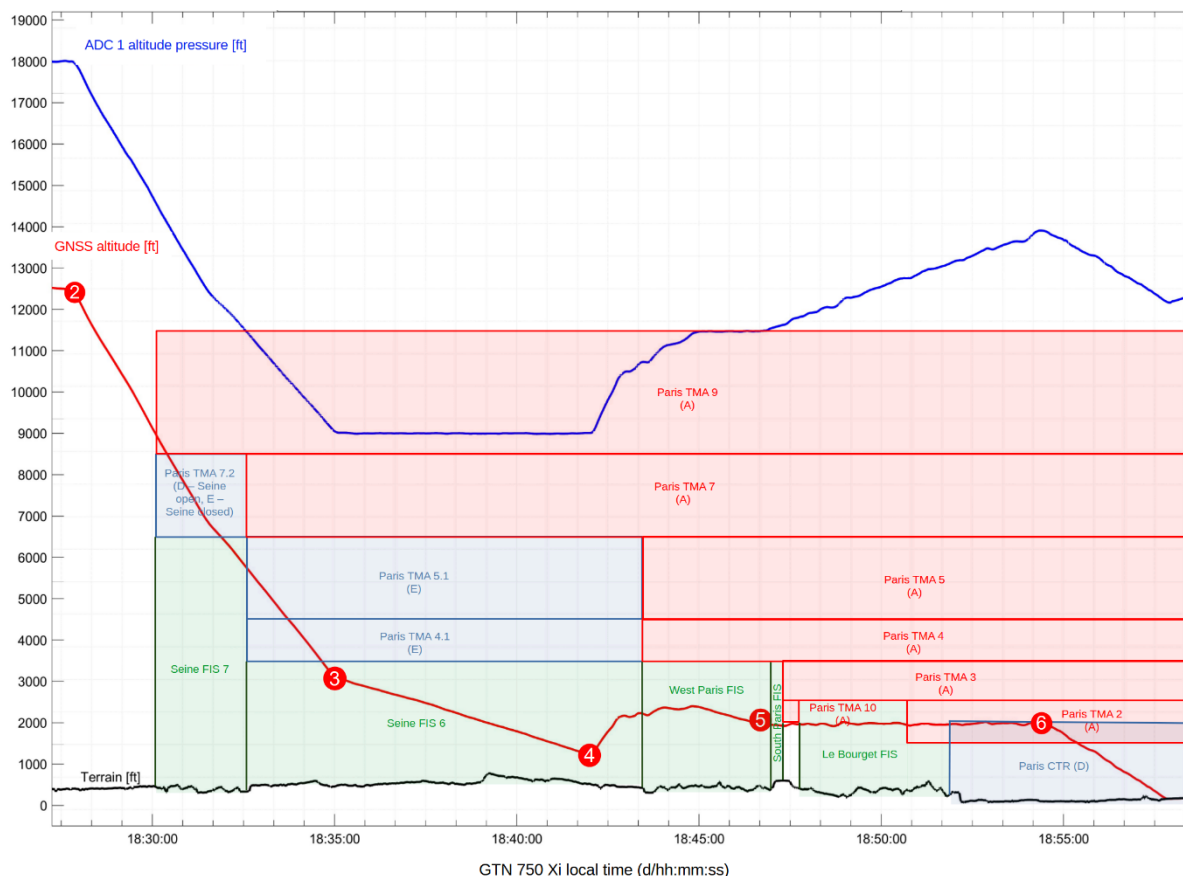
Figure 5: vertical flight path and airspaces crossed by F-HJAV in the last 30 flight minutes
(Source: BEA)

At 18:50, the aeroplane flew over Beynes - Thiverval (LFPF) aerodrome¹¹, then a few seconds later, over Chavenay - Villepreux aerodrome (LFPX)¹². The aeroplane was then flying at an altitude of 2,000 ft and a speed of 250 kt. Both these aerodromes are below Paris TMA 3 (Class A) whose floor is situated at 2,500 ft.

The analysis of the radar and GNSS data found that F-HJAV flew close to several VFR traffic during the last twenty minutes of flight, while flying at an altitude below 2,500 ft. The precise separations between F-HJAV and these other flights are currently being determined.
