**Accident** to the JODEL - D140 C  
registered **F-HJLB**  
on 21 May 2022  
at Les Adrets (Isère)

**Transition to the backside of the power curve, collision with a line of trees, post-impact fire, during an introductory (sightseeing) flight in the mountains**

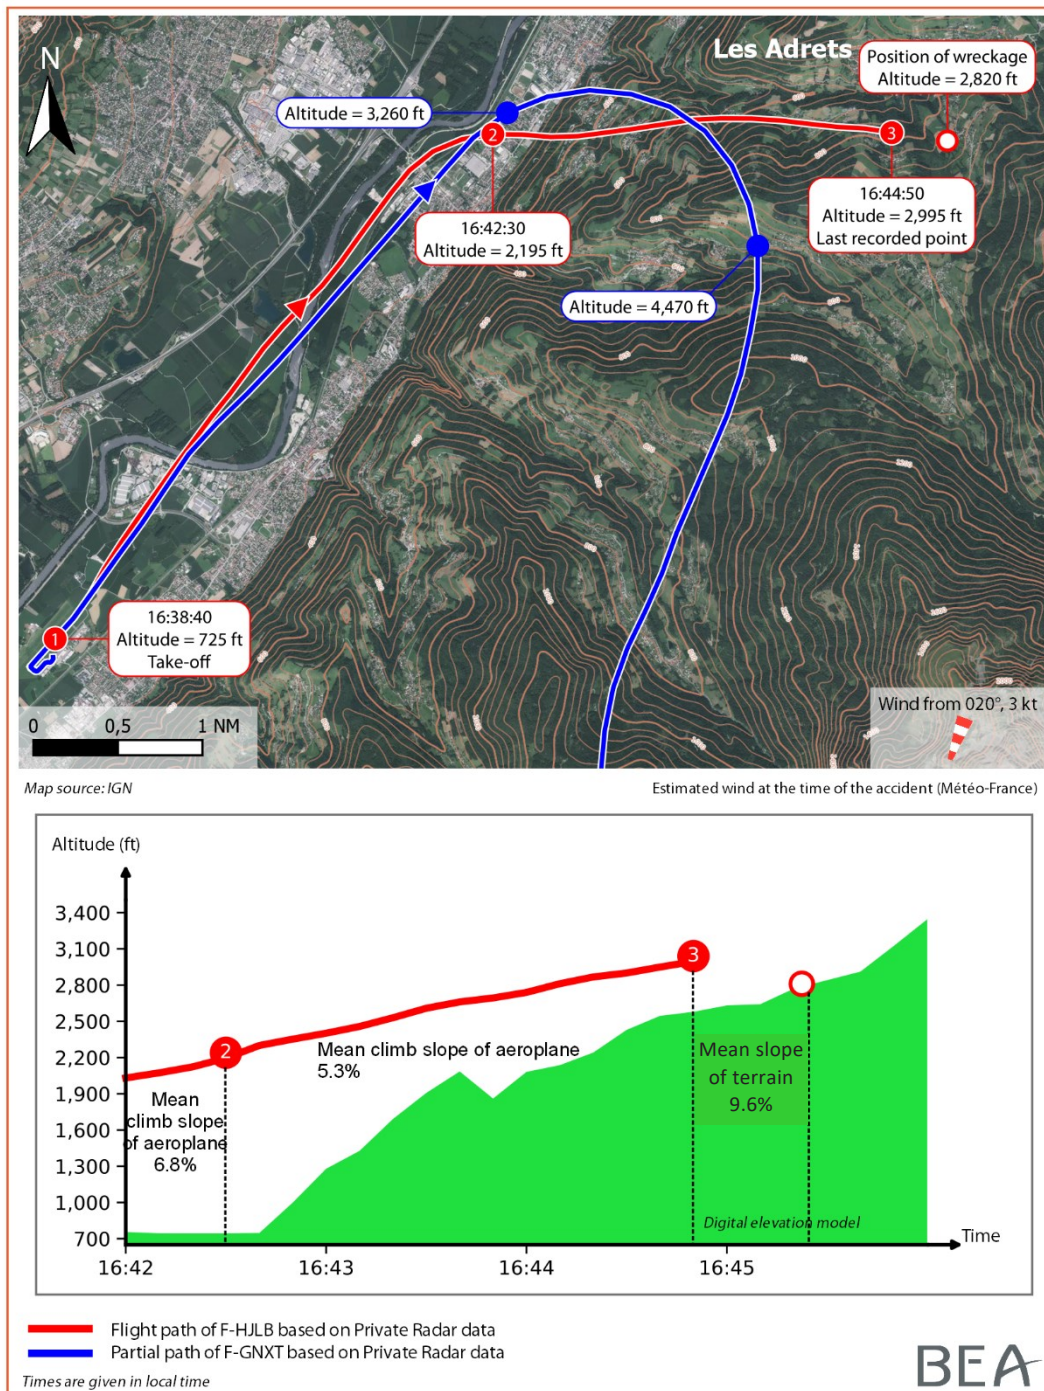
The pilot, accompanied by four passengers, took off at 16:39 from paved runway 04 at Grenoble-Le Versoud aerodrome (Isère) for his second<sup>2</sup> sightseeing flight of the afternoon. The pilot climbed on the axis and then turned right (see Figure 1, point **2**) into the Les Adrets valley, flying alongside the northern slope of the mountain to the south of Les Adrets. Witnesses saw the aeroplane heading east at low height and flying “slowly” (point **3**). A few minutes later, the aeroplane crashed through a line of trees into a field. When it collided with the ground, the aeroplane caught fire.

Figure 1: paths followed on the two sightseeing flights

During the initial climb, the ground speed was around 65 kt (120 km/h). When the pilot entered the Les Adrets valley (see Figure 1, point ②), the ground speed gradually decreased, reaching 57 kt (103 km/h) at the last recorded flight point (point ③), a few seconds before the accident.

During the second sightseeing flight in F-HJLB, when the pilot reached the northern exit point, the altitude was 2,200 ft, i.e. an altitude gain of 1,475 ft in about 4 NM. The pilot then headed towards the Les Adrets valley and chose to fly alongside the mountain slope while continuing the climb in a straight line. The entrance to the Les Adrets valley is narrow, making it difficult to turn around<sup>10</sup>. From the northern exit point, the remaining distance to the accident site is 2.9 NM.

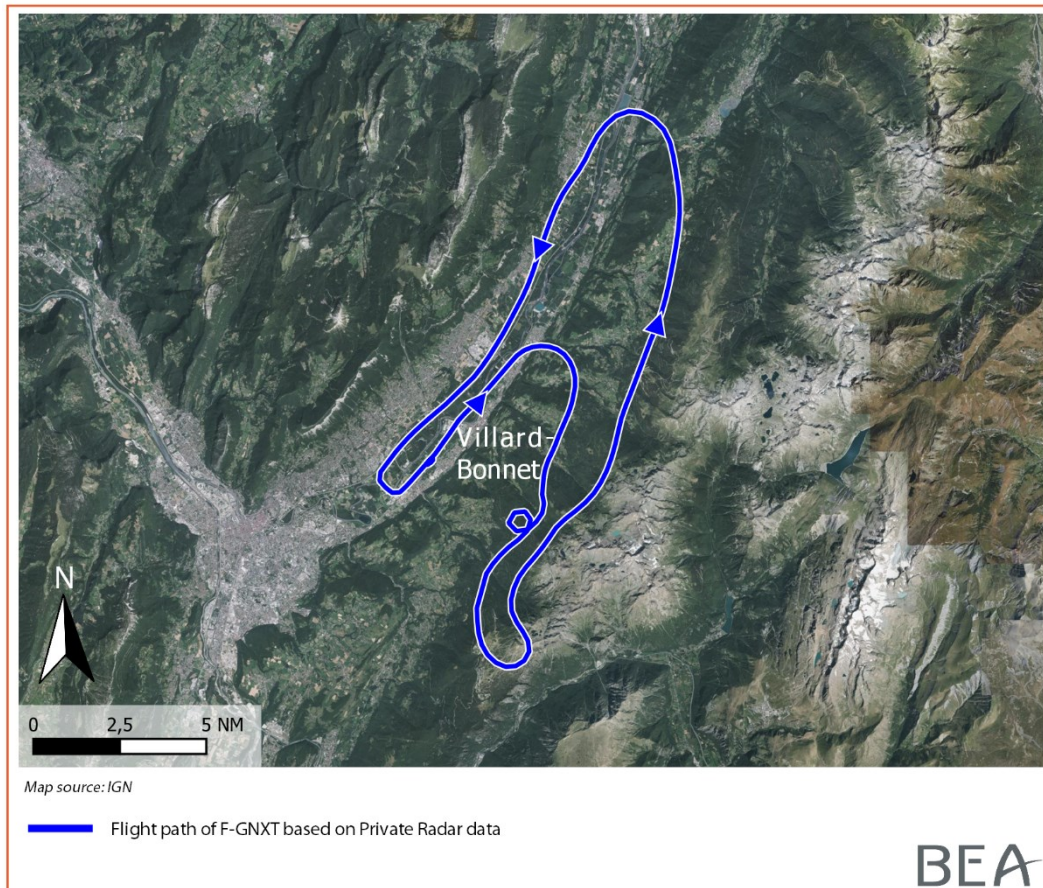
On the afternoon of 21 May 2022, at around 14:00, the pilot made a first sightseeing flight (see Figure 2) on the DR401/155, registered F-GNXT, powered by a TAE 125-02-114 engine. The engine is turbocharged and develops a maximum power output of 155 hp.

Figure 2: path of the first sightseeing flight on 21 May 2022

During the first sightseeing flight in F-GNXT, the pilot reached the northern exit point (Brignoud toll) at an altitude of 3,200 ft, i.e. an altitude gain since take-off of 2,475 ft. When the pilot initiated the right turn, still in climb, the aeroplane was at an altitude noticeably level with the ridge line (highest point around 3,300 ft) that it had to clear and the aeroplane’s rate of climb was over 700 ft/min. As it flew over the ridge line, the aeroplane was at an altitude of 4,450 ft, i.e. more than 1,000 ft above it.
