**Accident** to the MUDRY CAP232  
registered **F-HKAP**  
on Sunday 15 June 2025  
at Villepreux

**Opening and loss of canopy mid-air, turn around, collision with ground on final**

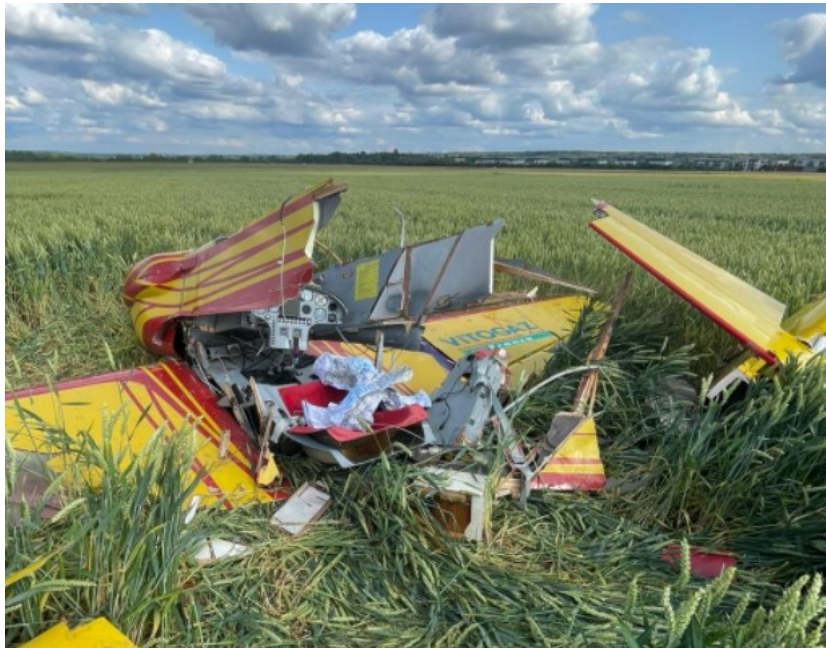
Apart from the canopy, the wreckage was complete and grouped together. The main part of the wreckage comprised the powerplant, the fuselage up to the pilot's seat and the wings. The four propeller blades had ruptured at the blade root, the ends of the wings were severed. The aft fuselage, from the pilot's seat to the tail plane, and the landing gear were destroyed in the impact. The flight control linkages were continuous; the only ruptures observed on these parts were caused by the impact. The canopy was found several days after the accident.

*Figure 1: main part of wreckage (source: BEA)*

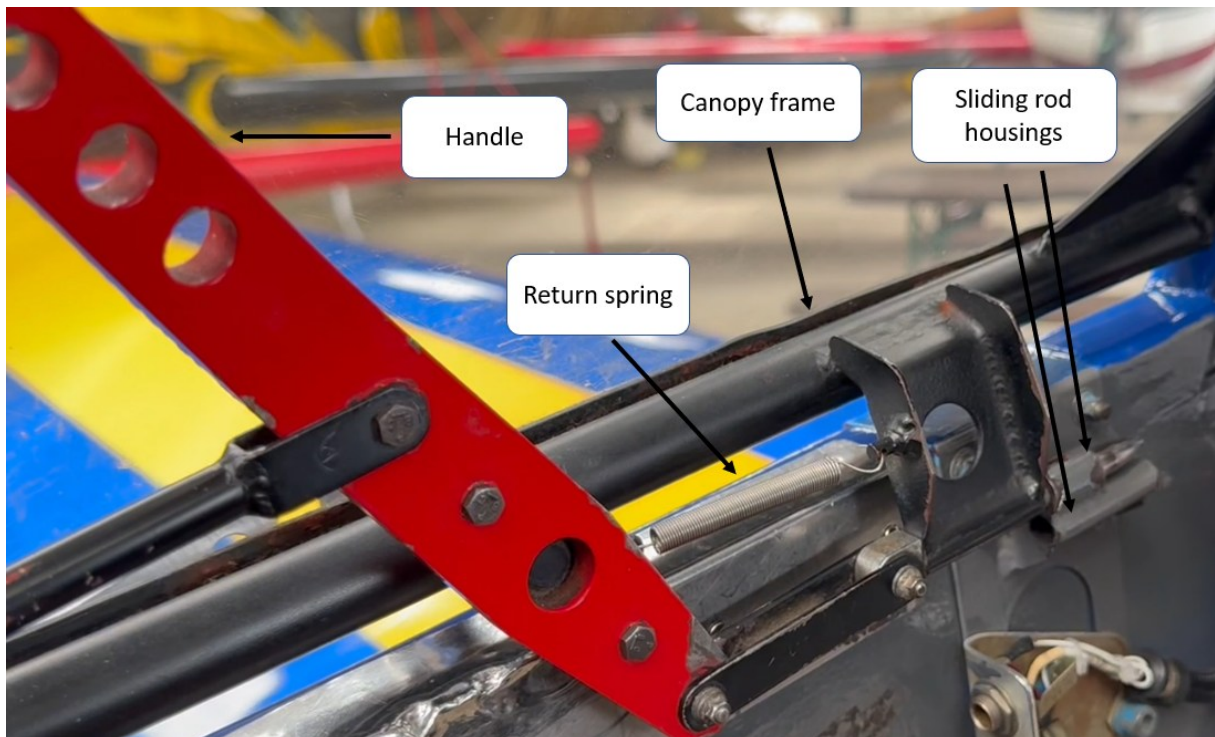
- a linkage fastened to the canopy frame allowing the pilot to action a sliding rod by means of a handle, with a return spring holding the handle in the locked position;
- two tubes fastened to the interior of the fuselage corresponding to two possible housings for the sliding rod.

According to the position of the rod in one of the housings, the canopy can be locked in a slightly-open position or completely closed. In the slightly-open position, the rod exceeds the upper housing and its end is visible (see **Figure 3** and **Figure 4**).

Figure 3: canopy in slightly-open position and locking mechanism (source: pilot, annotations BEA)

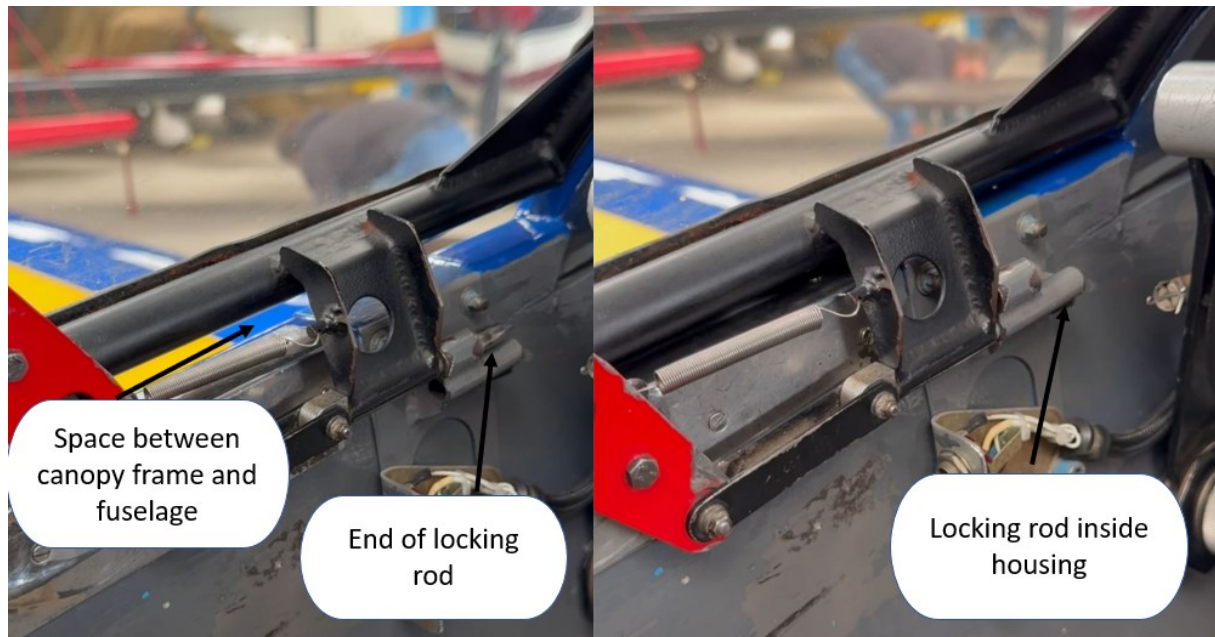
Figure 4: comparison between slightly-open position (on left side) and closed position (on right side) (source: pilot, annotations BEA)
