Accident to the Elixir Aircraft Elixir
registered **F-HKEC**
on Wednesday 14 February 2024
at La Rochelle - Île de Ré

**In-flight disconnection of elevator control, difficulty
controlling aeroplane on short final, hard contact with
runway, during a maintenance check flight**

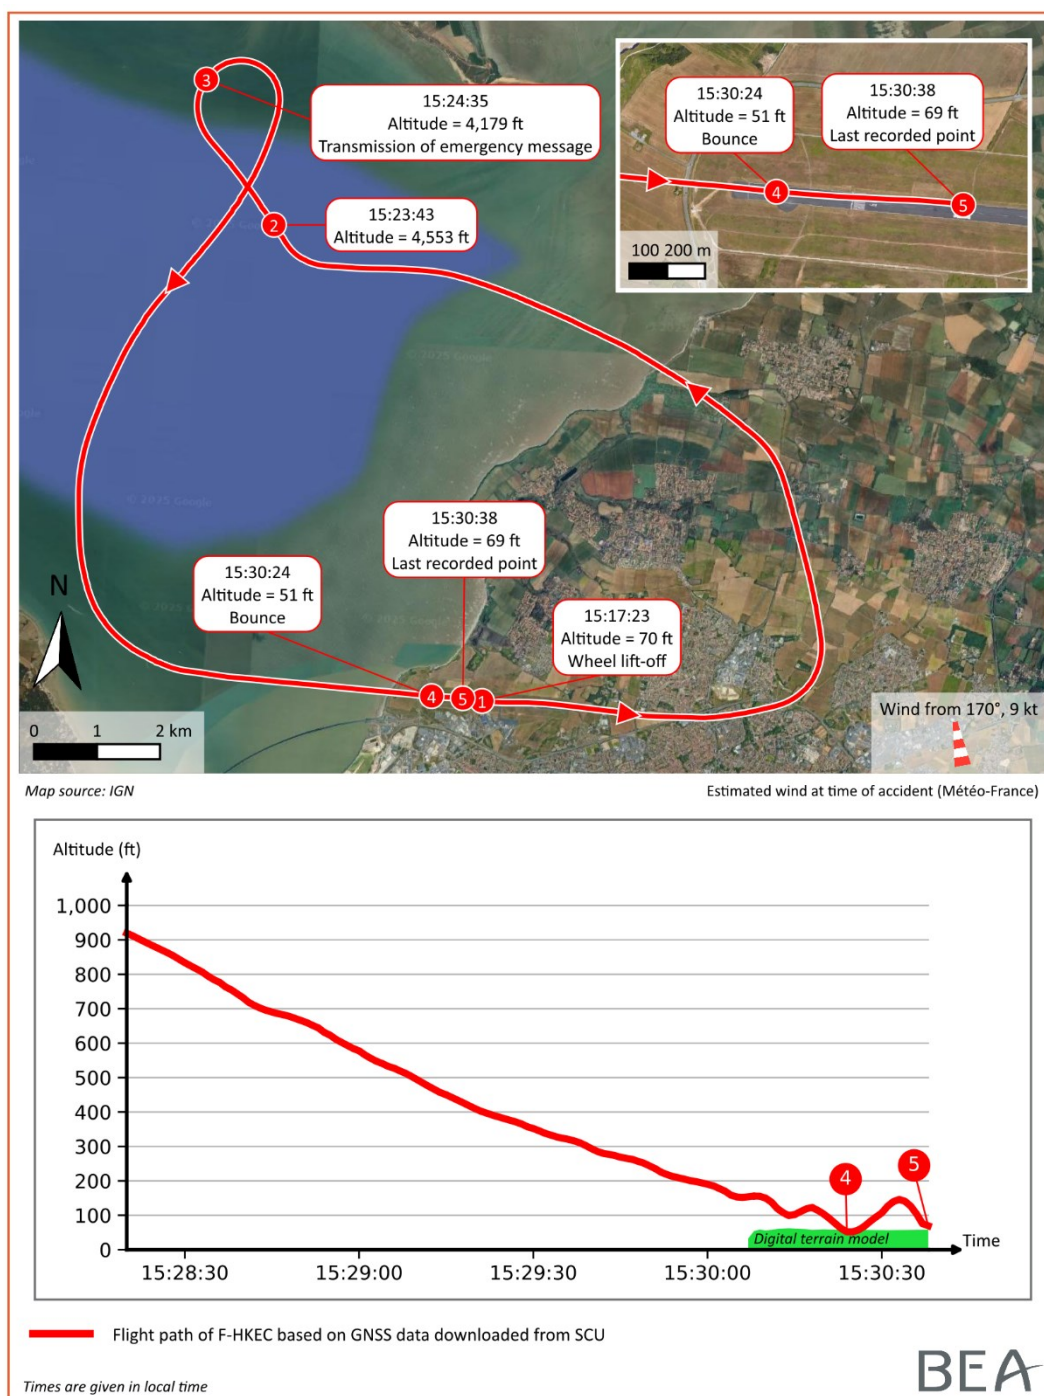
The pilot flared using power and the trim. The aeroplane bounced. The pilot initially decided to reject the landing and then tried to land again. He lost control of the flare and the aeroplane touched down hard on the runway. The nose gear broke. The aeroplane finished its run at the edge of the runway, around 250 m after the hard touchdown.

Figure 1: flight path

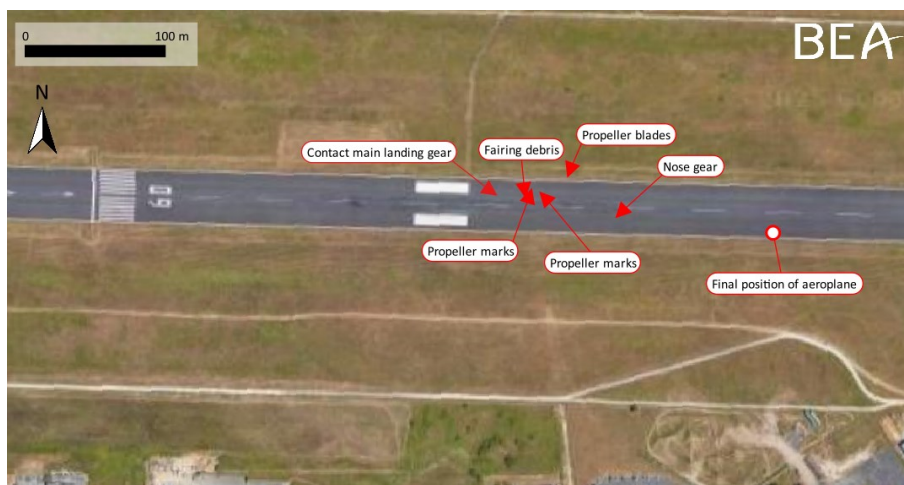
It was observed on the runway and in the area surrounding the runway (see **Figure 1**), that there were:

- marks made by the main landing gear coming into contact with the runway and a mark corresponding to the nose gear;
- debris from both the nose gear fairing and lower cowling;
- marks made by the propeller impacting the runway;
- pieces of propeller blade;
- the nose gear strut.

The aeroplane was found around 250 m after the first marks, immobilised at the edge of the runway with its nose in the grass.

Figure 2: position of marks and debris (source: BEA/IGN)

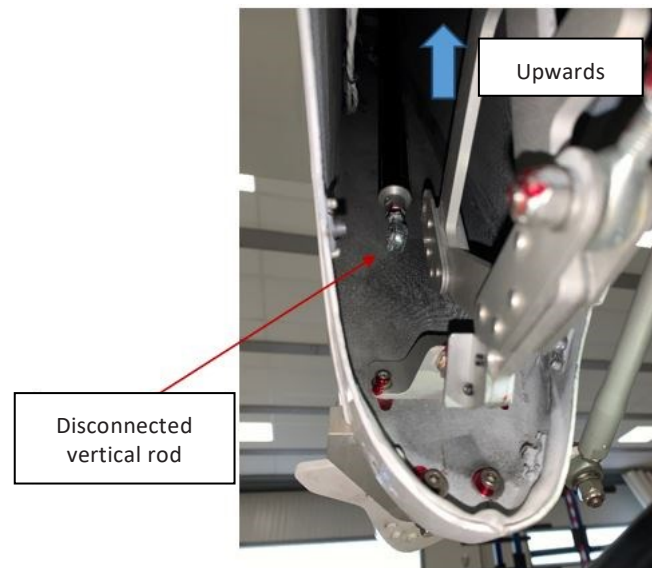
A screw and washer were found in the keel located under the fin when the keel was removed. This screw and this washer were identified as being part of the assembly attaching the vertical rod of the elevator control to the bellcrank in the base of the fin. The associated nut⁵ was not found. The examinations carried out determined that the nut would have been found in the keel if it had been present when the assembly was installed. Furthermore, there was no damage on the screw thread. The screw showed no sign of a lock varnish used to visually identify the tightening of the screw-nut assembly⁶. The vertical rod was disconnected from the bellcrank (see **Figure 3**).

Figure 3: vertical rod disconnected from bellcrank (source: BEA)

While re-assembling the elevator during a maintenance action, the mechanic very probably forgot to position the nut on the screw fitted through the ball joint connecting the vertical rod of the elevator control with the bellcrank in the base of the fin. In the absence of the nut, the screw was not held in place and came out of position during the second flight after this work. The stick became free in pitch due to the rod disconnecting from the bellcrank.

The following factors may have contributed to forgetting the nut:

- interruptions in the work to reassemble the elevator due to the mechanic being called upon by the production line technicians to carry out inspections because he was an experienced mechanic;
- the particular high workload and time pressure context due to the mandatory inspection of all the aeroplanes in service in the previous few months;
- no independent inspection as the task was not considered a critical task by the technical manager.

Although this was not a contributory factor in this accident, the reuse of Nylstop nuts is not recommended. In fact, their locking capability diminishes after several reassemblies and, as it is impossible to determine this number, the systematic replacement of these nuts at each maintenance is the only guarantee of safety.

- segregation between the production and maintenance workshops;
- introduction of means to avoid interruptions to tasks;
- recruitment of new mechanics, dedicated to CAO activities;
- identification of critical tasks on service requests;

- introduction of an extended pre-flight inspection in the presence of a mechanic before a flight following completion of a critical task;
- modification of the pilot training program to include training in potentially risky situations during post-maintenance flights;
- systematic replacement of Nylstop nuts with new ones after disassembly;
- taking into account requirements relating to maintenance check flights.
