**Accident** to the CESSNA 177 "CARDINAL"  
registered **F-HKLA**  
on Sunday 30 July 2023  
off the coast of Fréjus

## Reduction in engine power, forced ditching, in instruction

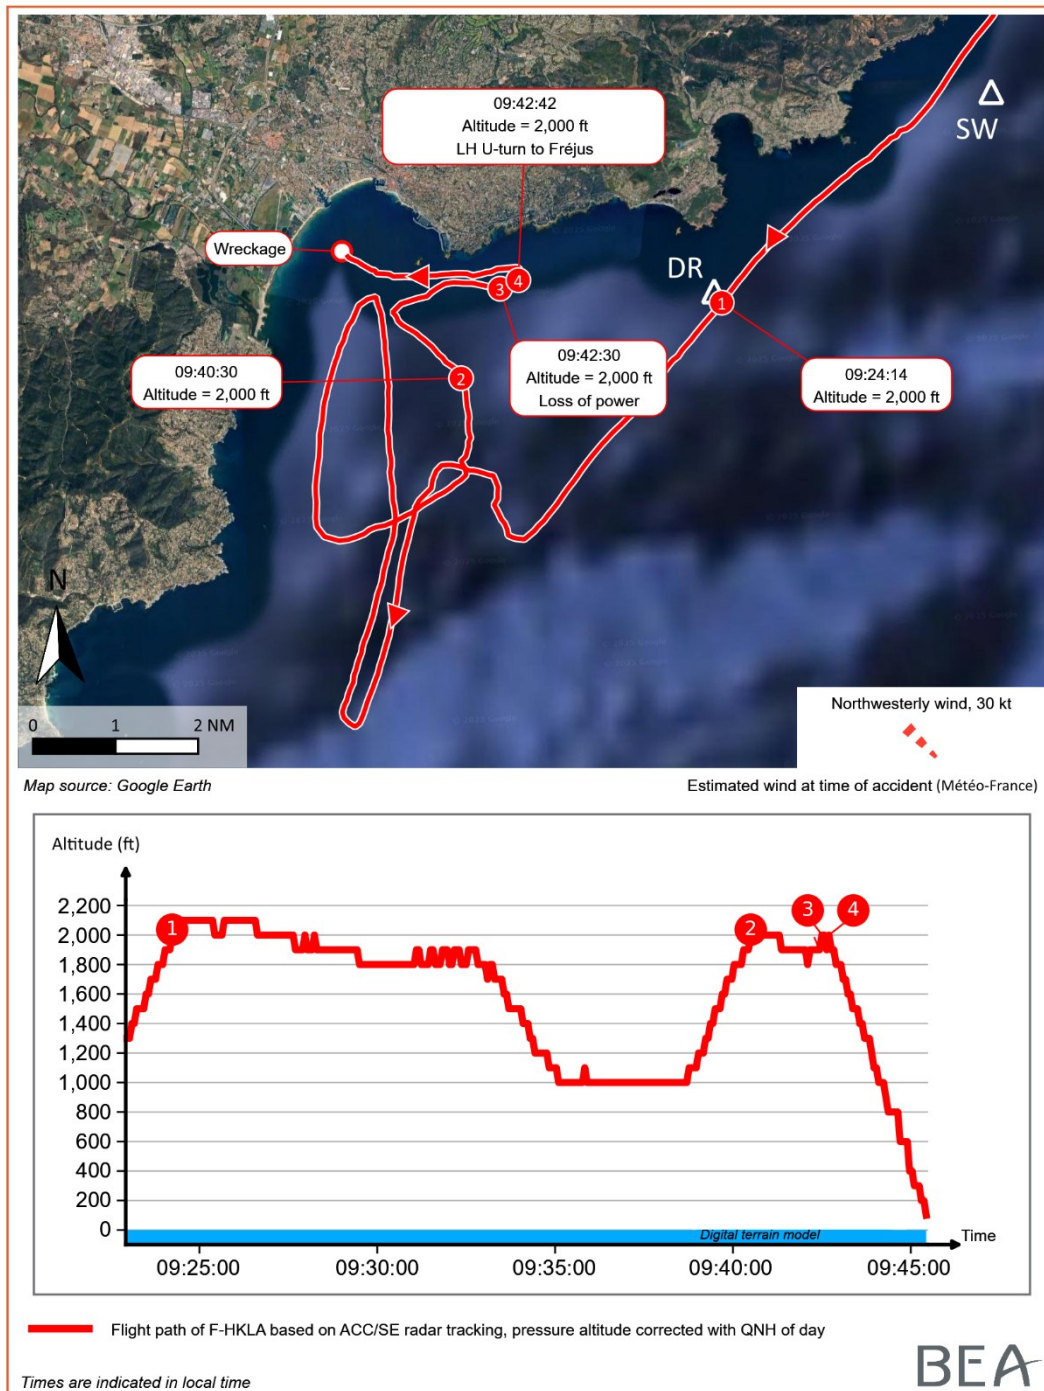
After a coastal transit at an altitude of around 800 ft to point SW, they climbed to 2,000 ft (see Figure 1, point ①), and then levelled off by reducing engine power from 2,500 rpm to around 2,075 rpm<sup>3</sup>. After passing point DR, they contacted Nice South Information at 09:26 and a minute later, the student pilot started handling exercises in Fréjus bay. After a series of turns between 2,100 and 1,900 ft, he descended to an altitude of 1,000 ft and then climbed again to 2,000 ft (point ②).

Two minutes later, when the aeroplane was in level flight heading towards point DR and the student pilot was getting ready to descend for the coastal transit to return to Cannes (point ③), the engine suddenly misfired several times. The aeroplane was at this point 0.5 NM off the coast where there was no obstacle free area in which to safely land due to the urbanisation. The instructor took the controls and carried out a 180° turn (point ④) in order to head towards the disused runway of the naval air base at Fréjus, located approximately 3 NM away. After making several inputs on the engine controls, the rpm returned to normal.

Less than a minute later, the engine started misfiring again, but this time the misfires were accompanied by strong vibrations making it difficult to read the engine parameters. The instructor was unable to obtain a normal engine speed again. At 09:44, he reported to the Nice Information controller that the engine was misfiring and that they were aiming for the Fréjus airfield. The controller replied that he would inform the emergency services. The aeroplane rapidly lost altitude forcing the instructor to ditch at 1 km off the coast (and 1.6 km from the disused runway of the former Fréjus naval air base).

Figure 1: flight path of aeroplane
