Accident to the Piper PA19
registered **F-HLOG**
on **23 August 2021**
near **Lille - Marcq-en-Barœul aerodrome (Nord)**

Time	Around 15:55 ¹
Operator	Union Aérienne Lille Roubaix Tourcoing (UALRT) flying club
Type of flight	Local
Persons on board	Pilot and passenger
Consequences and damage	Pilot and passenger fatally injured, aeroplane destroyed

**Engine failure after a touch-and-go, loss of control in turn,
collision with ground and fire**

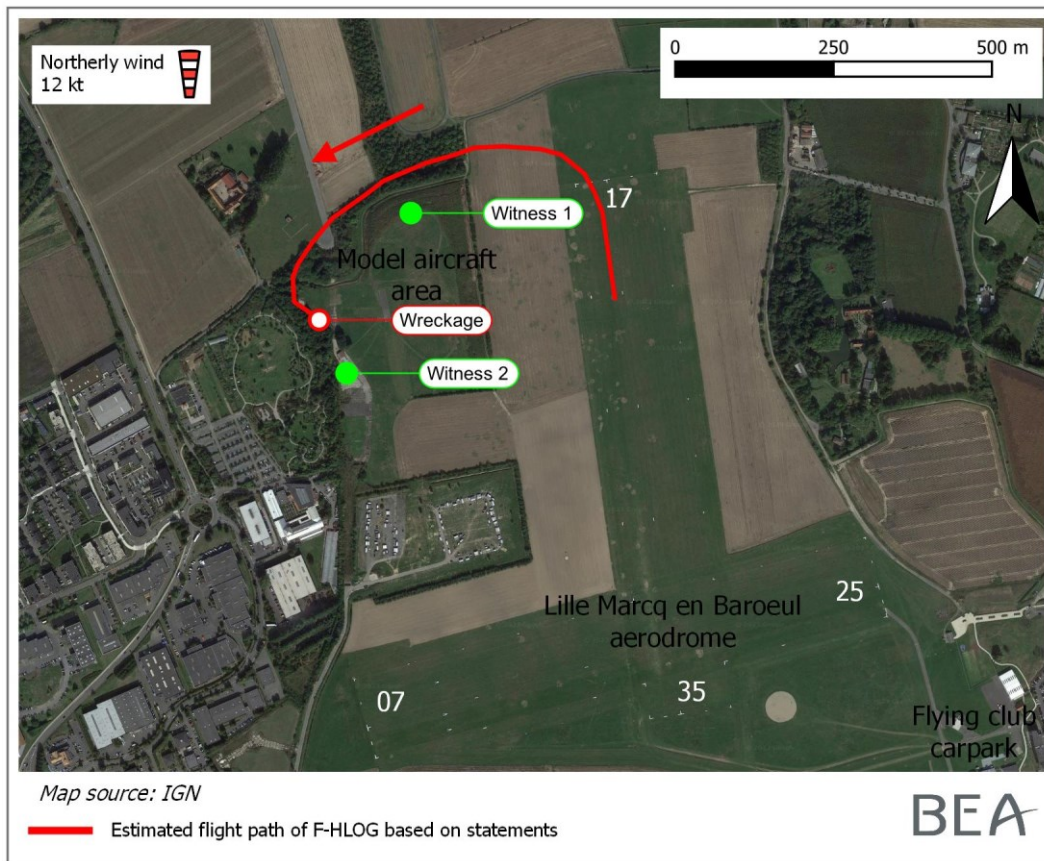
The pilot carried out a touch-and-go. Witnesses reported that the aeroplane took off on the last third of the runway. They then saw smoke coming out of the plane in initial climb at a height they estimated at 100 ft. The pilot turned onto the crosswind leg and announced over the radio that he was going to carry out a “short circuit”. Other witnesses, situated under the flight path, perceived a reduction in the engine speed. They estimated the height of the aeroplane as being at 300 ft. The pilot then started a left turn, but lost control of the aeroplane a few seconds later. The aeroplane immediately caught fire after the collision with the ground.

Figure 1: flight path estimated by witnesses (annotated by the BEA)

The accident site was located 500 m west of the end of runway 35, near the model aircraft area (see **Figure 1**).

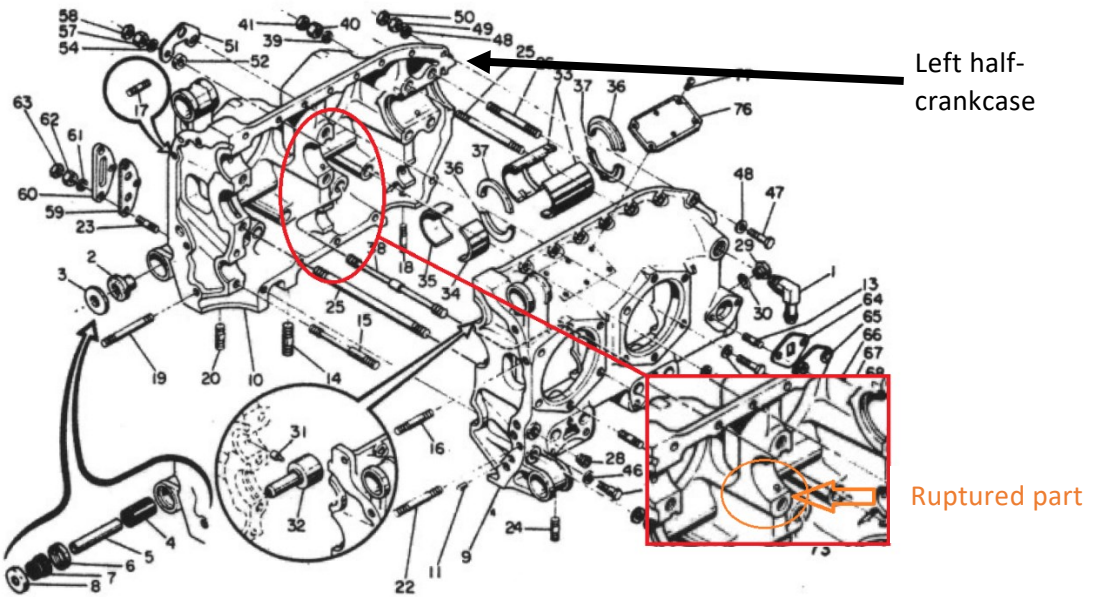
The examination revealed the rupture of part of the left half-crankcase, around the thread of one of the studs, in line with a crankshaft bearing.

Figure 2: view of rupture of left half-crankcase (source: Continental, annotated by the BEA)

The examination of the rupture in the BEA laboratory showed that the aeroplane's engine crankcase fractured slowly and progressively under a fatigue cracking process, until its final sudden rupture during the accident flight. It was not possible in the laboratory to reliably and precisely date the start of the cracking. However, the cracking spread from the core to the exterior of the crankcase. It would not have been possible to detect it during the various general overhauls as it had probably not opened out onto the surface at the time of the checks.

It is probable that the final rupture of a component inside the crankcase occurred after power was increased to take off again. This rupture in line with a crankshaft bearing was caused by previous fatigue-cracking type damage. The rupture probably generated vibrations and affected the oil system inside the engine, which gave rise to excess oil in a cylinder, generating smoke which escaped via the exhaust, as observed by several witnesses.

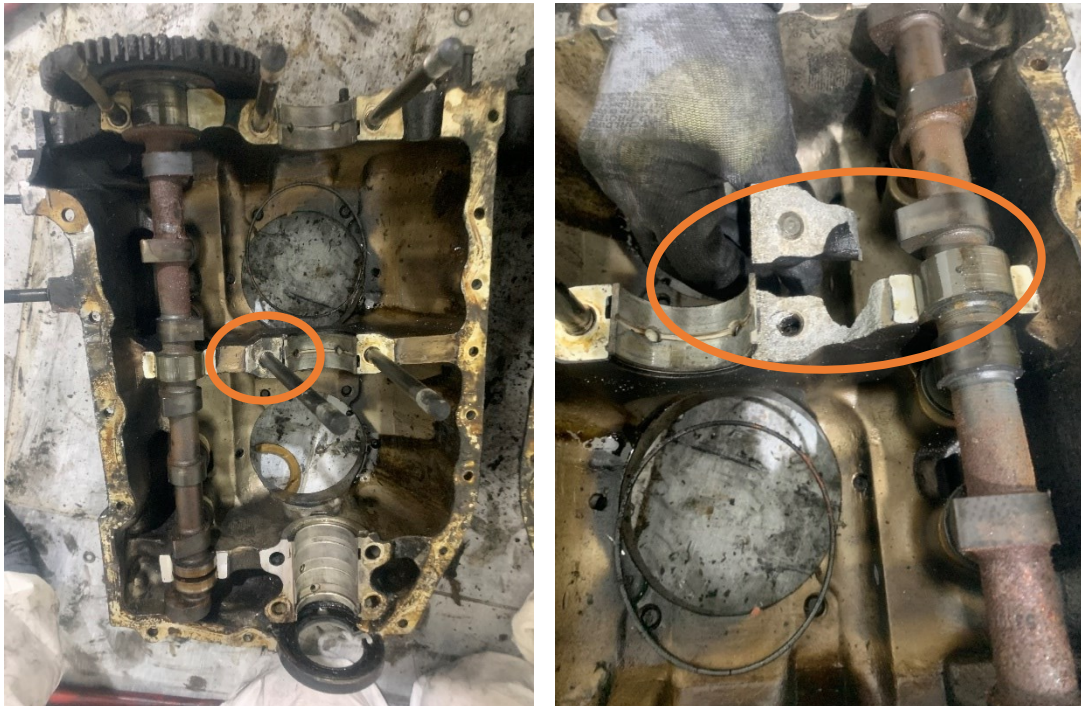
Figure 3: view of rupture of left half-crankcase (source: BEA)
