Accident to the ROBINSON R44 II
registered **F-HLOU**
on 31 October 2023
at Salazie (La Réunion)

This is a courtesy translation by the BEA of the Final Report on the Safety Investigation. As accurate as the translation may be, the original text in French is the work of reference.

Loss of control in flight, collision with the terrain

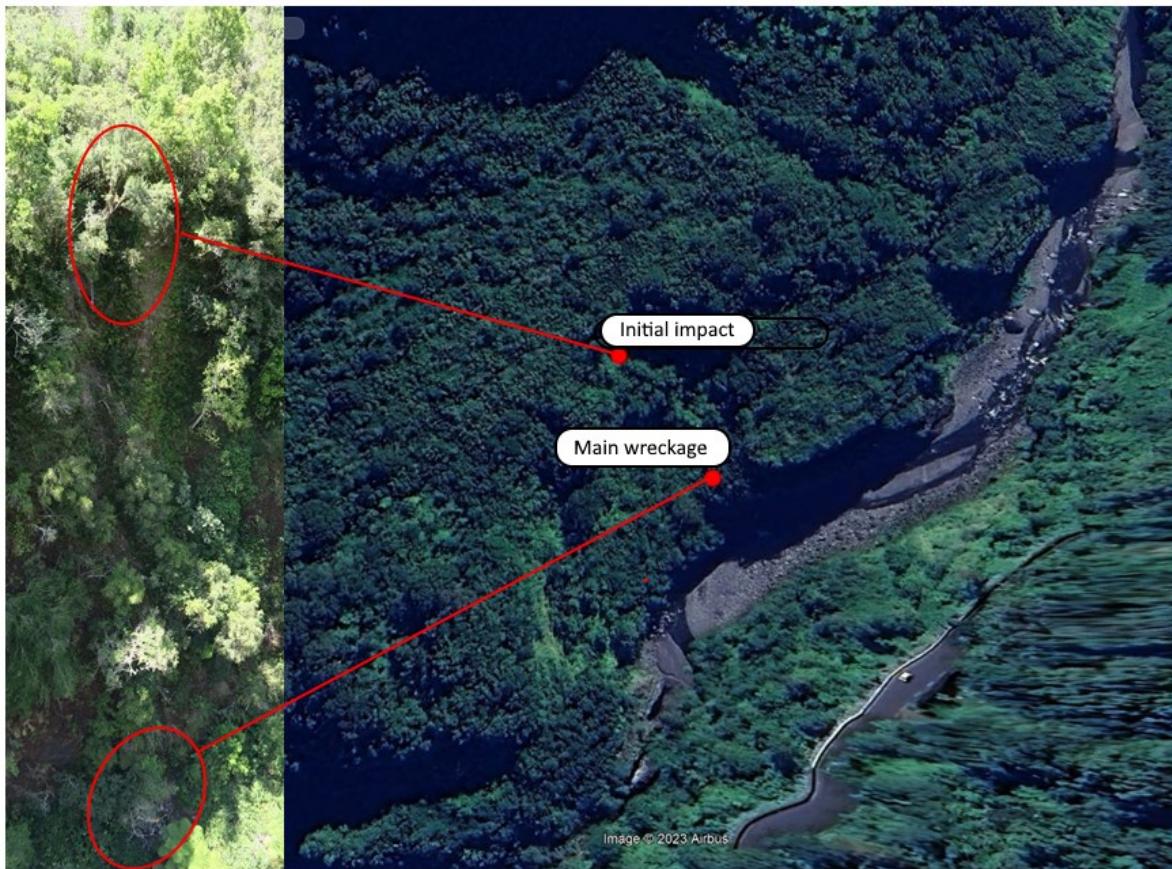
The accident site was located at an altitude of 1,150 ft, on the eastern slope of the mountain in the Mât river gorges (left bank) at the exit of the Salazie cirque, at Le Bois de Pomme, and in the direction of Saint André. The helicopter first struck the vegetation and then the ground 30 m above the area where the main wreckage was lying.

*Figure 2: location of wreckage and initial impact
(satellite image: Google Earth, left photo: BEA)*

The first impacts were observed in the branches of a tree, which showed signs of interference (tears, scars) with the airframe or rotating parts of the helicopter. No branches were found cleanly severed.

Several pieces of the main rotor blades, the tail rotor (TR), the tail gearbox (TGB), the tail boom, some airframe components, and one of the helicopter's skids were present on the slope. The location of this debris was consistent with the path followed by the helicopter as it slid down the slope after colliding with the terrain.

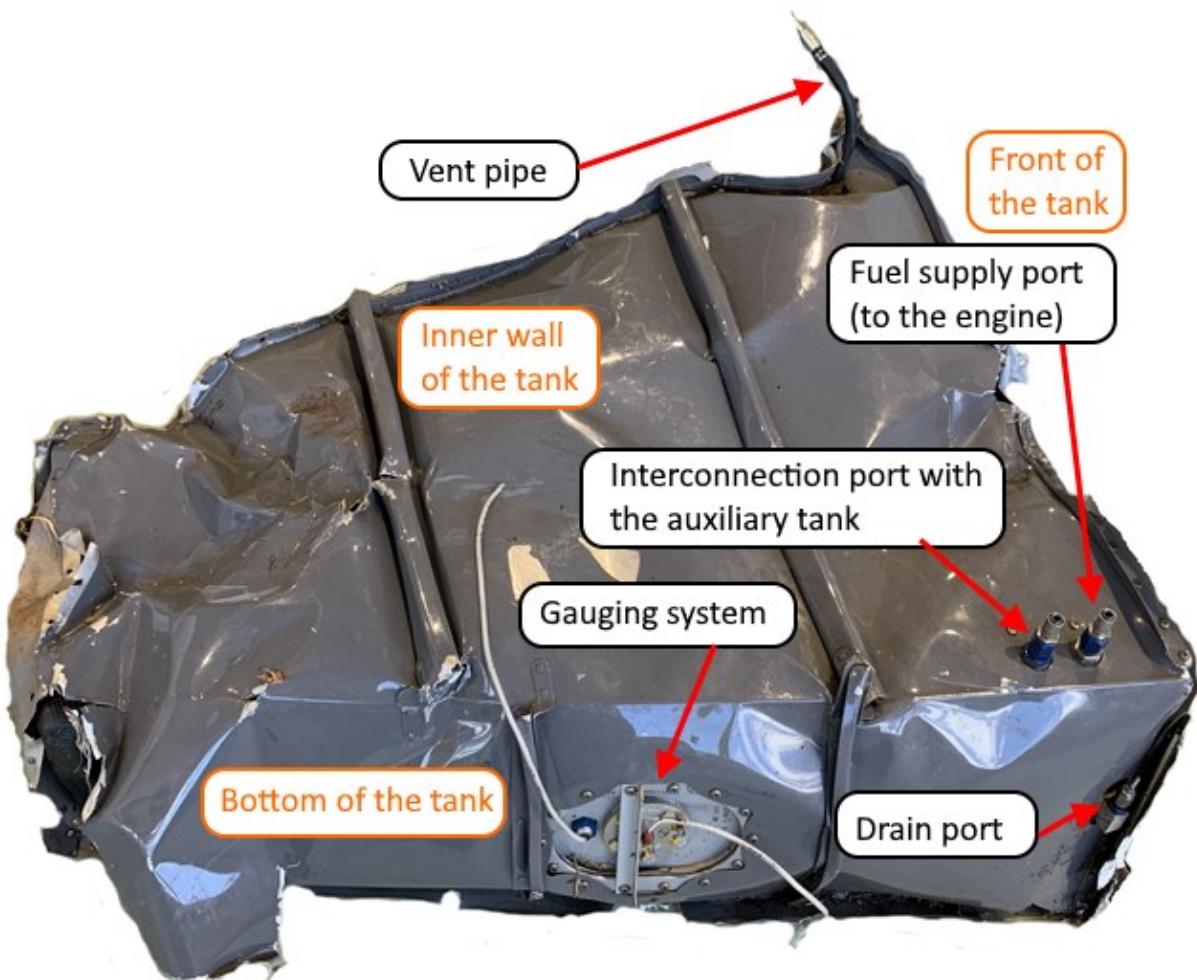
Figure 3: main fuel tank of R44 F-HLOU (source: BEA)

Each tank has a refuelling port (at the top) and can be drained independently. The fuel draining point is located at the front bottom of the tank at the lowest point⁸. The two tanks are permanently interconnected. The bottom of the auxiliary tank is positioned higher than that of the main tank,

which allows the auxiliary tank to be emptied first. The fuel supply port to the engine is located on the main tank. It is located on the vertical inner wall of the tank, approximately three centimetres above the bottom of the tank and next to the connection port to the auxiliary tank. The two tanks have independent gauges, and the main tank has a low fuel level indicator. The fuel valve in the cockpit has only two positions: open or closed.
