**Accident** to the Airbus AS350 - B3E  
registered **F-HMFA**  
on 30 May 2022  
at Borce, vallée d'Aspe, locality of "Belonce" (Pyrénées-Atlantiques)

<b>Time</b>	Around 13:00 <sup>1</sup>
<b>Operator</b>	Héli Béarn
<b>Type of flight</b>	Cross-country flight - Non-commercial operation (NCO)
<b>Persons on board</b>	Pilot and 2 passengers
<b>Consequences and damage</b>	Body structure and tail boom substantially damaged

**Vortex ring state close to the ground during approach,  
hard landing**

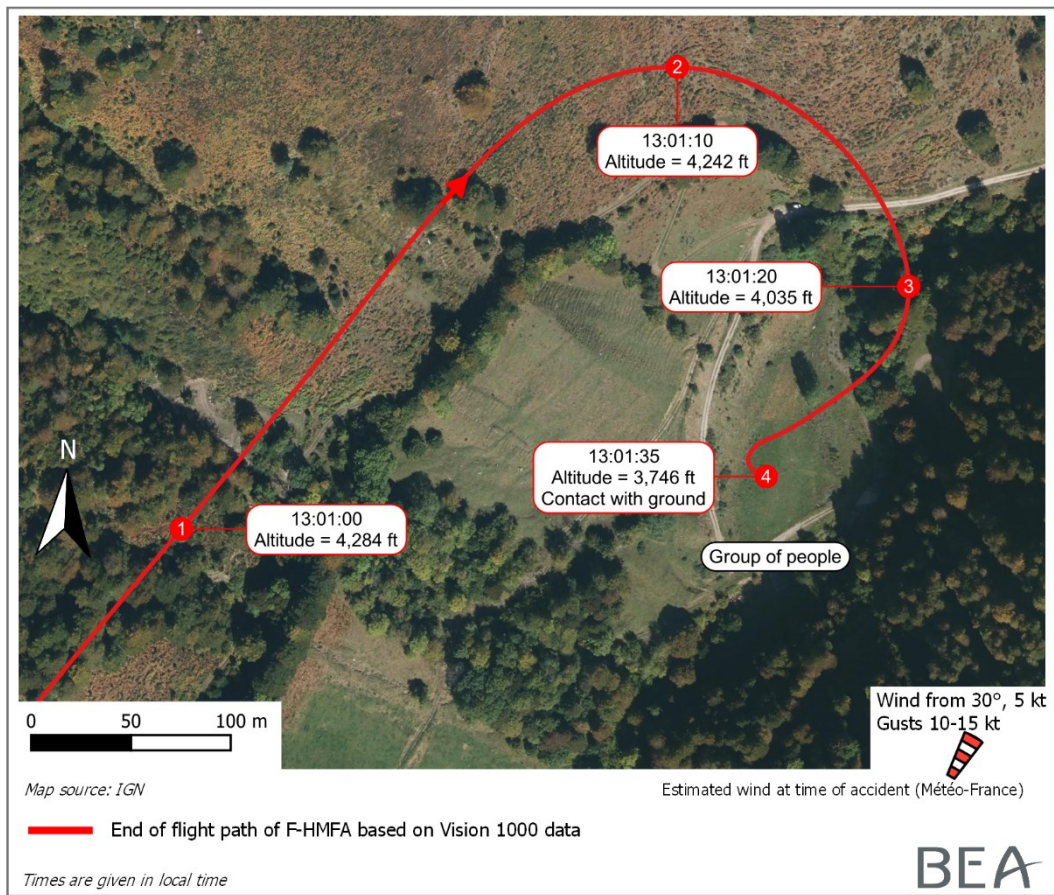
The approach to Borce was flown at low horizontal speed, almost overhead the landing area. A low-intensity and irregular slope breeze was blowing up the valley from behind the helicopter. About 30 metres above the ground, the pilot pulled the helicopter's nose up to slow it down, then eased the stick forward. The pilot and the rear passenger felt the helicopter sink and identified an entry into a vortex ring state. The pilot decided not to move the cyclic stick forward because of the helicopter's proximity to the ground and the presence of a group of around 10 people in front of him. He did not change path and let the helicopter fall. Just before the touchdown, he turned 90° left to avoid the mountain slope. The hard impact bent and damaged the tail boom.

Figure 1: final approach path of F-HMFA

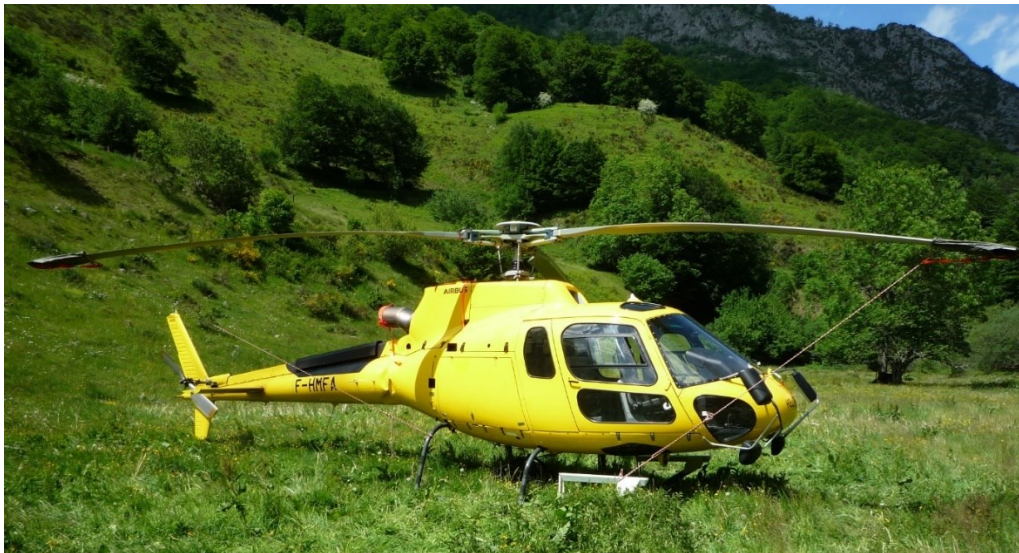
- all its components were present; the cabin was intact; neither the main rotor nor the tail rotor came into contact with the ground;
- the landing gear was damaged;
- the tail boom and rear body structure were distorted and folded;
- the flight control linkages were operational and the engine had no anomaly.

Visual examination did not reveal any technical malfunction that may have contributed to the accident.

Figure 2: photograph of F-HMFA (Source: Hélic-Béarn)

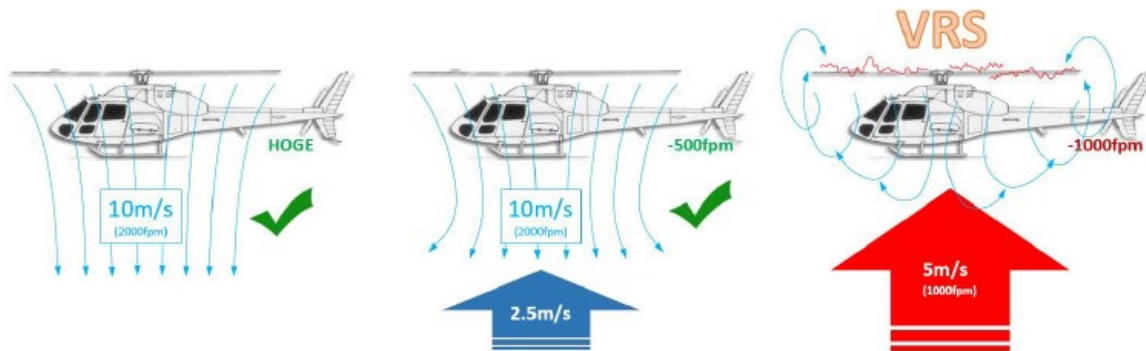
Figure 3: description of the conditions in which a vortex ring state occurs  
(Source: Airbus, SIN No. 3123-S-00)

When the H/C is still in the air (HOGE) nothing opposes this airstream from moving continuously away from the rotor disc plane. However, when the H/C descends vertically with a RoD of (say) 500 fpm (=2.5 m/sec), the opposing mass of still air does not allow the downwash to move downwards freely. When the RoD increases to a value of about **half** the H/C downwash velocity in hover, i.e. 1000 fpm, then the opposing mass of still air will effectively block the rotor downwash. Without any 'escape route' the downwash will 'bend', 'brake', and unavoidably return back to the rotor disc plane, creating a giant violent recirculation. Contrary to normal operation (HOGE or low RoD) this recirculated air is highly turbulent and heavily degrades the lift generated by the blades. Under these conditions, the blades will have difficulty following the inputs (collective/cyclic) from the pilot, and the rotor will become sluggish. Moreover, the giant recirculation of turbulent air will engulf most parts of the H/C fuselage and tail, pushing and pulling it in every direction chaotically.

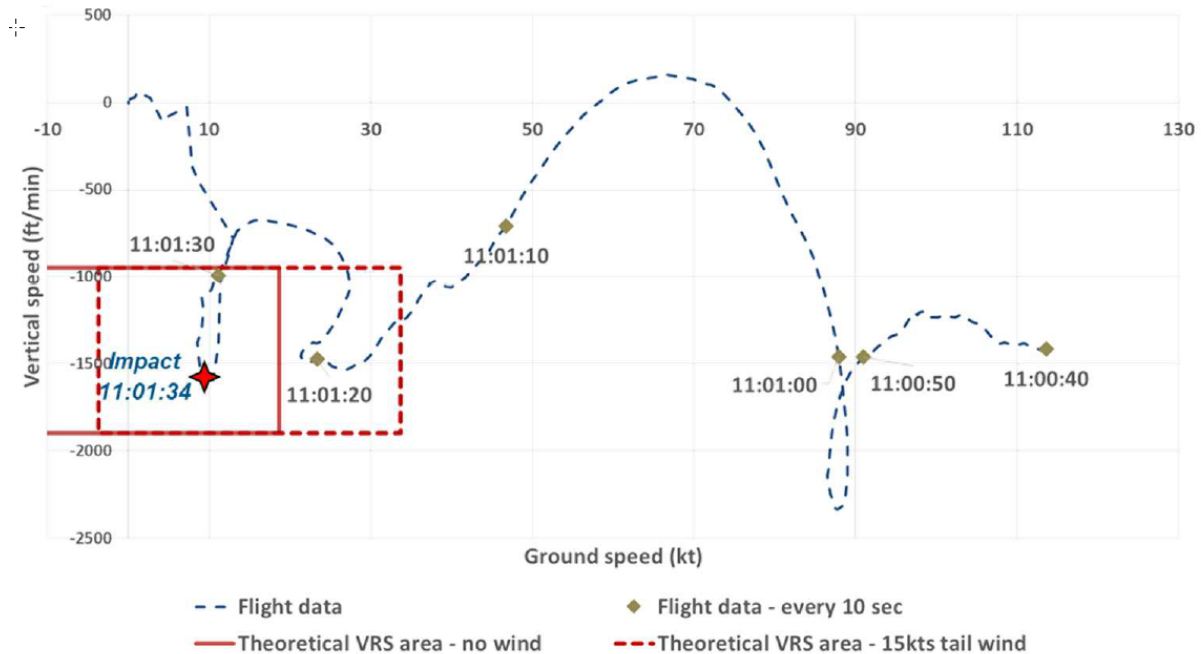
The read-out of the parameters recorded in the Vision 1000 revealed that during the last twenty seconds of flight, the helicopter’s vertical speed was very high, with a low ground speed. Examination of the video and recorded data showed that during the final descent, the vertical speed increased from around 1,000 ft/min to 1,600 ft/min in 11 s, without any substantial input on the collective pitch being observed.

The theoretical envelope conducive to the occurrence of a vortex ring state is thus defined as  $\begin{cases} 0 < V_x < V_{i0} \\ -V_{i0} < V_z < -\frac{V_{i0}}{2} \end{cases}$ , this envelope varies depending on the tailwind speed and aircraft attitude. It is shown in red on the following graph (see *Figure 4*).

*Figure 4: theoretical area where a vortex ring state may occur, with or without wind (Source: Airbus)*

*The helicopter's vertical speed is plotted as a function of the ground speed during the last minute of flight.*

Analysis of the parameters and the video taken by the witnesses on the ground confirmed that the helicopter entered into a vortex ring state.

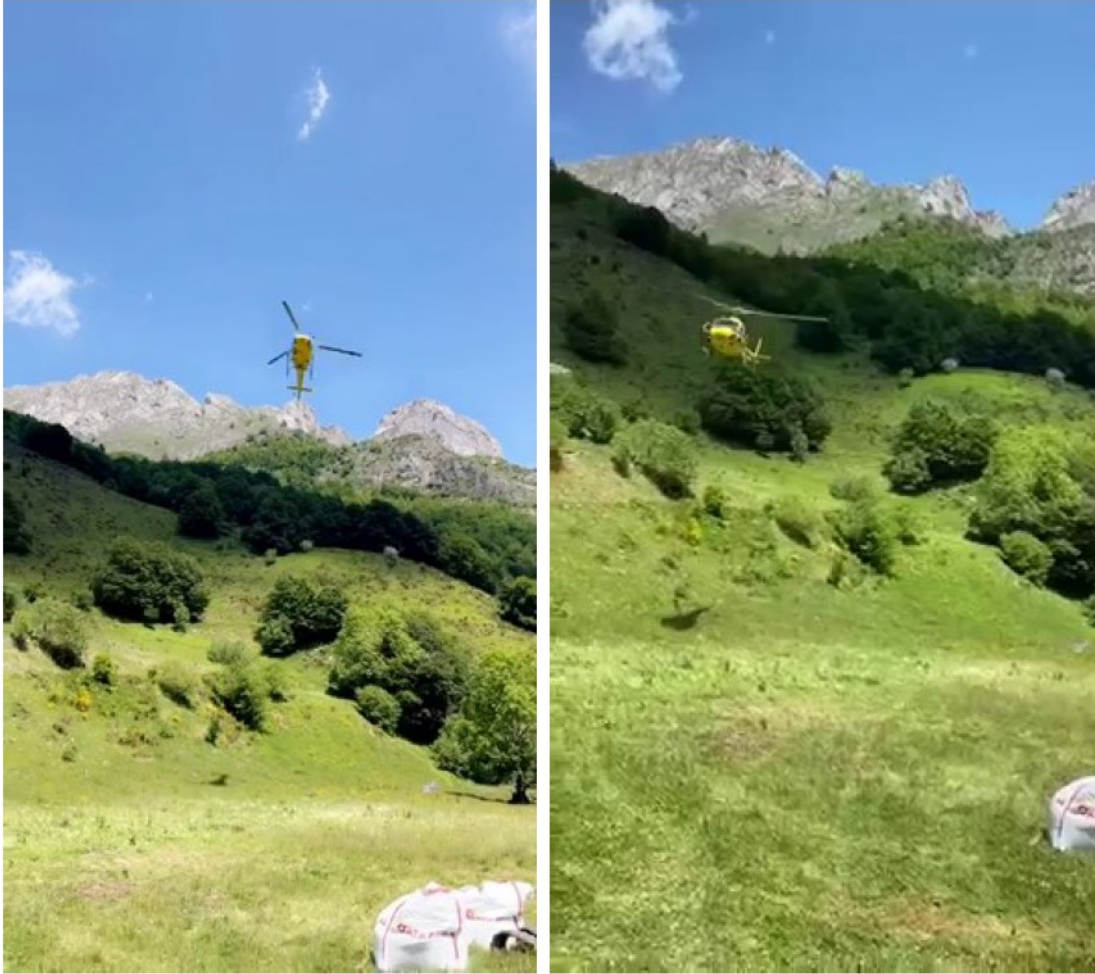
Two other video recordings, taken by two members of the group of persons on the ground (see Figure 1) showed the final approach carried out by F-HMFA until impact with the ground.

It is possible that the pilot was surprised and stressed by the acceleration during the descent and was slow to react and input on the collective pitch to counter an excessive rate of descent. The pilot in the rear seat noticed this late reaction and specified that he reported it to the pilot immediately, telling him that he needed to correct his approach angle.

Figure 5: extracts from videos taken from ground during final approach
