Accident to the Sonaca S201
registered **F-HMRZ**
on 28 February 2023
at Tours-Val de Loire (Indre-et-Loire)

This is a courtesy translation by the BEA of the Final Report on the Safety Investigation. As accurate as the translation may be, the original text in French is the work of reference.

Bounced landing, nose gear failure, in solo instruction

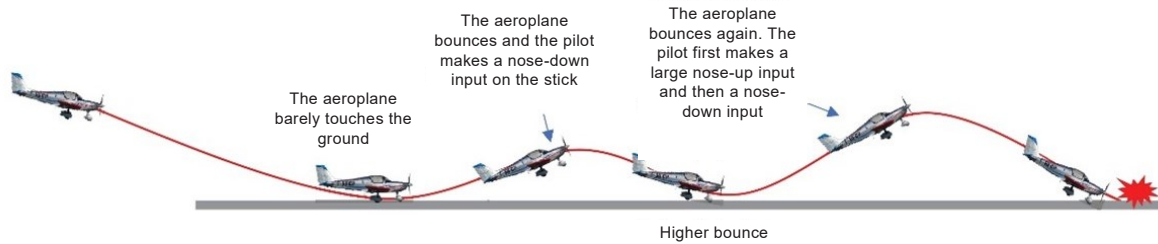
It also describes the possible effects of bouncing (see **Figure 3**).

Figure 3: effects of bouncing

The manual specifies that a pilot with little experience must go around in the event of a bounce on landing.
