Serious incident to the Cessna 525A Citation CJ2
registered **F-HMSG**
operated by Valljet
on 28 October 2023
at Paris - Le Bourget airport

Nose landing gear malfunction on take-off, in-flight fault management, landing with nose gear retracted

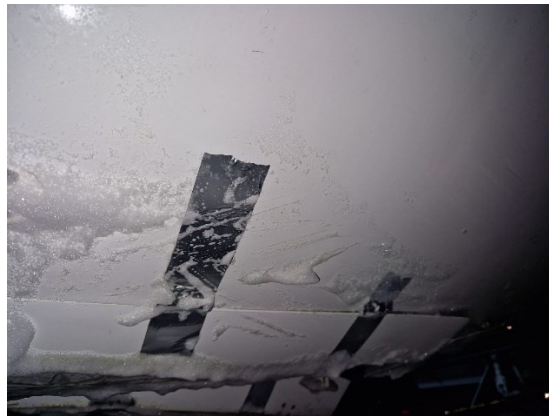
The BEA was not present when the aeroplane was recovered and transferred to the hangar. These operations took place on the night of the serious incident. A technician who was present during the operations indicated to the BEA that aluminium adhesive strips were taped on the doors of the nose landing gear and that he removed them after taking photographs of them.

Figure 2: adhesive strips on nose gear doors (Source: R&O)

- the installation of adhesive strips or a red flag without this being mentioned elsewhere;
- the crew's failure to identify the adhesive strips taped on the nose landing gear doors during the pre-flight inspection.

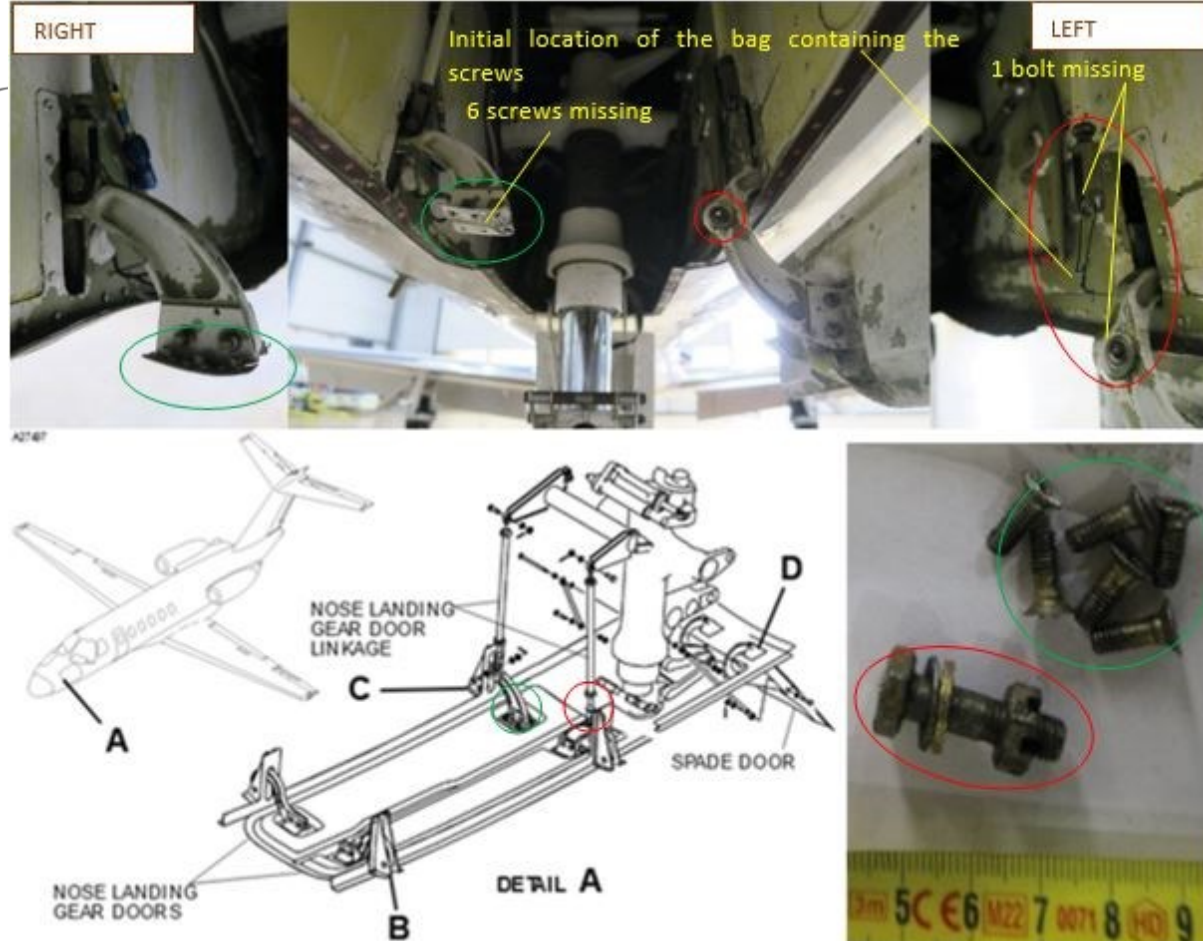
The aeroplane was examined by the BEA in the hangar of the R&O maintenance workshop (see para. 2.5). It was observed that the door actuation mechanism for the nose landing gear was disconnected:

- The right rear hinge was disconnected from the right door (green circles on Figure 3) and the corresponding six screws were in a bag attached to the left door actuating rod.
- The left door actuating rod was disconnected from the left rear hinge (red circles on Figure 3) and the corresponding screw-nut assembly was present in the bag containing the screws.

Figure 3: door actuation mechanism for the nose landing gear on F-HMSG
(Source: AMM Textron Aviation; photographs and annotations BEA)

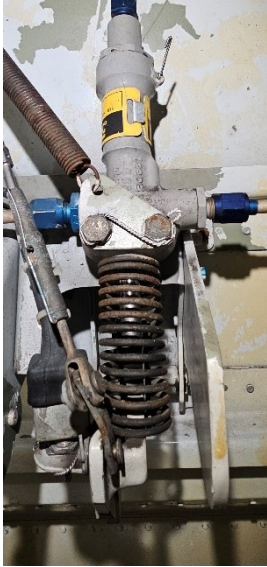
- Signs of corrosion on springs: technician 1 indicated that this was surface corrosion and that cleaning and greasing would be sufficient. He had also noticed this during his inspection.
- The lack of anti-corrosion protection on the walls of the well: technician 1 indicated that this was not very important, that this could wait until the next major check and that it was not possible to repaint everything.

Figure 5: signs of corrosion on springs of nose landing gear mechanism²² (Source: R&O)

²² The BEA shared some photographs with Textron Aviation. The latter indicated that, given the level of corrosion observed in the photographs, had they been consulted, they would have recommended replacing the springs.

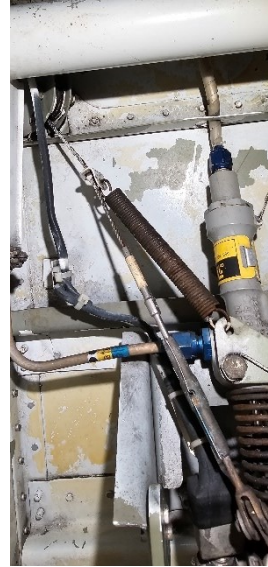
Figure 6: no anti-corrosion protection (yellowish in colour) on the walls of the nose landing gear well (Source: R&O)
