**Accident** to the ROBIN - DR400 - 500  
registered **F-HMYY**  
on 5 August 2021  
close to the Col du Glandon pass (Savoie)

<b>Time</b>	Around 14:50 <sup>1</sup>
<b>Operator</b>	Aéroclub de Loire Atlantique
<b>Type of flight</b>	Cross-country
<b>Persons on board</b>	Pilot and three passengers
<b>Consequences and damage</b>	Pilot and two passengers fatally injured, one passenger seriously injured, aeroplane destroyed

## **Collision with trees, fire, during a flight through a valley in a mountainous area**

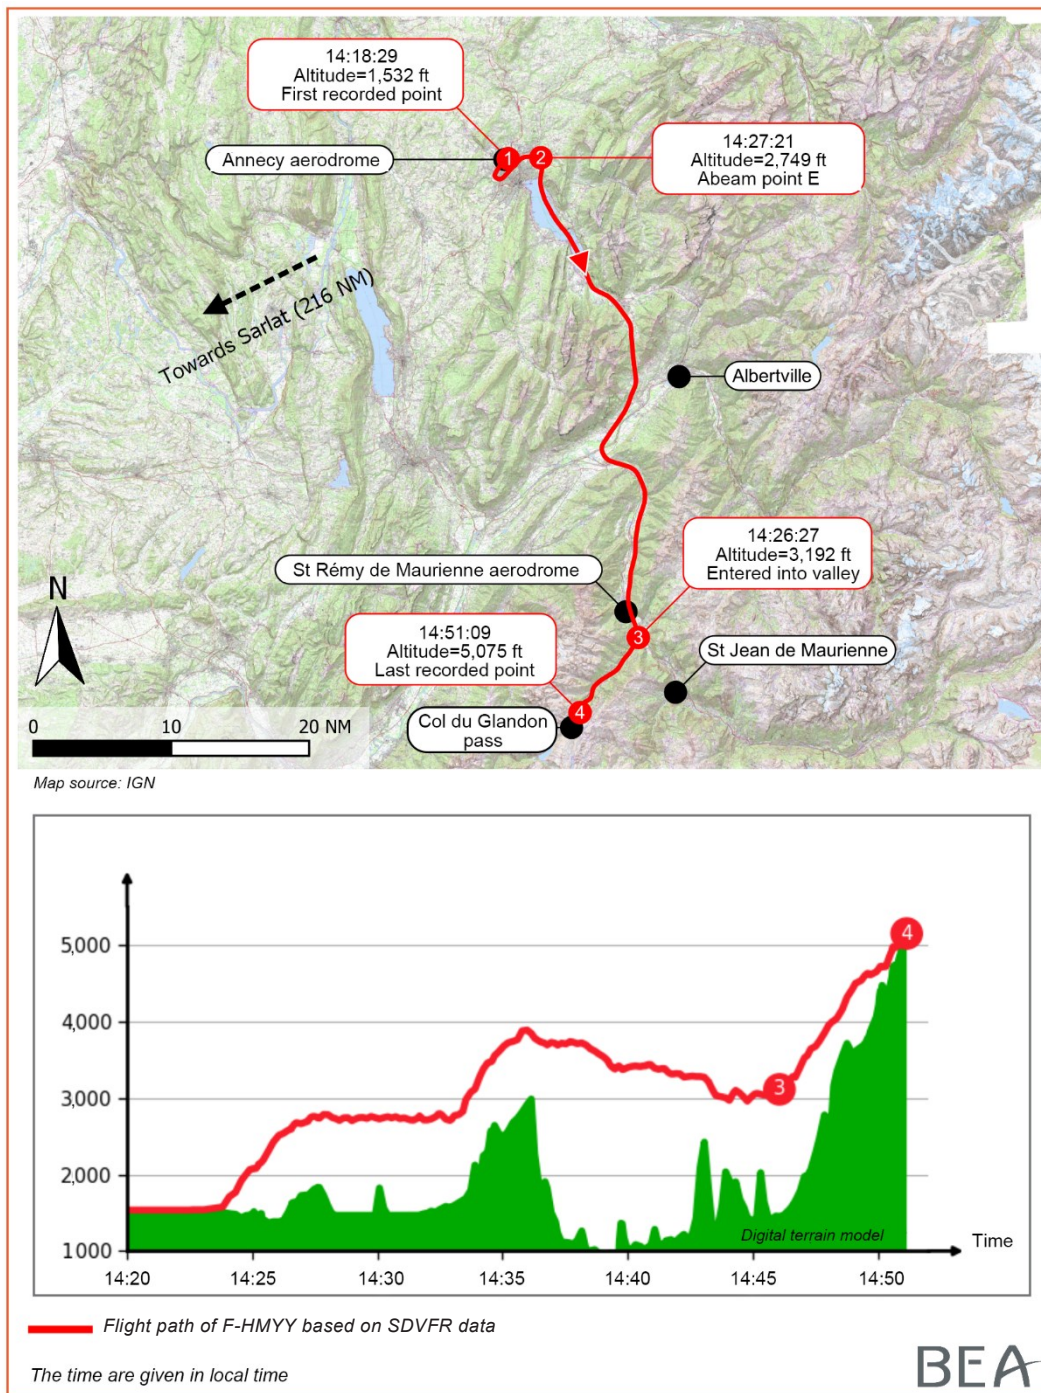
Figure 1: aeroplane's flight path

After flying over the lake, he followed the valley south and climbed to an approximate altitude of 3,700 ft. After passing Albertville, he continued southwards and took the valley towards Saint-Jean-de-Maurienne. His altitude decreased to 3,000 ft. After going past Saint-Rémy-de-Maurienne aerodrome, he turned south-west and took the valley leading to the Col du Glandon pass. On entering this valley (see *Figure 1* and *Figure 2*, point **3**), the aeroplane was at an altitude of approximately 3,200 ft, i.e. a height of 1,500 ft.

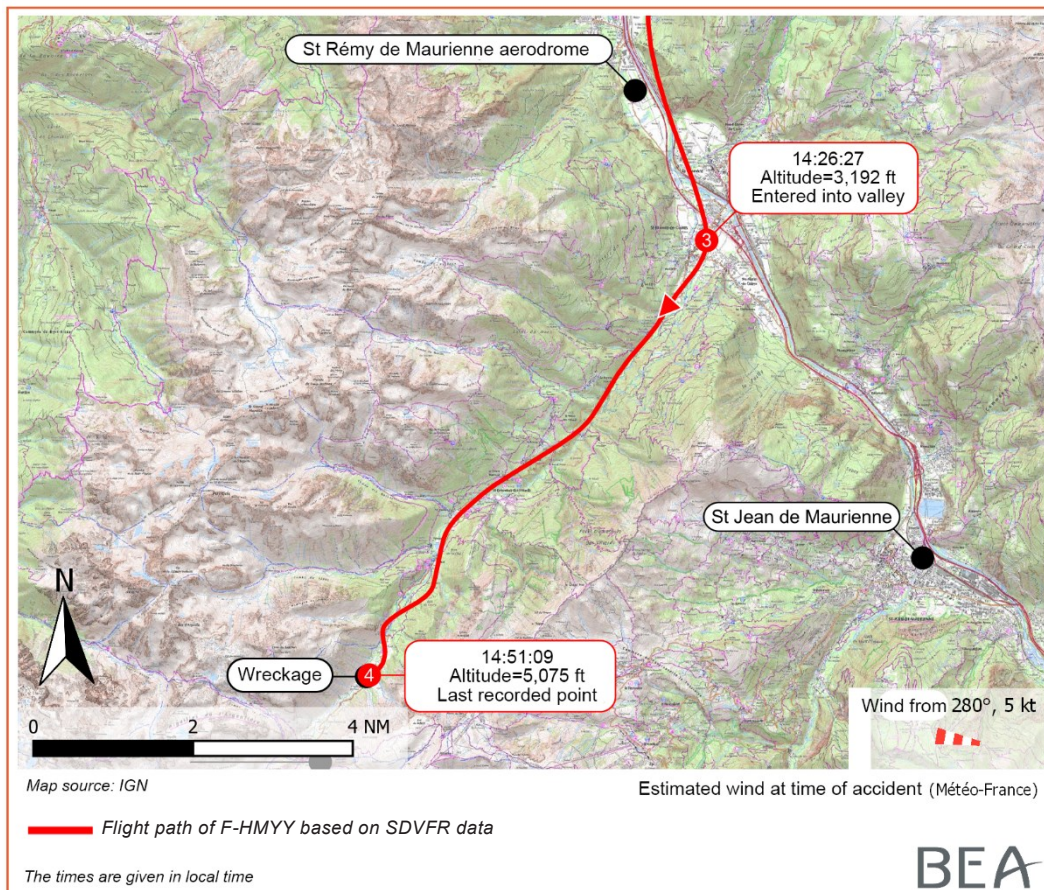
Figure 2: aeroplane's flight path in the valley leading to the Col du Glandon pass

The pilot flew up the valley roughly following the road in the centre of the valley. The aeroplane climbed with a mean gradient of 5.1%<sup>2</sup> which is below the mean gradient of the valley. Although the aeroplane's altitude increased, its height progressively decreased because of the rising terrain.

The pilot then entered the valley leading to the Col du Glandon pass and followed a direct track towards the pass. This direct flight path, given the aeroplane's performance and the altitude at which it entered the valley, did not leave the aeroplane sufficient time to gain the altitude required to cross the pass. As a result, although the aeroplane gained altitude, it gradually approached the ground and the slopes of the valley. Furthermore, flying in the centre of the valley, the pilot had only half the space available to perform a U-turn.

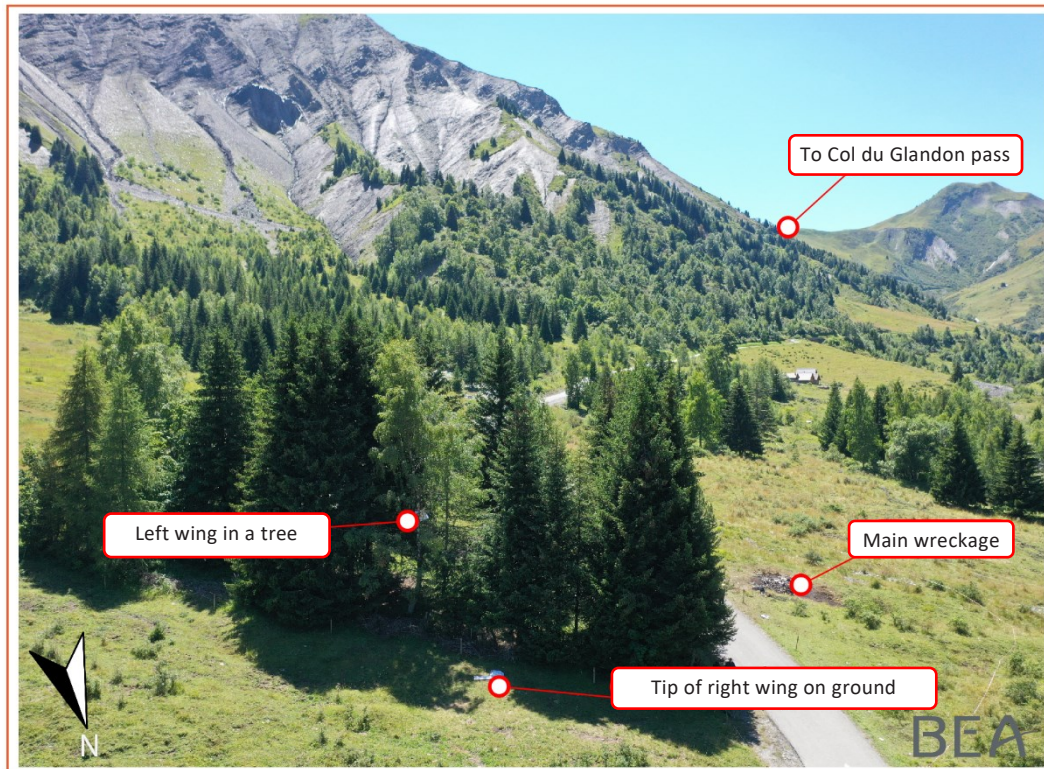
Figure 3: aerial view with drone (source: BEA)

The wreckage was situated at an altitude of 5,070 ft, around 2.4 km before the Col du Glandon pass, at the edge of the road leading to the pass.

The valley is roughly oriented 040°/220°. The mean gradient between the entrance to the valley and the site of the accident is around 8.4%. It then increases up to the pass.

Observations of the site and the wreckage indicate that the aircraft, coming from the north-east, struck the vegetation at a height of around eight metres, with its wings relatively flat, a roughly horizontal flight path and a significant horizontal speed.

The aeroplane was completely destroyed by the impact and the fire. The examination of the wreckage showed that at the time of impact with the vegetation, the flight controls were continuous on all three axes and the engine was delivering power. The continuity and position of the elevator and rudder trims could not be verified. The flaps were in the “retracted” position at the time of the accident. During the examination, no technical failure which could have contributed to the accident was identified.

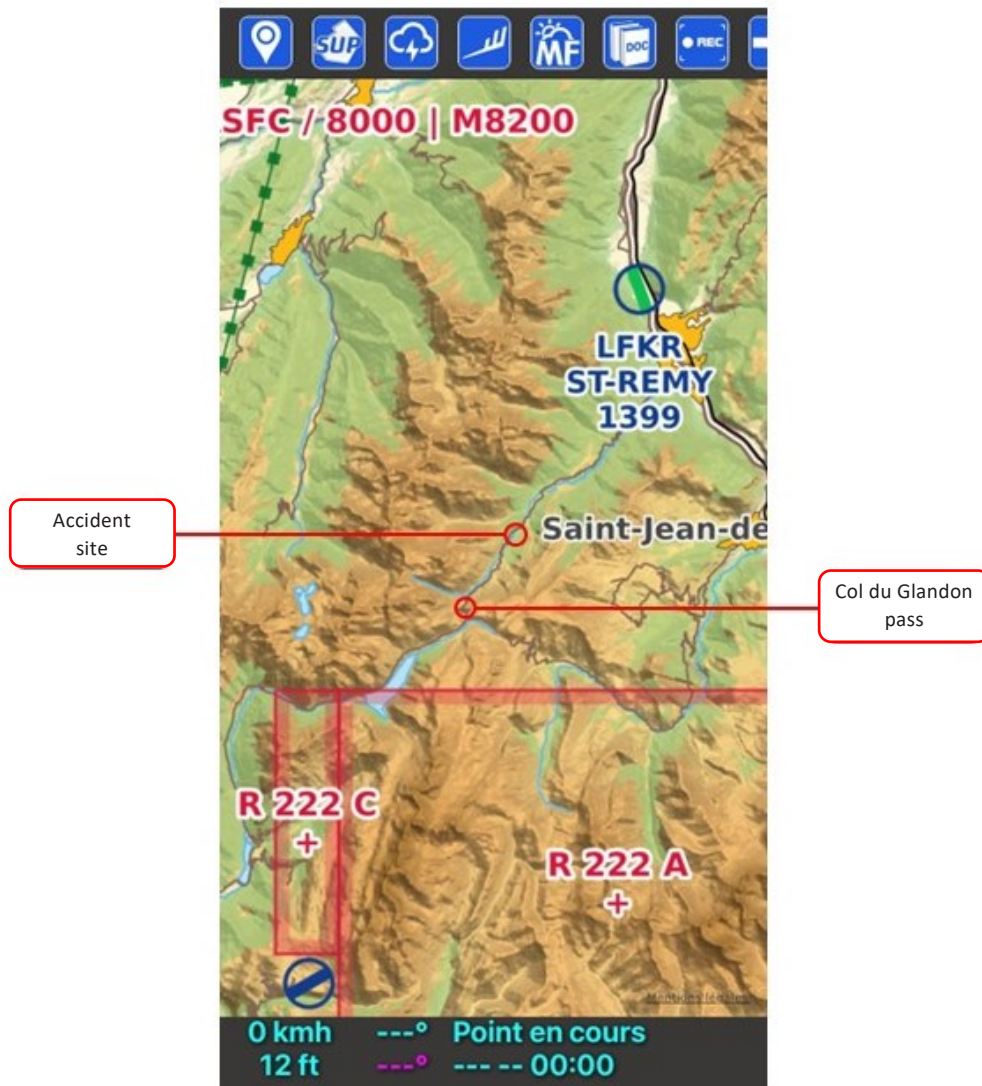
Figure 4: screenshot of the SDVFR application on another tablet

Several base maps can be used. The commonly used ICAO SD map displays the topography of the terrain using a colour code (see *Figure 4*). Contour lines and the altitudes of peaks and passes are not shown.

- an underestimation of the risks inherent in flying in mountainous areas;
- insufficient knowledge of the specific flight techniques for mountainous areas and a very probable lack of experience of mountain flying;
- the possible mental picture of a direct flight path on the navigation application commonly used by the pilot, which has a display format which makes it difficult to visualize the topography of a valley.

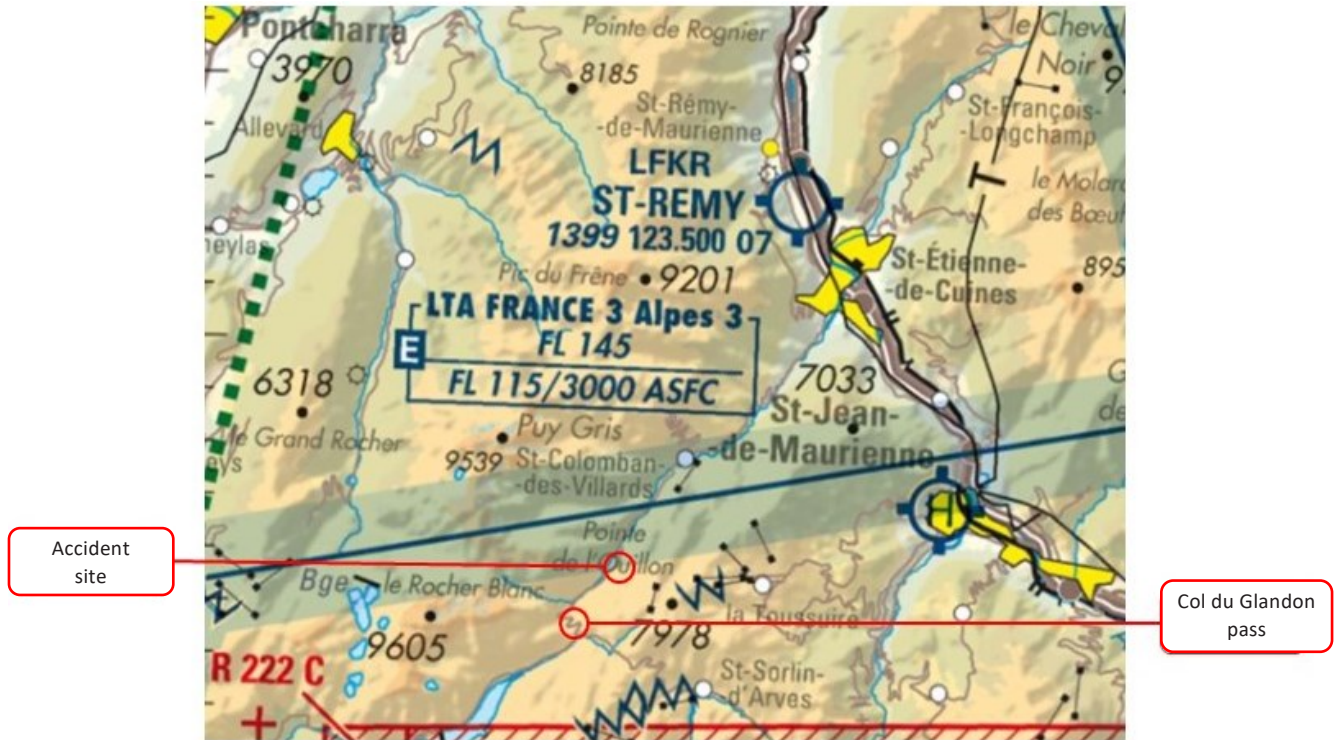
Figure 5: excerpts from OACI IGN map (source: Géoportail)

For comparison, on the ICAO IGN map (see Figure 5), some terrain altitudes<sup>4</sup> are shown. On the IGN map (see Figure 6), the contour lines provide a better image of the topography. However, this type of map is difficult to use in flight.
