**Accident** to the AIRBUS A350-900  
registered **F-HNET**  
on 5 December 2021  
on approach to Cayenne Félix Éboué airport (French Guiana)

**Turbulence in descent, cabin crew member seriously injured**

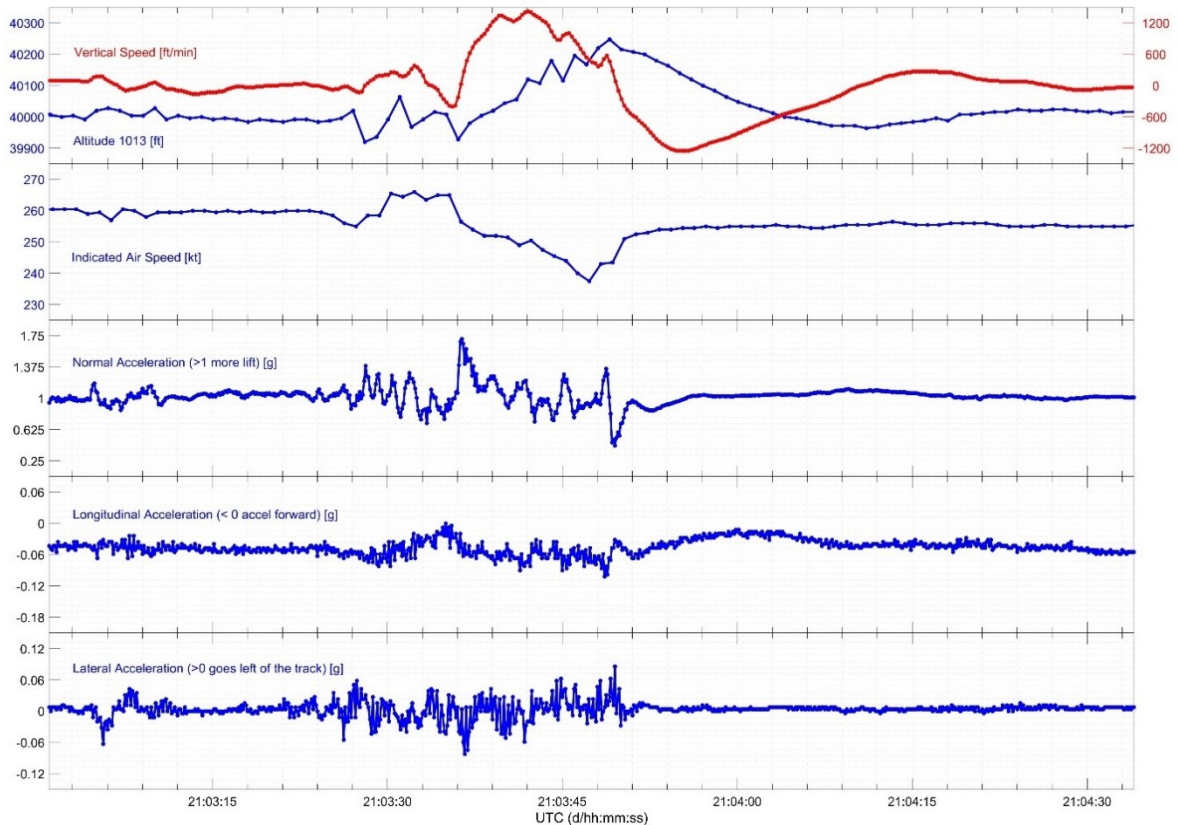
**Figure 1: flight parameters for 1st zone of turbulence**

Shortly after 21:00, at the end of the cruise phase at FL 400, the crew anticipated a first zone of turbulence. The food trays had been previously handed out and had not yet been cleared away. After exchanging with the cabin crew, the captain activated the “Fasten seatbelt” signs and informed the occupants in the cabin that they were going to fly through a zone of turbulence for five to ten minutes. A short time later, the aeroplane entered a zone of turbulence lasting around 30 s. The normal (vertical) acceleration varied between 0.43 G and 1.71 G with a maximum differential of 0.93 G and the lateral acceleration varied between -0.08 G and 0.09 G. The speed fluctuated between Mach 0.79 and Mach 0.88, the vertical speed increased to 1,400 ft/min before decreasing to -1,250 ft/min. The autopilot (AP) and the auto-thrust (A/THR) remained engaged for this period.

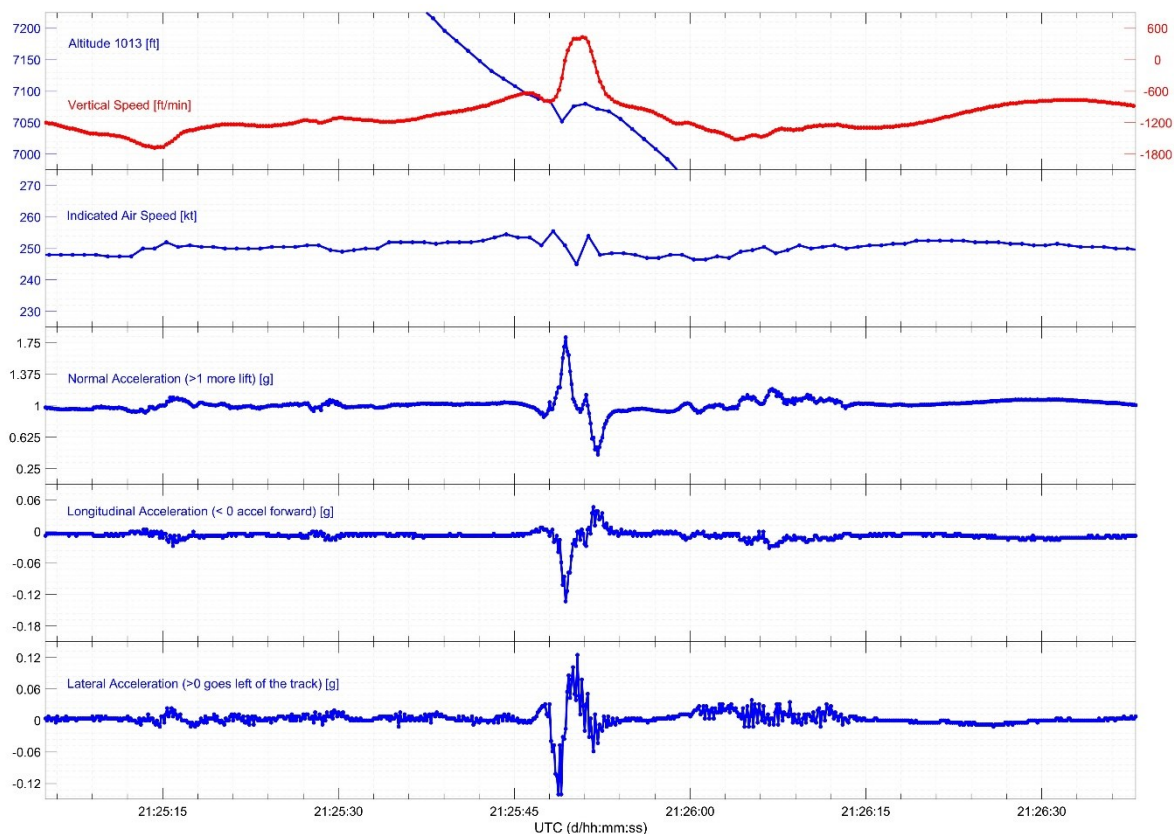
**Figure 2: flight parameters for 2nd zone of turbulence**

The vertical acceleration varied between 0.42 G and 1.82 G with a maximum differential of 0.95 G and the lateral acceleration varied between -0.14 G and 0.12 G with a maximum differential of 0.26 G. The Calibrated AirSpeed (CAS) fluctuated between 245 kt and 256 kt, the vertical speed increased from - 1,100 ft/min to 430 ft/min before returning to - 1,100 ft/min. The AP and A/THR remained engaged during the turbulence.

The purser and the cabin crew members in the rear of the aeroplane felt a quick, rough jolt and fell over. The purser suffered an ankle injury and two cabin crew members suffered back and head injuries respectively. The purser was replaced by another cabin crew member for the end of the approach. Medical assistance was requested at the plane's arrival.

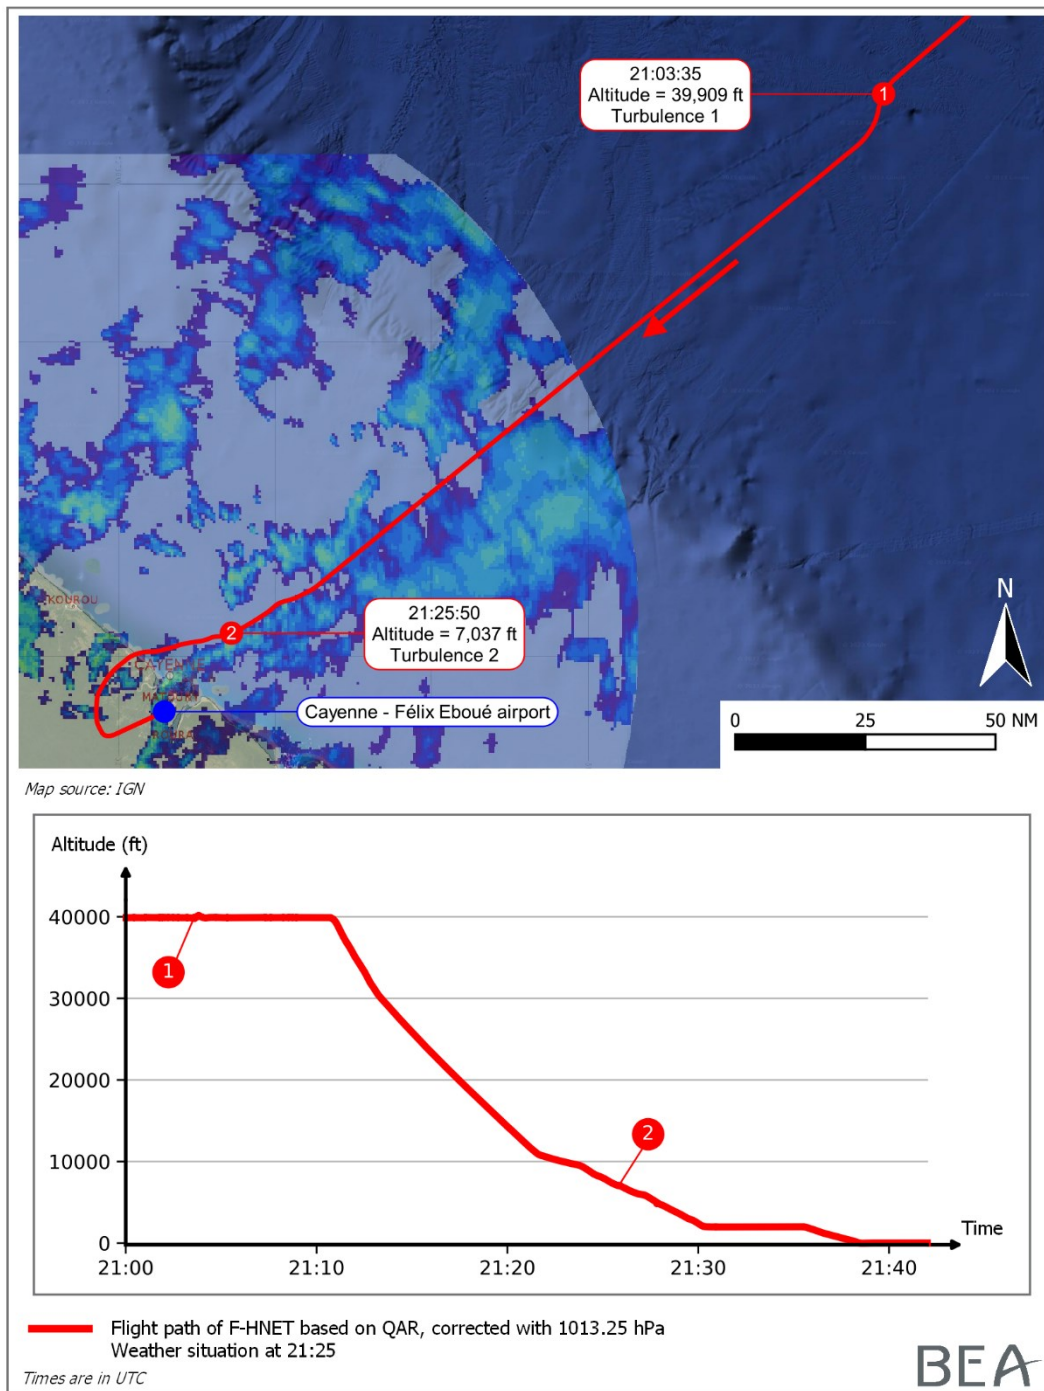
Figure 3: end of flight path of F-HNET

The precise time and position of the aircraft which were provided located the aeroplane at the edge of a line of rainfall (see point 2 below), at the point where the convection was strongest according to the rainfall radar images. These cloud limits, downstream of the line of movement of convective clouds, could be the site of significant vertical movements, strong turbulence and wind shear.

A few minutes later, a sudden brief turbulence caused accelerations which resulted in the purser losing balance and sustaining serious injuries and in two cabin crew sustaining injuries. This zone of turbulence was probably generated by a convective cell close by. The crew may not have been able to detect or may have underestimated the distance or extent of the zone of influence of this cell.
