Serious incident to the PILATUS - PC12 - 47E
registered **F-HNFC**
on 19 July 2021
on La Môle aerodrome (Var)

Hard landing, touchdown on nose wheel and propeller contact with ground, rejected landing, in instruction

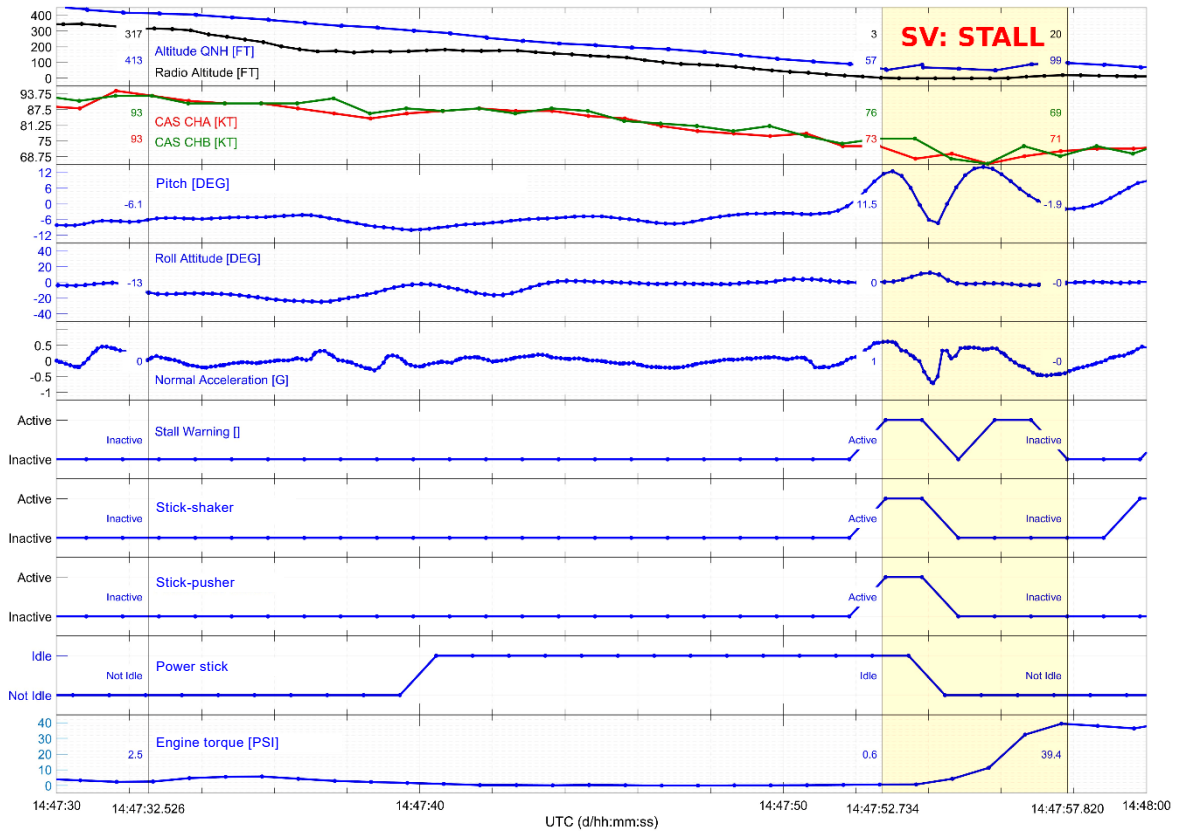
1 *Figure 3: parameters of final approach up to touch-down (source: BEA)* 2
(SV (Synthetic Voice generated in cockpit))

At point ① (see Figure 4), the aeroplane was aligned on final (20 s before the flare) in the landing configuration (flaps 40° and landing gear extended), its Calibrated AirSpeed (CAS) was 93 kt and decreasing and its height around 300 ft.

At 16:47:40, on passing a height of 180 ft, the pilot reduced power to flight idle, and the CAS stabilised at 87 kt⁵.

At 16:47:49, the instructor called out four times for the pilot to watch the speed. No variation in the parameters was recorded. At this point the CAS was 79 kt.

At 16:47:51, the pilot flared by pulling hard on the stick, the pitch attitude increased to 11° and the CAS decreased to 73 kt.

At point ②, at 16:47:53, a first "STALL" warning⁶ sounded. The AOA protections were activated and the stick-pusher brought the pitch attitude from +11° to -6°. The speed decreased to the minimum value of 68 kt. The nose gear and propeller struck the runway.

In the following second, the RH main landing gear followed by the LH main landing gear touched down on the runway. The pilot increased power and rejected the landing. The "STALL" warning sounded three times, at two second intervals.

Given the dynamics of the event, the actions of the stick-shaker and the stick-pusher and the "STALL" warning were simultaneous. No SWPS operating anomaly was observed.
