Accident to the Cameron - A160
registered **F-HNIJ** operated by PACA'P Montgolfière
on Sunday 25 June 2023
at Valensole

**Loss of burner effectiveness due to exhaustion of propane
in standby cylinder, forced landing,
collision with medium-voltage power line**

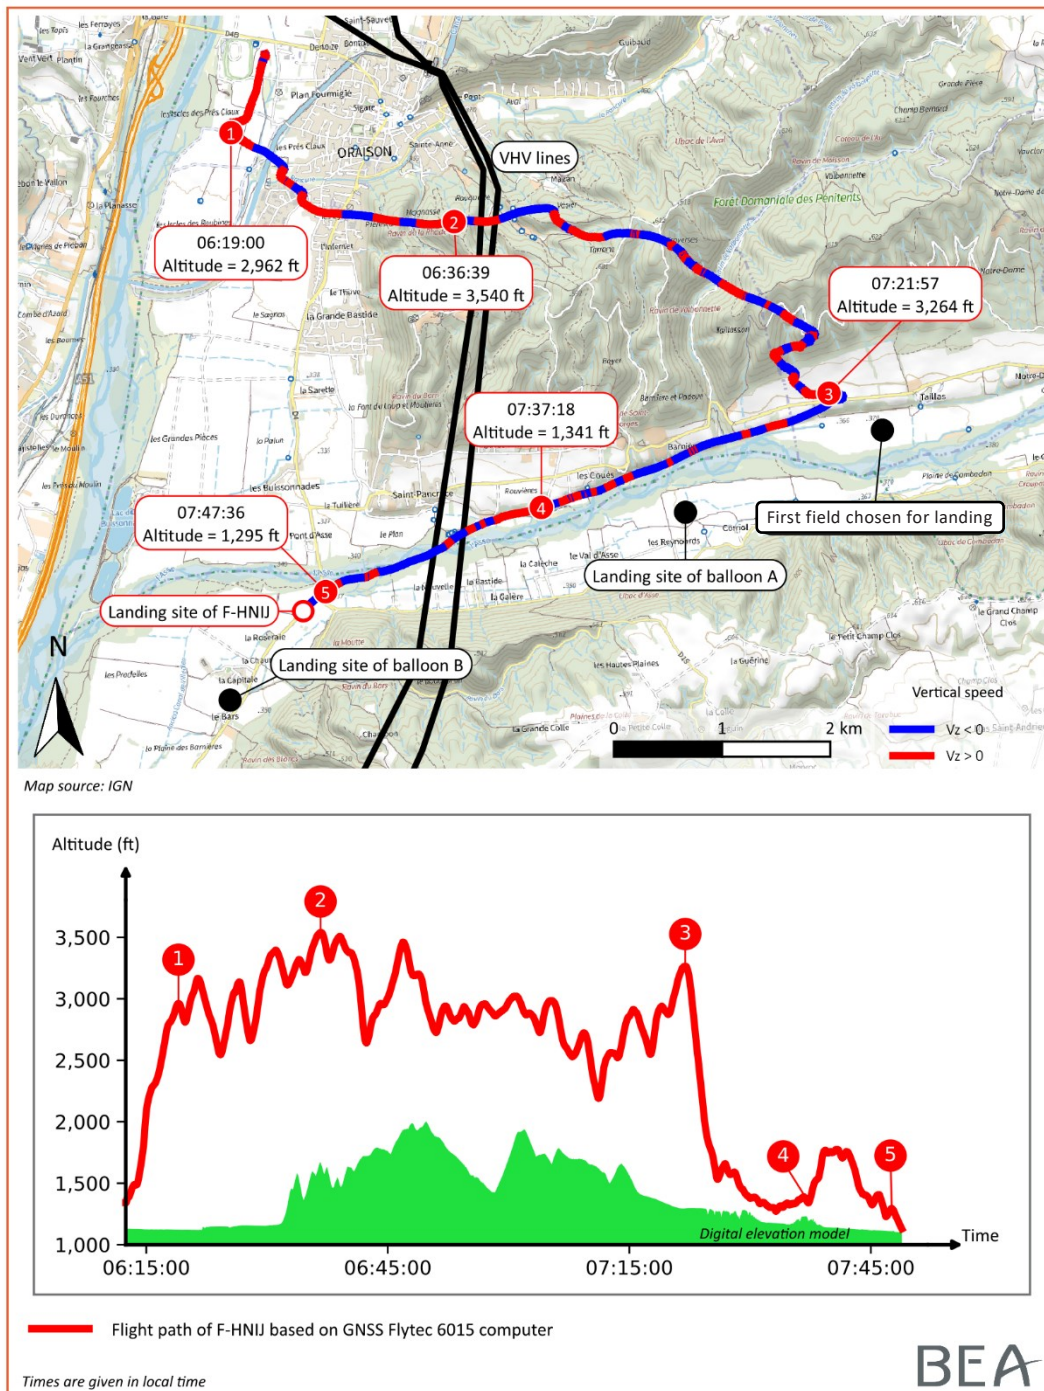
Figure 1: accident flight path

At 07:37 (point 4), i.e. around 1 h 30 min after taking off, he started a slow descent towards another patch of land situated less than 300 m before two very-high-voltage power lines perpendicular to the valley and the flight path of the balloon. At this point the balloon was around 700 m from the power lines. Believing that the balloon would probably land towards the end of the site and fearing a collision with the power lines if the landing had to be rejected, he chose to gain height to pass over the lines and land after them. After passing over the two VHV lines, he changed cylinders again, returning to one of the cylinders already used. Five minutes later, the pilot of balloon B landed in a field and then took off again, indicating over the radio not to land there as the owner of the field refused the landings. The pilot of F-HNIJ continued the flight and a few minutes later, when the balloon seemed to be heading towards a field of corn, it suddenly started losing height. The pilot actioned the burner⁵, to no avail, and observed that it was no longer providing power.

After a flight time of around 1 h 40 min (point 5), as the balloon was heading towards a medium-voltage power line (20,000 V), the pilot was obliged to land. He shut down the cylinder supply, the burner and the pilot light. He indicated that he then pulled the rapid deflation line. The envelope caught on the upper part of one of the power line poles then one of the envelope's steel suspension cables touched the power line cables, causing an electric arc which touched the pilot's upper body. The envelope then collapsed on the cables. The pilot managed to extinguish an incipient fire in his compartment close to the cylinders.

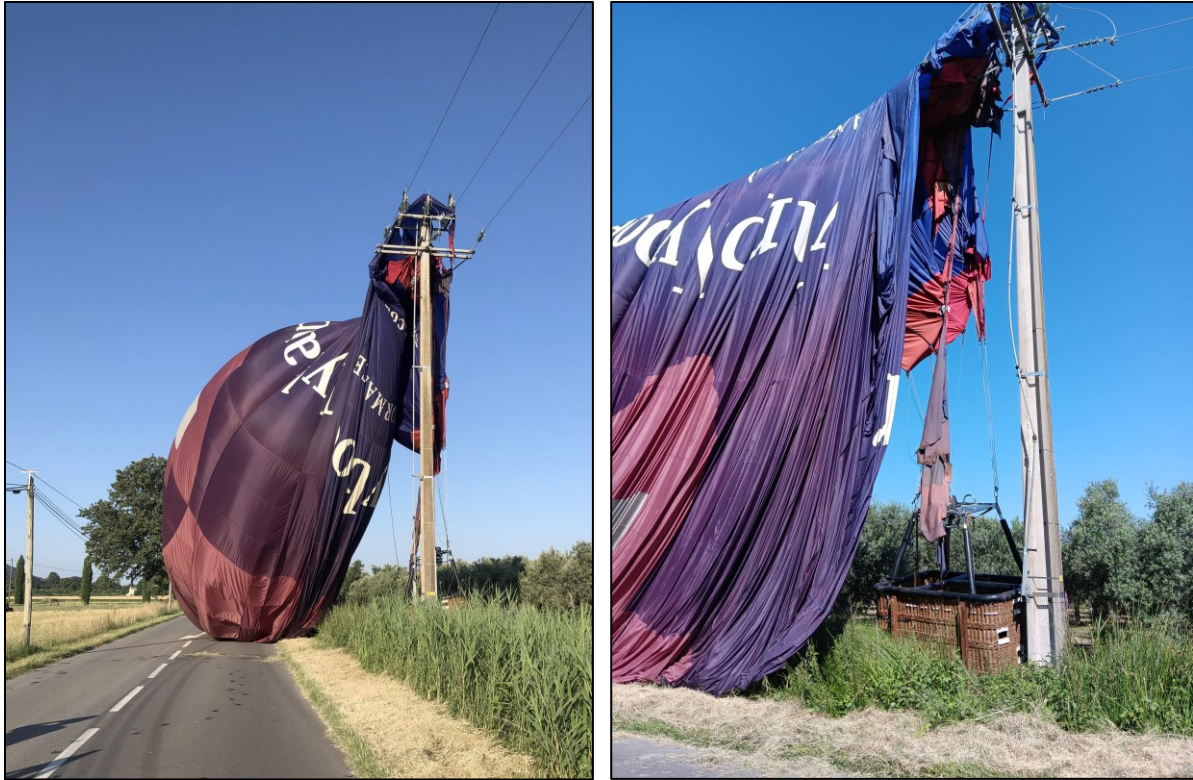
Figure 2: position of balloon after accident (Source: BGTA)

The lower part of the envelope was substantially damaged (torn and burnt) and several metal suspension cables connecting the envelope to the load frame had ruptured (see **Figure 2**).

The visual examination of the basket found burn marks at the end of the ruptured envelope suspension cables, very probably the result of the electric arc. In the pilot compartment, black marks which could correspond to projections of incandescent material were visible on the basket floor. No examination of the envelope was carried out.
