Accident to the Guimbal — CABRI — G2
registered **F-HOLA**
on 12 May 2022
at Aix-les-Milles (Bouches-du-Rhône)

Loss of yaw control while hover taxiing, hard contact with the ground, in solo instruction

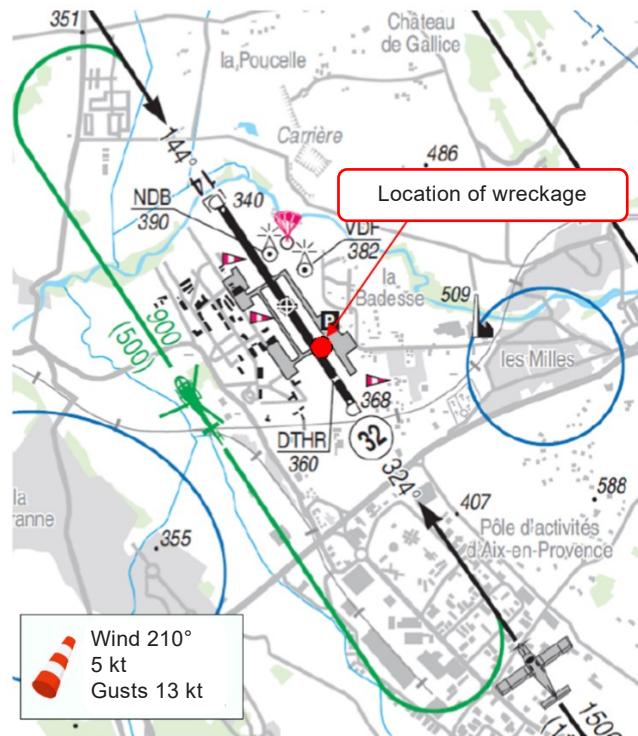
After a near hover at a height of between three and four metres, the student pilot started hover taxiing over the runway, at a height of between two and five metres. As he was about to turn left to clear the runway at taxiway A, he lost control of the helicopter, which made two or three complete rotations about its yaw axis to the left. The student pilot then lowered the collective pitch control. The helicopter made contact with the ground and bounced before falling back hard and flat onto the runway. On impact, the skids sagged on either side of the fuselage and the helicopter came to a stop on its belly on the runway at taxiway A (see **Figure 1**)

Figure 1: accident site (Source: AIS)

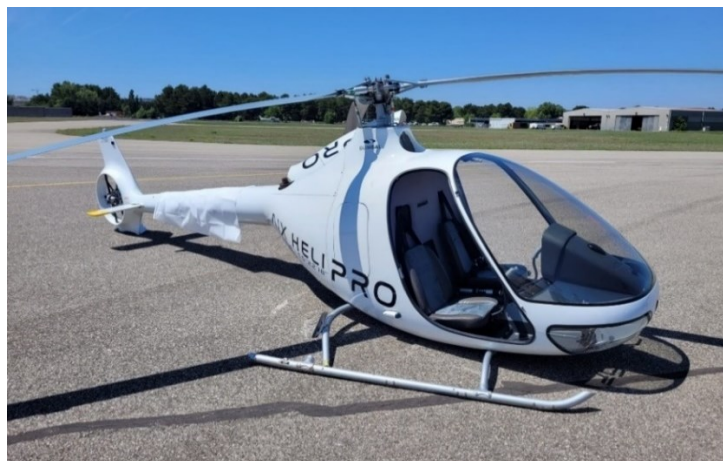
The helicopter came to a stop at the junction of the runway and taxiway A. The landing gear rear arch (crosswise) separated from the skids (lengthwise), and the helicopter was lying on the lower section of the fuselage, damaged as a result of the compression of the landing gear. The tail skid and the lower part of the Fenestron were folded 90° to the left. Several blades of the Fenestron were damaged and friction marks from the tail rotor (T/R) blades were visible inside the Fenestron skin structure, at the bottom. Examination of the helicopter showed that all of the damage resulted from the accident (see **Figure 2**).

Figure 2: photograph of the aircraft after the accident² (Source: BEA)

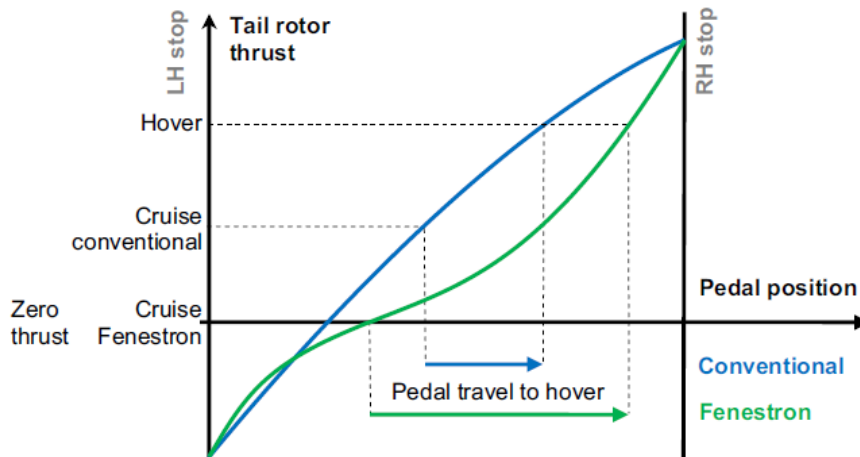
The document issued by Guimbal indicates that compared to conventional tail rotors equipping most small helicopters, the Cabri G2 Fenestron features a higher disk loading and a shroud giving it a high thrust capability, but with a different Pedal position / Tail rotor thrust curve to that of a conventional tail rotor (see **Figure 4**). Moreover, the tail rotor thrust is null when the left pedal is about 3 cm forward (6 cm between the two pedals).

Figure 4: comparison of thrust curves for identical performance
Conventional vs Fenestron tail rotors (Source: Guimbal)
