**Accident** to the Robin DR400-160  
registered **F-HOLE**  
on Wednesday 9 July 2025 at Bessan

## Reduction in engine power, forced landing

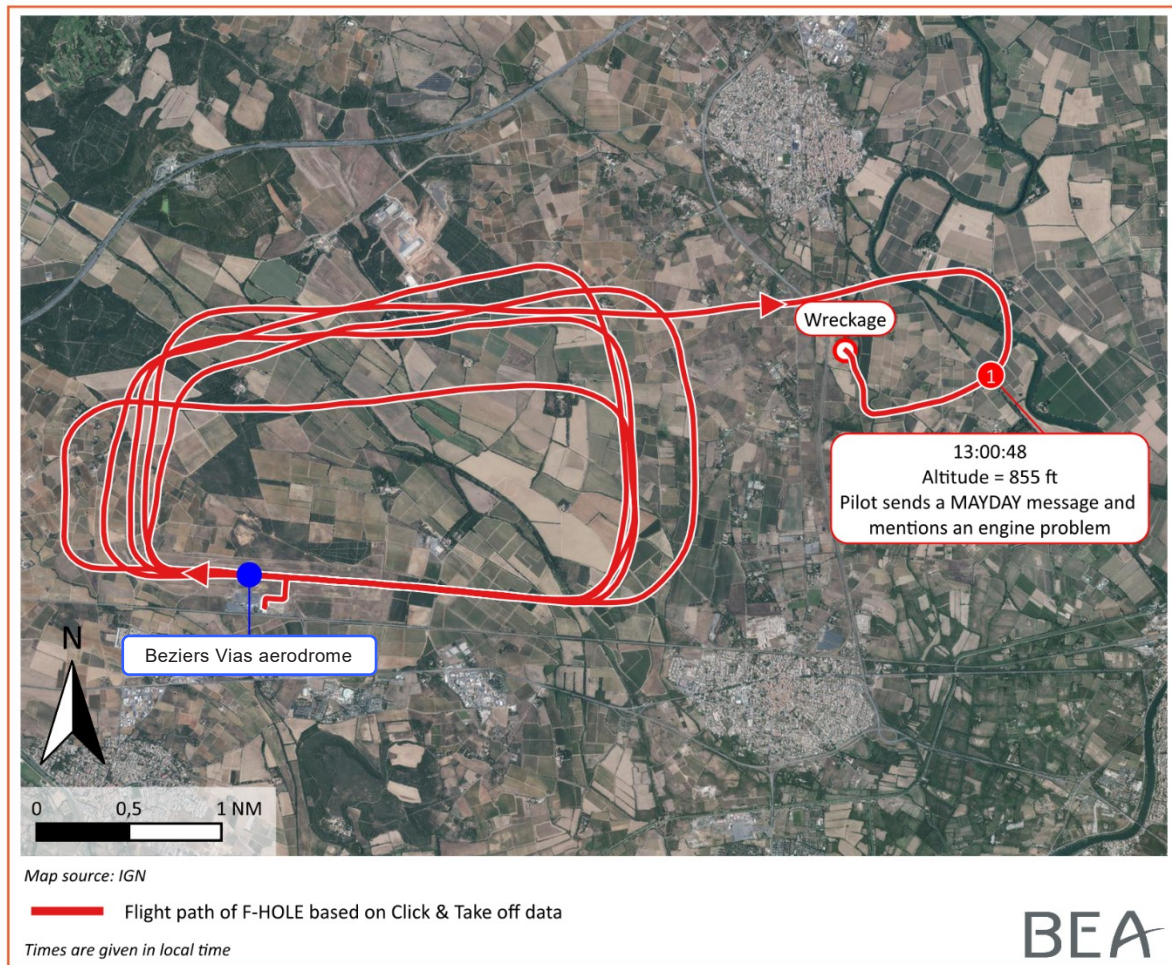
On final, aware that he would not be able to reach the runway, he identified a field to the north of his position and tried to carry out a forced landing. He flew along the side of it before crashing into a vineyard field situated a few metres to the right-hand side of the chosen field.

Figure 1: flight path of F- HOLE of occurrence

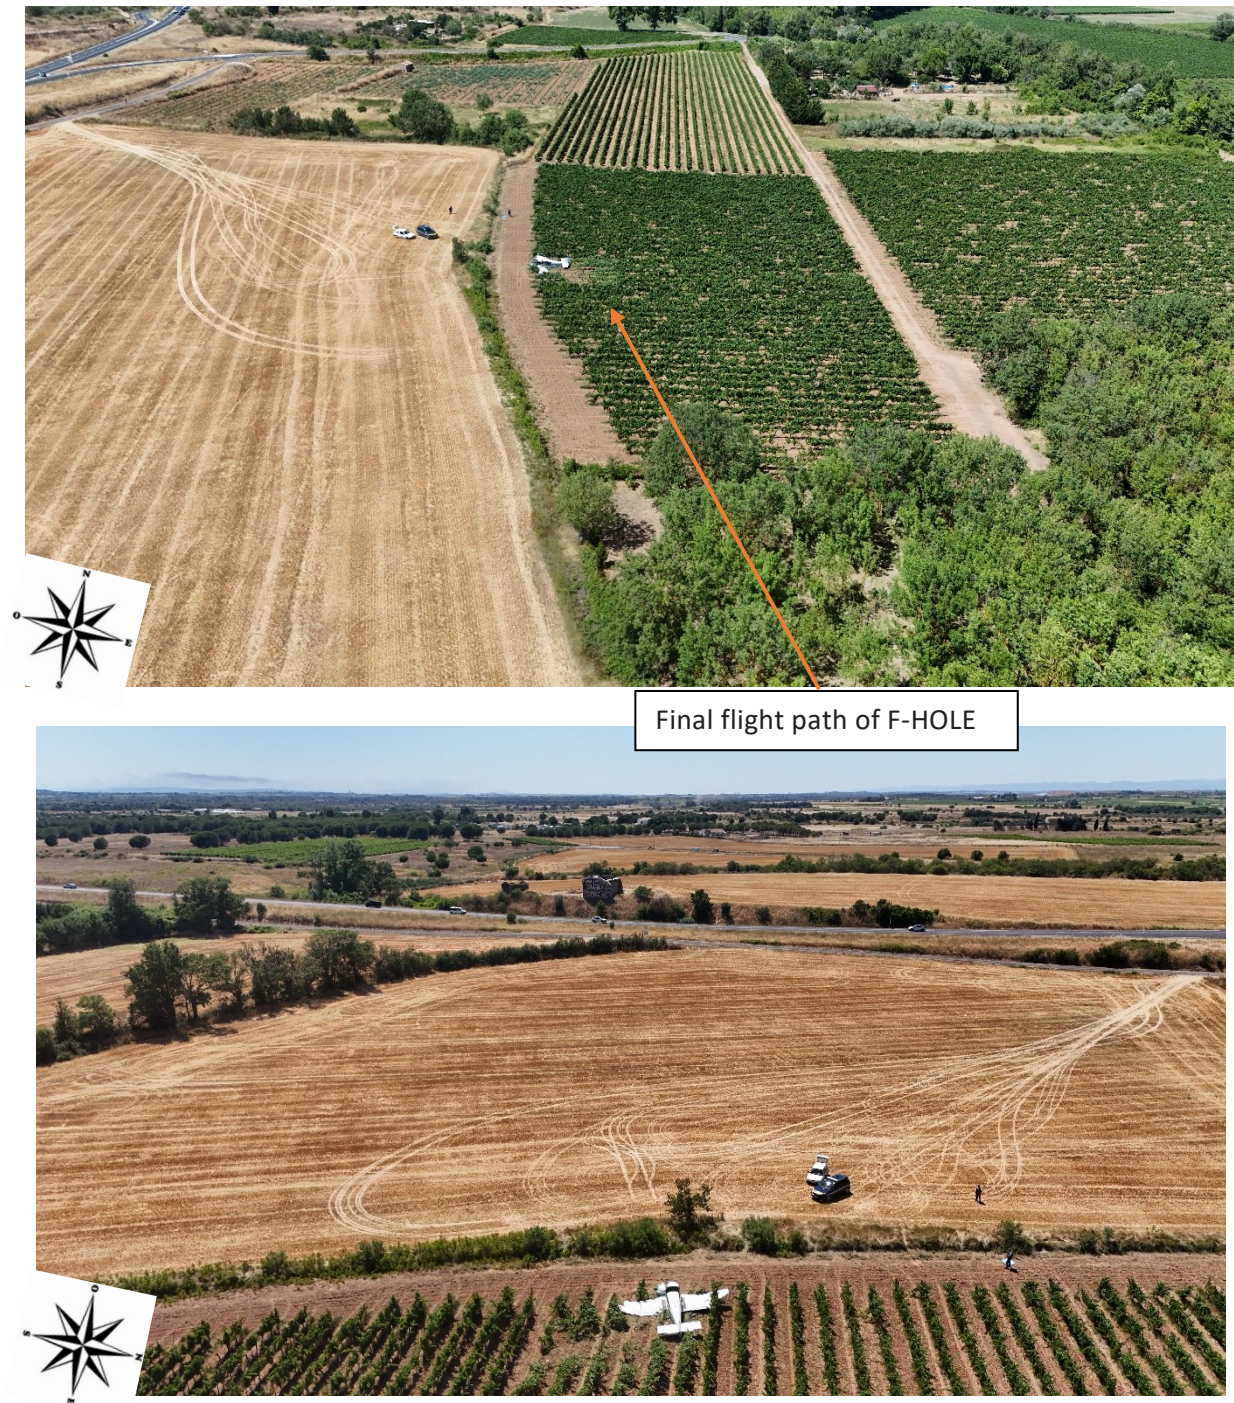
Figure 2: site and wreckage of F- HOLE (source: BEA)

The fuselage had ruptured in line with the firewall.

The deformations found on the two propeller blades bore witness to the absence of engine torque when the aeroplane collided with the ground.

The left-hand wing had ruptured in line with the landing gear. The right-hand wing was in position, but its leading edge was largely destroyed. The right-hand landing gear was folded towards the rear. At the front, the floor was destroyed and deformed.

The flaps were extended to flaps 1 (take-off position).

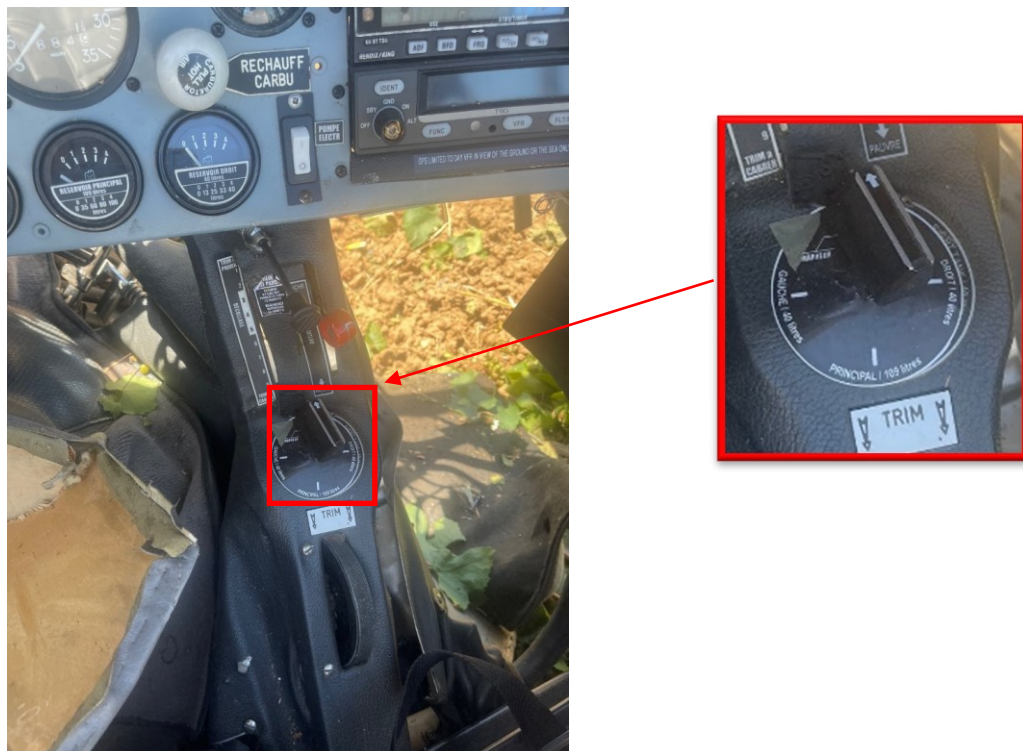
| Fuel selector | CLOSED position<br><i>The system associated with the selector was deformed making it impossible to change the selector’s position after the collision with the ground (see paragraph 2.4.2).</i> |

Figure 3: fuel selector in CLOSED position (source: BEA)

The selector was still mechanically connected to the control in the cabin, by means of a metal rod. The latter was deformed. Due to this deformation, the control was no longer functional. It was not possible to move it when on site or during the examinations due to this deformation which was very probably the result of the collision with the ground.

Note: This last action is incompatible with the deformation preventing the fuel selector from being moved after the impact. It is therefore very probable that the fuel selector was already in the CLOSED position before the collision with the ground.

The reduction in engine power was very probably the result of the pilot making an erroneous action on the fuel selector. Wanting to change the fuel tank selection at the end of the downwind leg, he may, in error, have positioned the selector close to the CLOSED position. As the reduction in power was not instantaneous, the pilot only perceived it when he rejected the descent and asked for more power.

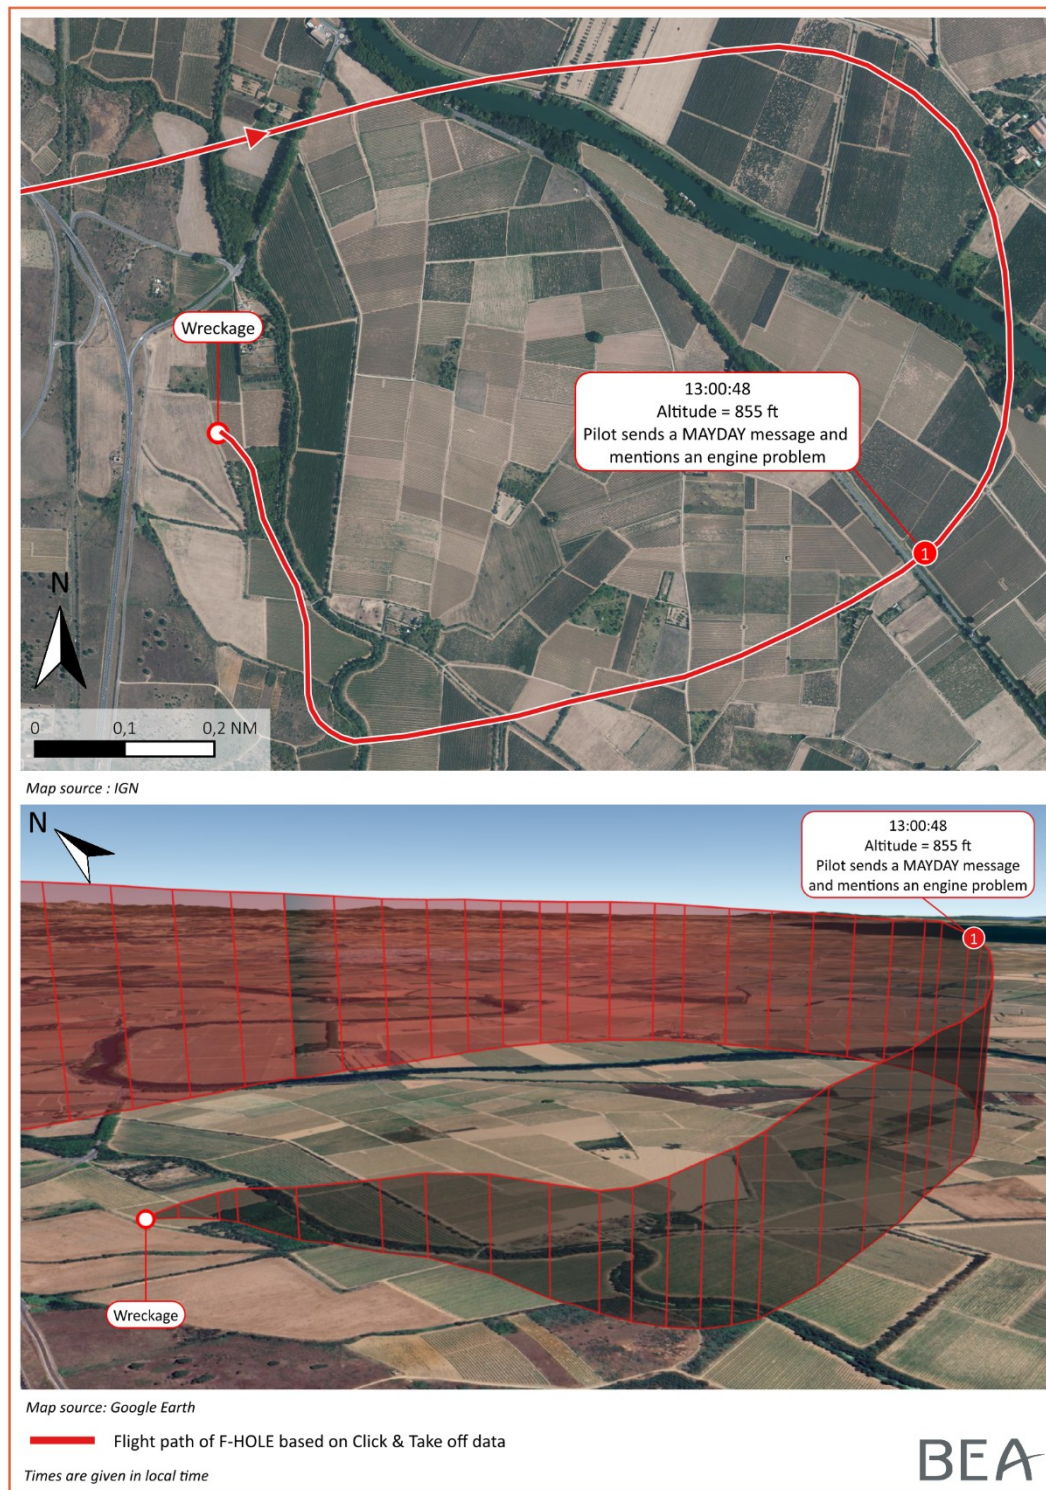
Figure 4: final flight path of F-HOLE

He then concentrated on the management of his flight path but did not manage to reach the field selected for a forced landing. While flying over a group of trees and then a vineyard field in a northerly direction, parallel and in the immediate vicinity of the field of stubble that he was aiming for, the pilot struck vegetation and lost control of the aeroplane which crashed into the vines.
