Accident to the CESSNA - FA150K
registered **F-HPRE**
on 30 January 2023
at La Drenne (Oise)

**Collision with a power line en route,
main landing gear torn off**

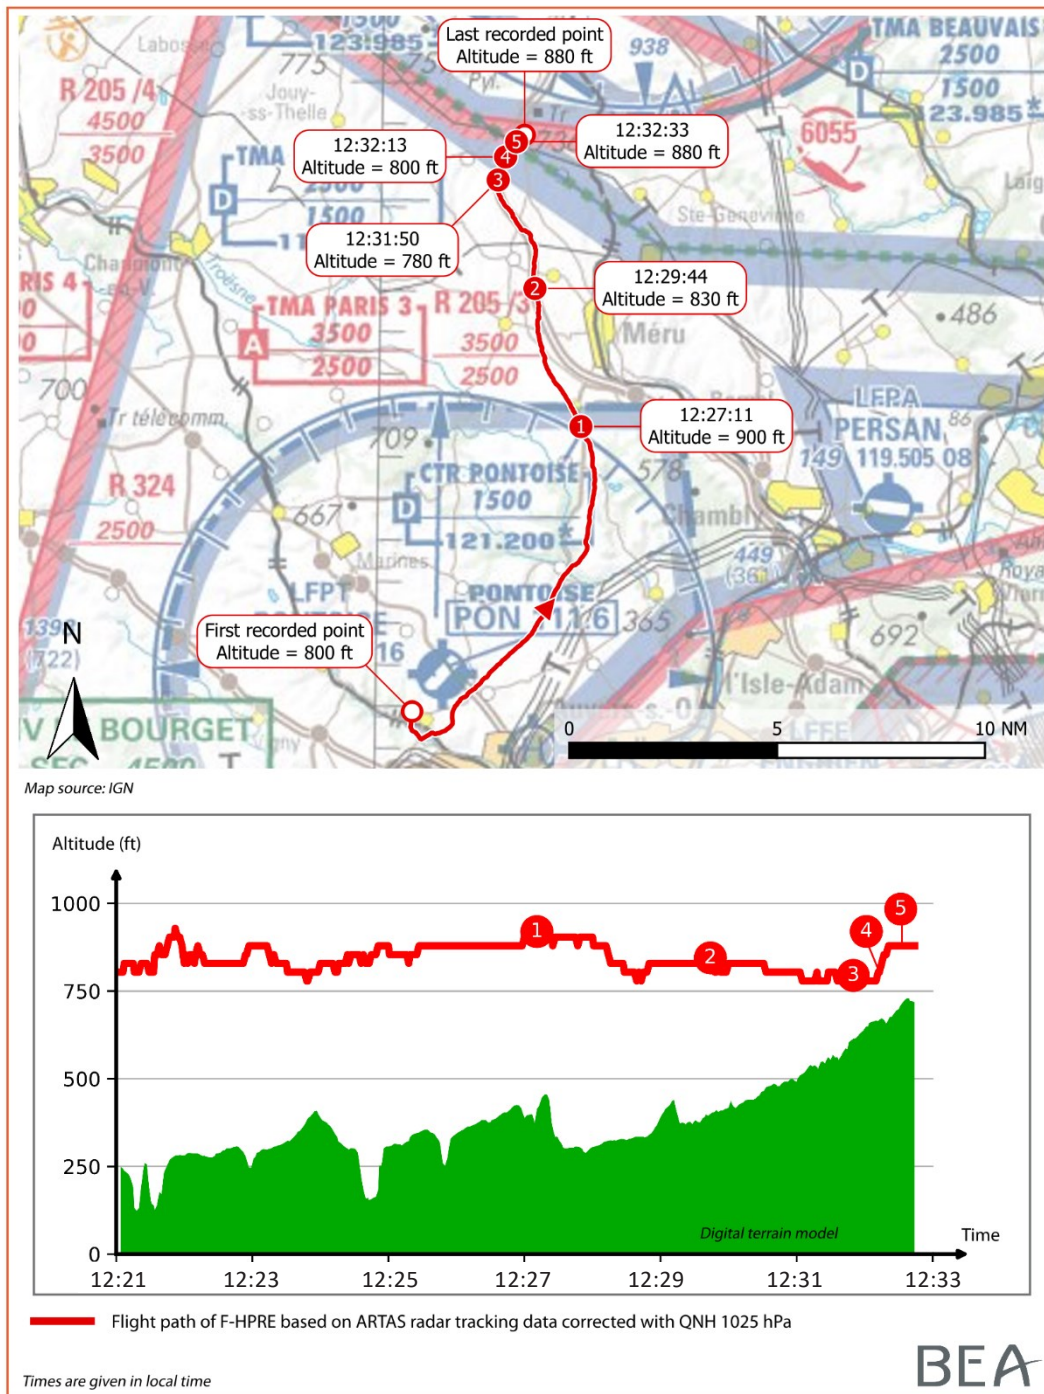
Figure 1: path of F-HPRE³ (source: BEA)

At 12:27:11 (see **Figure 1**, point **1**), the pilot exited Pontoise airspace and was flying at an altitude of around 900 ft, below the cloud ceiling. Two minutes later, at 12:29:44 (point **2**), the pilot contacted the Beauvais tower controller and specified that they were flying at an altitude of 800 ft (the aeroplane's height was then around 400 ft). At 12:31:50 (point **3**), the controller indicated to the pilot that he was transiting in special VFR and provided him with the weather conditions measured at Beauvais airport: visibility greater than 10 km, broken clouds at 1,000 ft AGL (i.e. an altitude of around 1,400 ft) and at 2,700 ft AGL.

At 12:32:13 (point **4**), the instructor indicated to the controller that the conditions were not good and that they were therefore climbing as a safety measure. He added that they were in IMC. At this point, the aeroplane was at an altitude of around 775 ft (height of around 100 ft). The controller then asked him to try to maintain VMC conditions to continue. He then announced to the pilot that he no longer had radar contact with the aeroplane and asked him to turn around to recover VMC conditions.

Between these last two radio messages, at 12:32:33 (point 5), the aeroplane collided with a power line, its highest point being at an altitude of approximately 850 ft, the height of the aeroplane being around 150 ft. The transponder stopped transmitting about ten seconds after the collision.

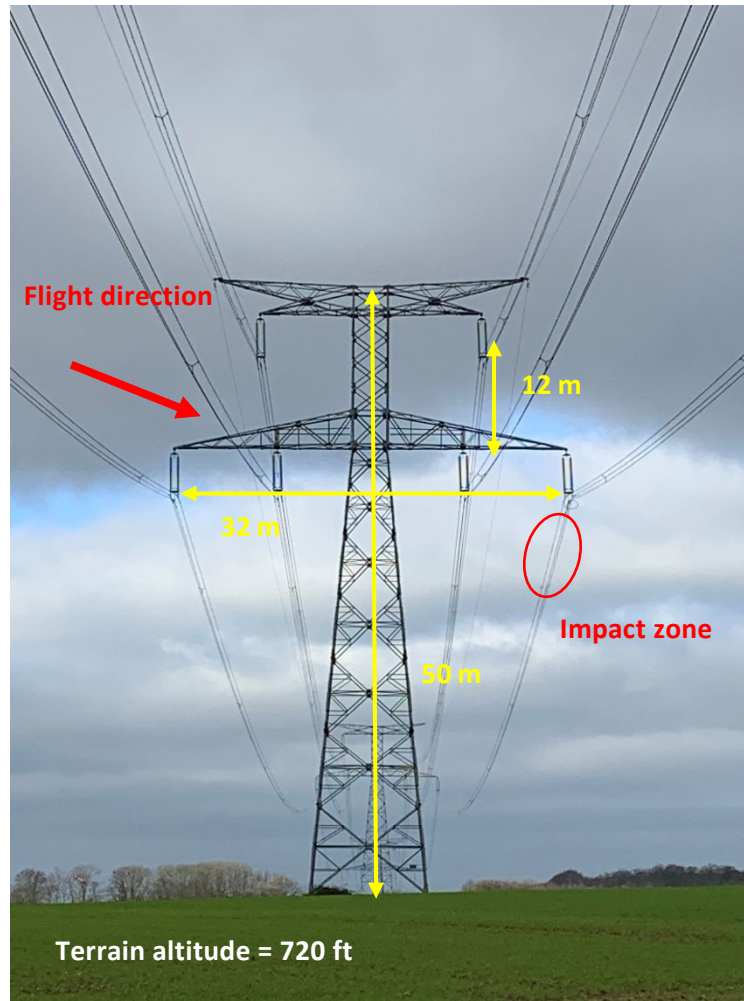
Figure 2: annotated photograph of the power line (source: BEA)
 Photograph taken the day after the accident

The power line is made up of two power links (on either side of the pylon), each made up of three bundles (three-phase current), each comprising three cables. These cables are twisted strands of unshathed steel, 3 cm in diameter. The electrical potential difference between each phase is 400 kV. Above each link is an overhead ground cable, connected to earth, which acts as lightning protection.

The height of the bundle struck was approximately 125 ft, i.e. an altitude of around 850 ft. It was slightly frayed. The impact zone is located around 15 m from the pylon. At this point, the pylons are spaced around 550 m apart.

The two struts of the main landing gear were found approximately 15 m after the power line.
