Accident to the GUIMBAL - CABRI - G2
registered **F-HPTI**
on 3 April 2021
at Saint-Georges-de-Reneins

Time	Around 13:45 ¹
Operator	Savoie hélicoptères
Type of flight	Instruction
Persons on board	Instructor and student-pilot
Consequences and damage	Helicopter substantially damaged
This is a courtesy translation by the BEA of the Final Report on the Safety Investigation. As accurate as the translation may be, the original text in French is the work of reference.

**Engine failure during forward movement at take-off,
emergency running landing, overturn, in instruction**

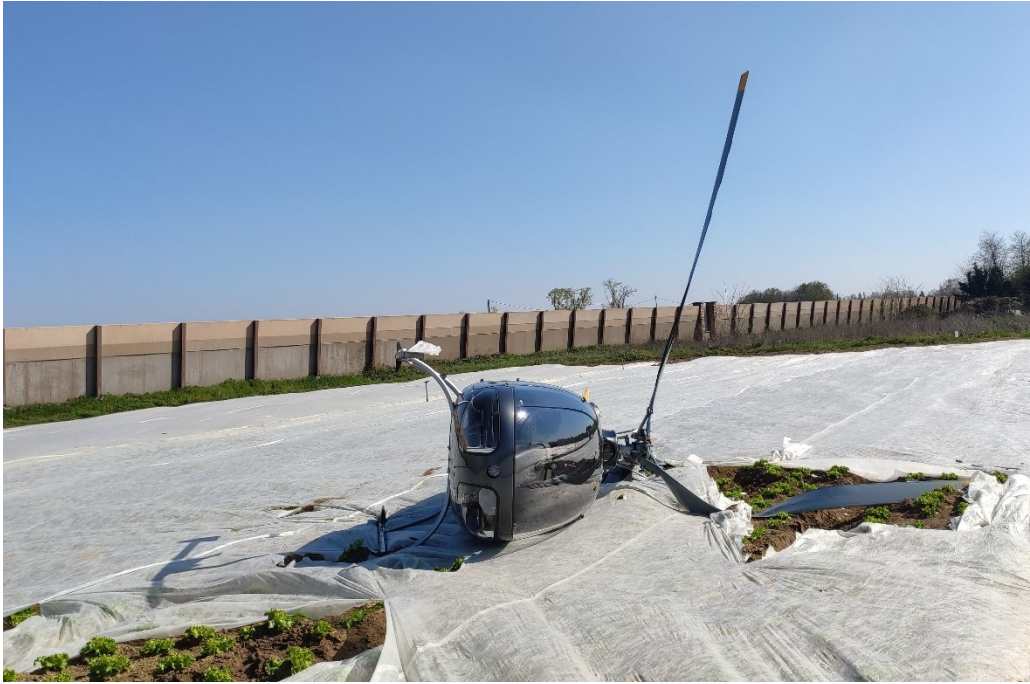
The student-pilot, accompanied by an instructor, took off from a dirt track for a flight bound for the helicopter landing site of the flying club located at Marnaz (Haute-Savoie). After entering hover, he positioned the helicopter into the northerly wind, then flew forward into climb. During climb, around 15 m from the ground, a clacking noise was heard and the helicopter jolted abruptly and yawed. The instructor reacted by slightly lowering the collective pitch lever to relieve the stress on the engine. He told the student that he was taking the controls and that he planned to return to land on the dirt track. He then carried out a left U-turn and continued flying southward. To avoid having a descent rate that was too high, he planned to fly beyond the dirt track, then to make another U-turn (that was not made) before landing at the point from which they had departed facing into the wind. Near the dirt track, heading south at a height of around five metres and at a speed of just below 30 kt, the engine power decreased and a continuous aural signal sounded in the cabin. The instructor continued the descent and now decided to land in the field opposite. The front part of the skids made contact with a tarpaulin covering the field and sank into the loose soil. The helicopter tipped forward, damaging the main rotor and breaking the tail boom. The helicopter then came to a stop and tipped over onto its left side.

Figure: accident site (Source: BEA)

One of the main rotor blades caused the tail boom to separate forward of the horizontal stabilizer at a skew angle, indicating a low rotation speed of the rotor.
