Accident to the DIAMOND - DA40 - NG
registered **F-HRPM**
on 5 March 2021
en route over the Mediterranean Sea (Haute-Corse)

Total decrease in power en route, emergency landing on water, in instruction

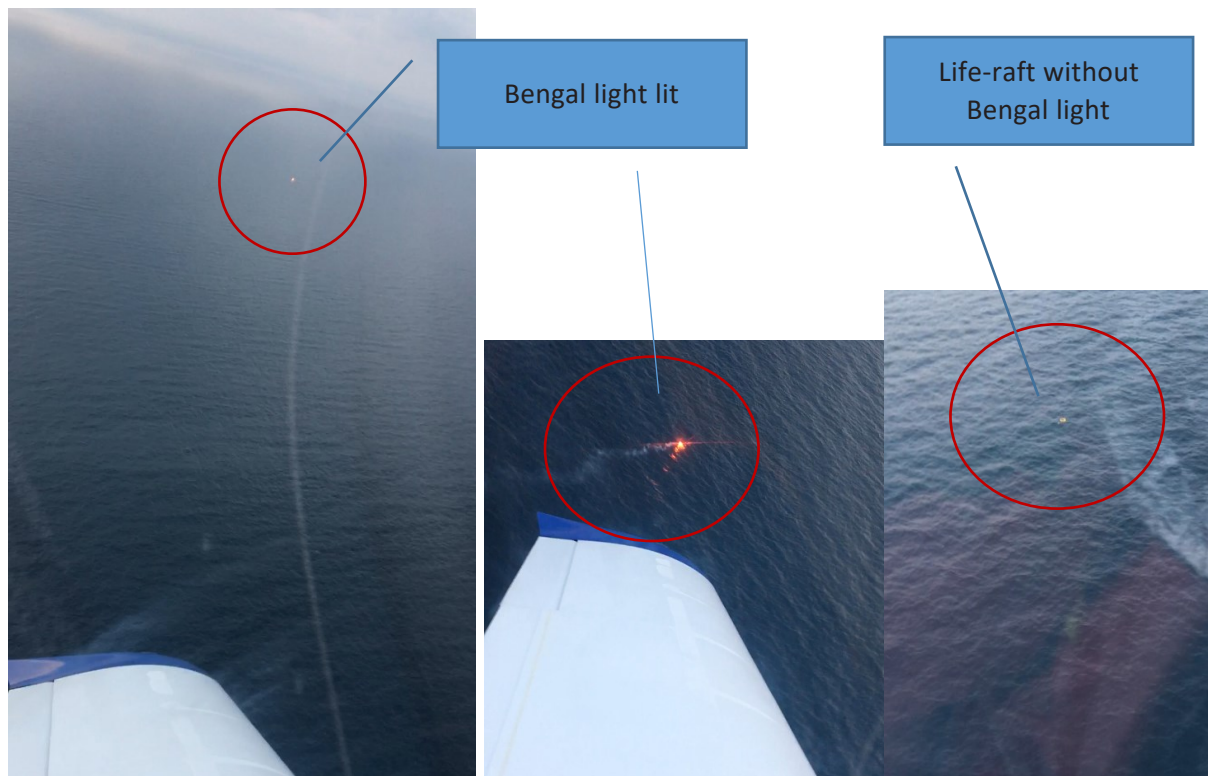
The survivors heard the noise of an engine and saw a small plane. The instructor set off the first Bengal light. At 18:17, i.e. seven minutes after ditching, the pilot of F-HNIZ saw the Bengal light and located the life-raft and its occupants. He informed the Nice controller, confirmed the presence of three people in the life-raft and gave him their GPS position. At 18:23, the pilot set course for Calvi. The survivors were unable to dry off and were getting colder and colder.

Figure 2: photos from video taken from inside cockpit of F-HNIZ
