**Accident** to the CESSNA 208  
registered **F-HSLE**  
on Sunday 15 October 2023  
at Monétier Allémont

<b>Time</b>	Around 10:50 <sup>1</sup>
<b>Operator</b>	Skydive Center
<b>Type of flight</b>	Skydiving activity
<b>Persons on board</b>	Pilot
<b>Consequences and damage</b>	Pilot fatally injured, aeroplane destroyed

**Collision with terrain during descent,  
during a skydiving flight**

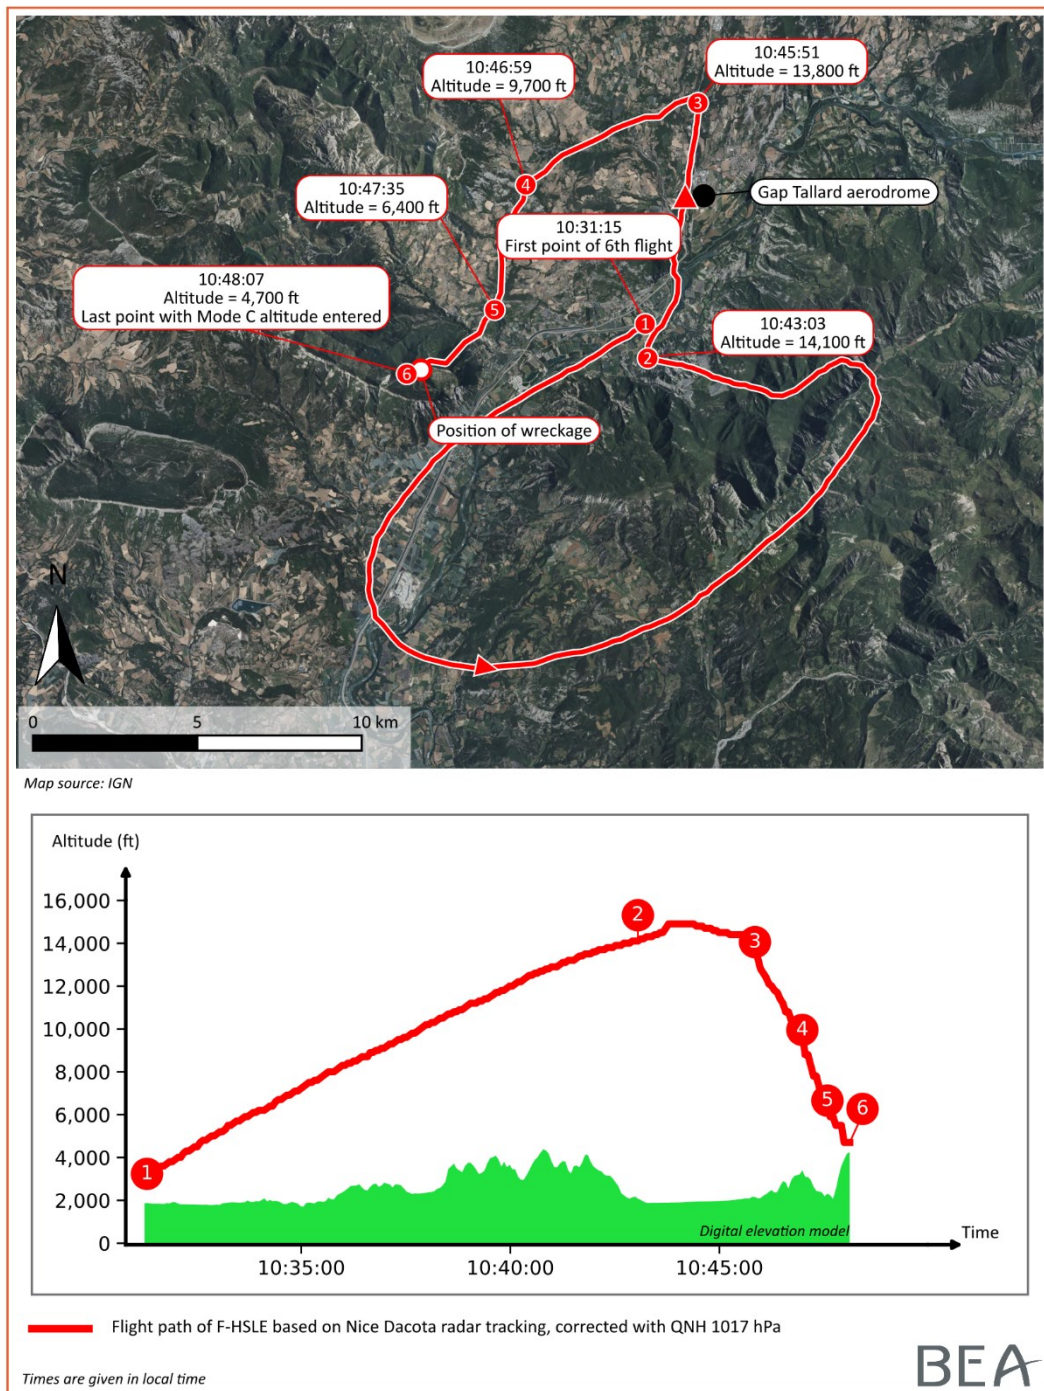
Figure 1: flight path followed during 6th flight

During the descent and return to the aerodrome of the sixth flight, neither the reported positions nor the various flight paths of the aircraft flying in the aerodrome airspace can explain the change in flight path of F-HSLE (see point 5, Figure 1).

At the end of the day's sixth skydiver drop, the pilot, in descent towards the aerodrome, took a south-easterly heading towards the terrain. The aircraft's flight path and speed, as well as the pilot's tone of voice during a final exchange with the "Starter Para" a few seconds before the collision with the terrain, point to a deliberate manoeuvre.

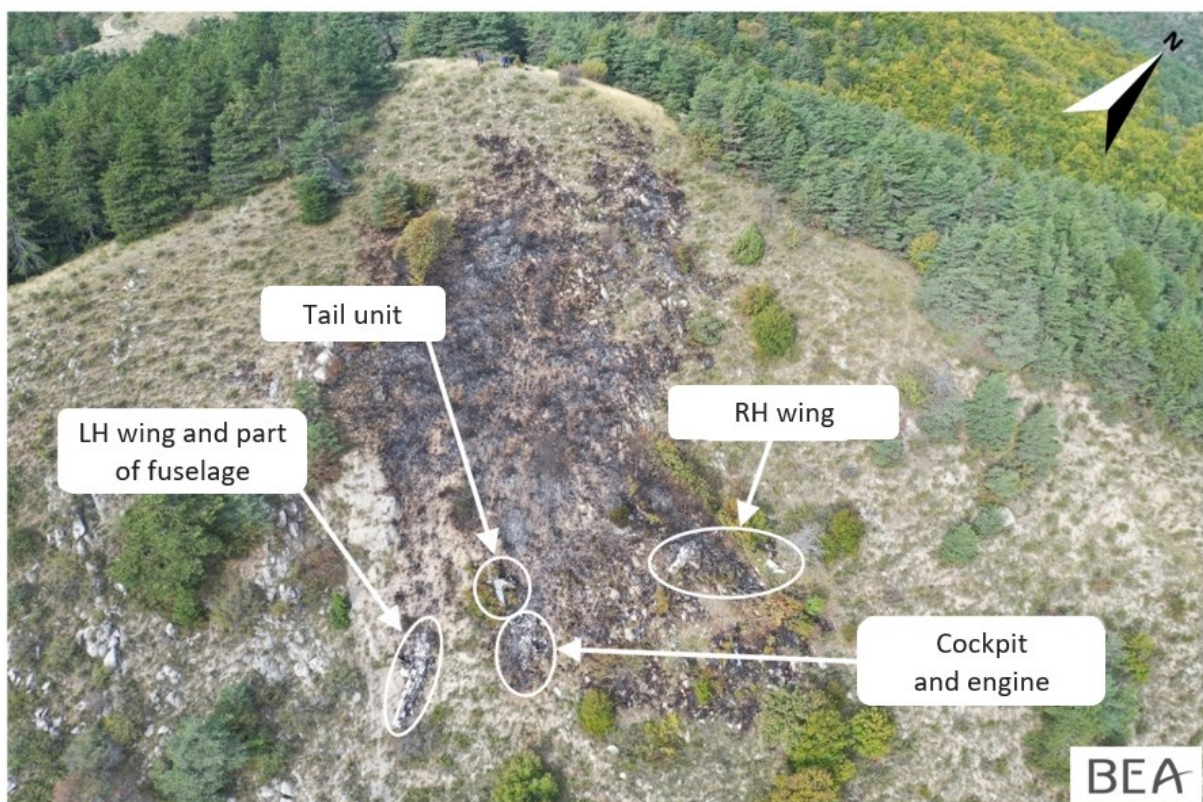
The wreckage was scattered in a mid-mountain ravine at an altitude of around 1,300 m, 10 km south-west of Gap-Tallard aerodrome (the aeroplane's operating base). The point of collision with the terrain was situated on the extended flight path. The accident site was located at the bottom of the northern slope of the mountain.

The aeroplane was dispersed and substantially damaged by a fire which broke out after the collision. The main components of the aircraft were present on the accident site which indicates that the aeroplane was complete at the time of the collision with the terrain.

Figure 2: distribution of debris (aerial view, source: Gendarmerie)

The ruptures to the various elements of the airframe and their distribution on the ground were consistent with a high-energy impact and a nose-down attitude at the time of the collision with the ground. The aeroplane then turned over before completely dispersing.
