Accident to the Airbus BK117 C-2 (EC145)
registered **F-HSOC**
on Saturday 23 November 2024
at Montanel

Time	13:00 ¹
Operator	Babcock MCS France
Type of flight	Air ambulance
Persons on board	Pilot, technical crew member and three passengers
Consequences and damage	Helicopter damaged
This is a courtesy translation by the BEA of the Final Report on the Safety Investigation. As accurate as the translation may be, the original text in French is the work of reference.

Tail rotor strike with an obstacle or an object, during a yaw rotation in hover flight before landing

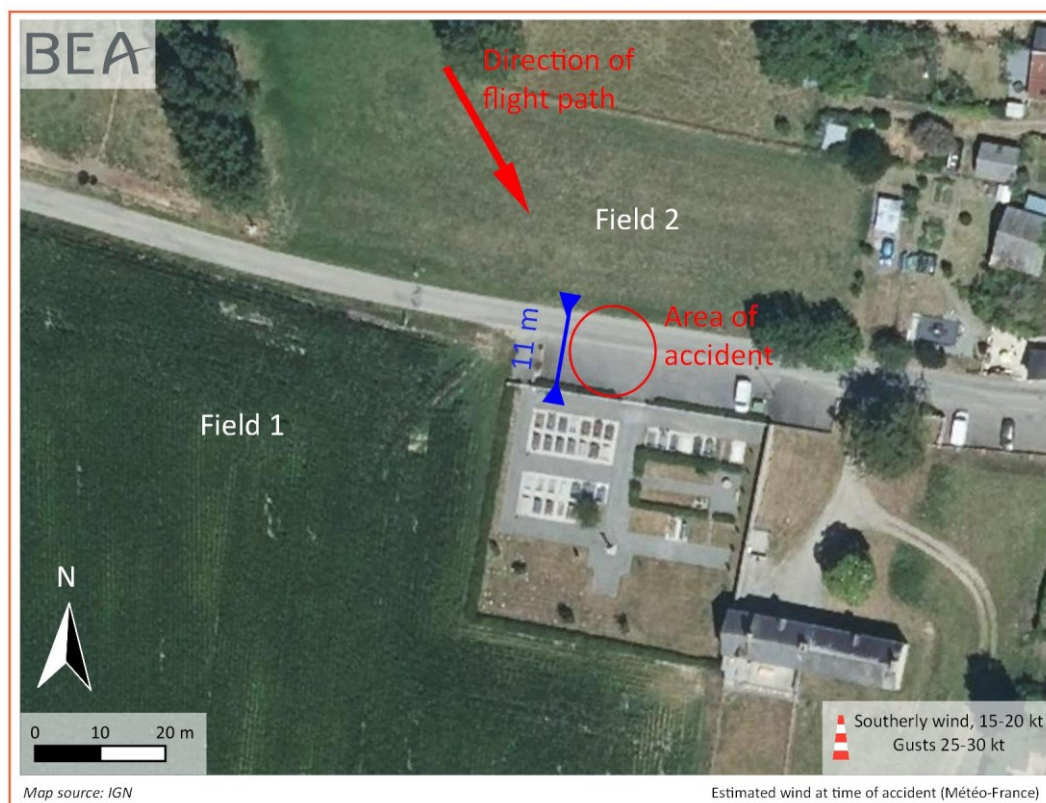
Figure 1: site layout

The paved area chosen for the landing was a road adjoining the car park of a cemetery. It has a ground width of around 11 m. The road has an east to west downward slope of roughly 5° (see **Figure 1**).

The cemetery is surrounded by a barrier made up of a 1.20 m high stone wall on top of which there is a 60 cm high plastic fence, and approx. 1.80 m high stone pillars spaced roughly 8 m from each other. The wall running along the car park is bordered by a hedge of hortensia around 1.70 m high and 1 m thick. There is a gate in the wall. The road follows a field where there is a bank of a height of between 50 and 120 cm.

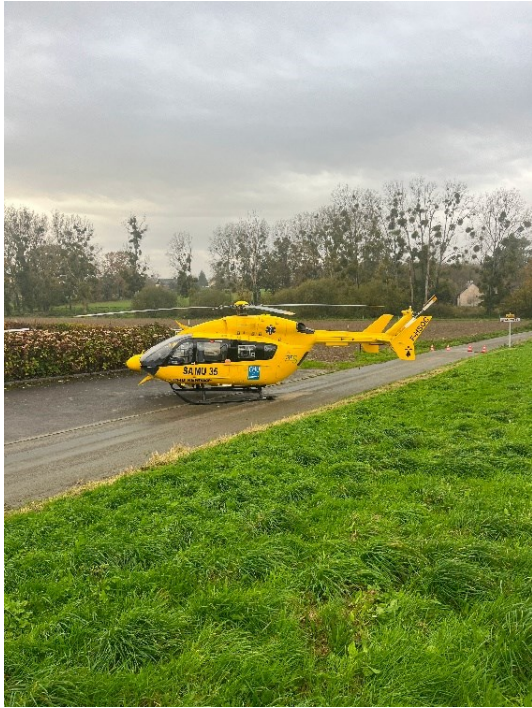
*Figure 2: final position of helicopter
(source: GTA)*

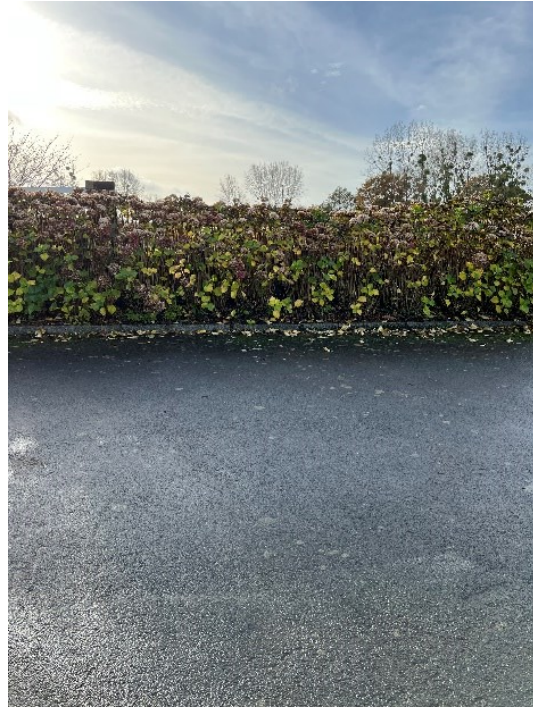
No element observed (wall, pillars, plastic fence) that could have formed a fixed obstacle showed damage that could be attributed to a strike by a tail rotor blade turning at high speed (around 2,170 rpm). Only a few hortensia stems of a diameter of less than one centimetre were broken.

*Figure 3: hortensia hedge at landing site
(source: BEA)*

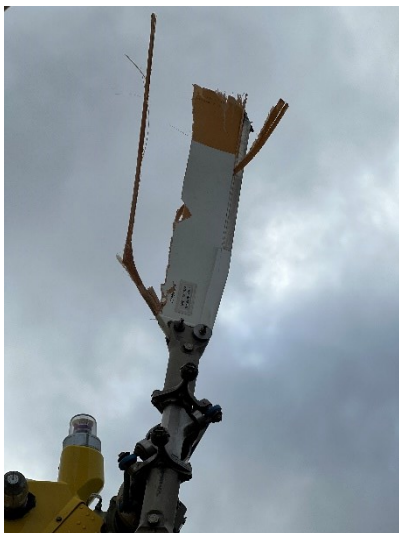
The most significant damage observed on the helicopter was situated on the tail rotor (TR) and tail rotor drive shaft. The two tail rotor blades were destroyed. Their metal leading edges were torn over approximately 5 cm and the separated parts showed substantial rub marks. The two blades were substantially delaminated. There were no vegetation marks on the blades. Debris was collected in the cemetery, on the landing area and in the fields. There were no damage or marks on the two vertical stabilizers and the tail guard.

*Figure 4: delaminated blade
(source: BEA)*

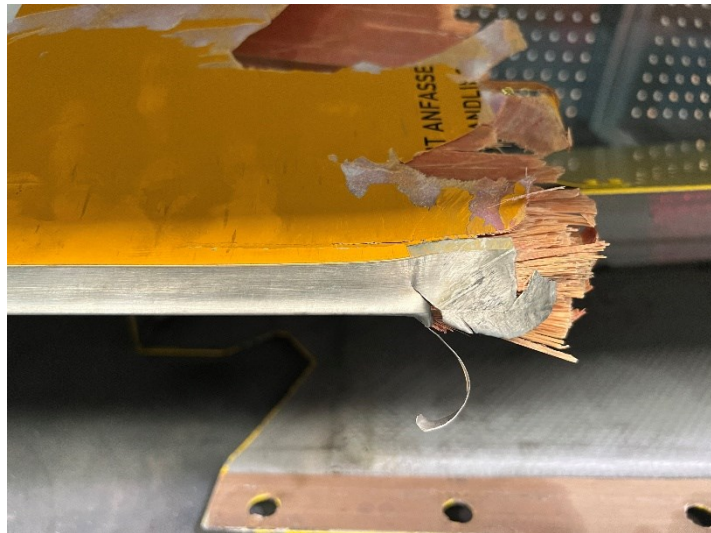
*Figure 5: damaged leading edge
(source: BEA)*

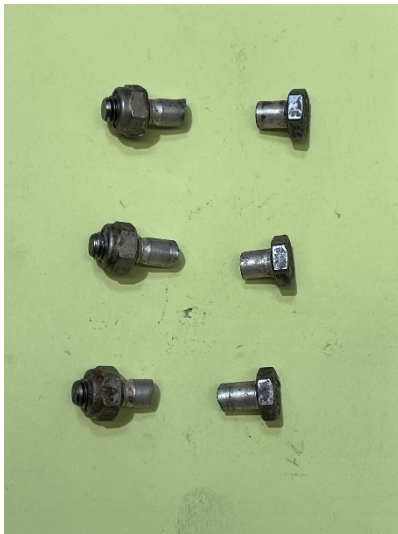
The three bolts of the flange attaching the front drive shaft to the MGB and the rivets of the rear attachment of the long drive shaft had sheared in the direction of the engine torque.

*Figure 6: ruptured bolts
(source: BEA)*

This damage was consistent with the TR blades coming into contact with an external object while the engines were providing substantial torque. The manufacturer, Airbus Helicopters Deutschland, specified that the damage observed was similar to that usually observed during accidents in which the TR has struck hard obstacles such as rock.

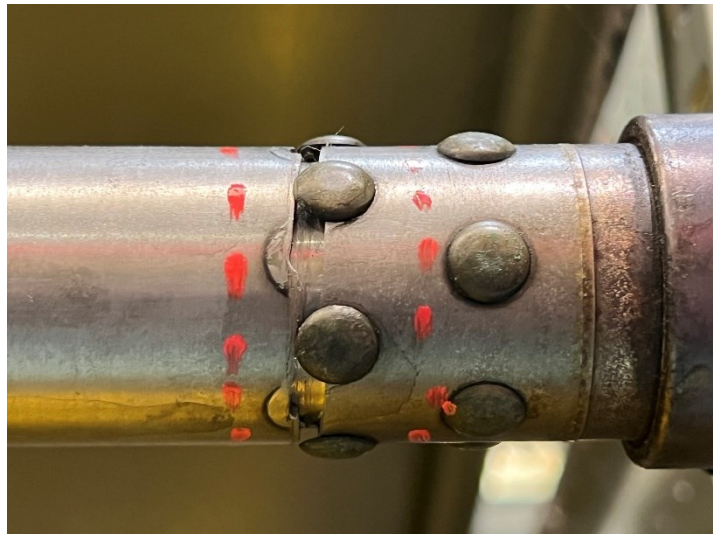
*Figure 7: ruptured rivets
(source: BEA)*
