Accident to the Robin DR400/500
registered **F-HSOO**
on 17 June 2022
at Martillac (Gironde)

Time	09:25 ¹
Operator	Aéroclub de Bordeaux
Type of flight	Cross-country
Persons on board	Pilot and two passengers
Consequences and damage	Pilot and passengers fatally injured, aeroplane destroyed
This is a courtesy translation by the BEA of the Final Report on the Safety Investigation. As accurate as the translation may be, the original text in French is the work of reference.

Loss of control after take-off, collision with trees, fire

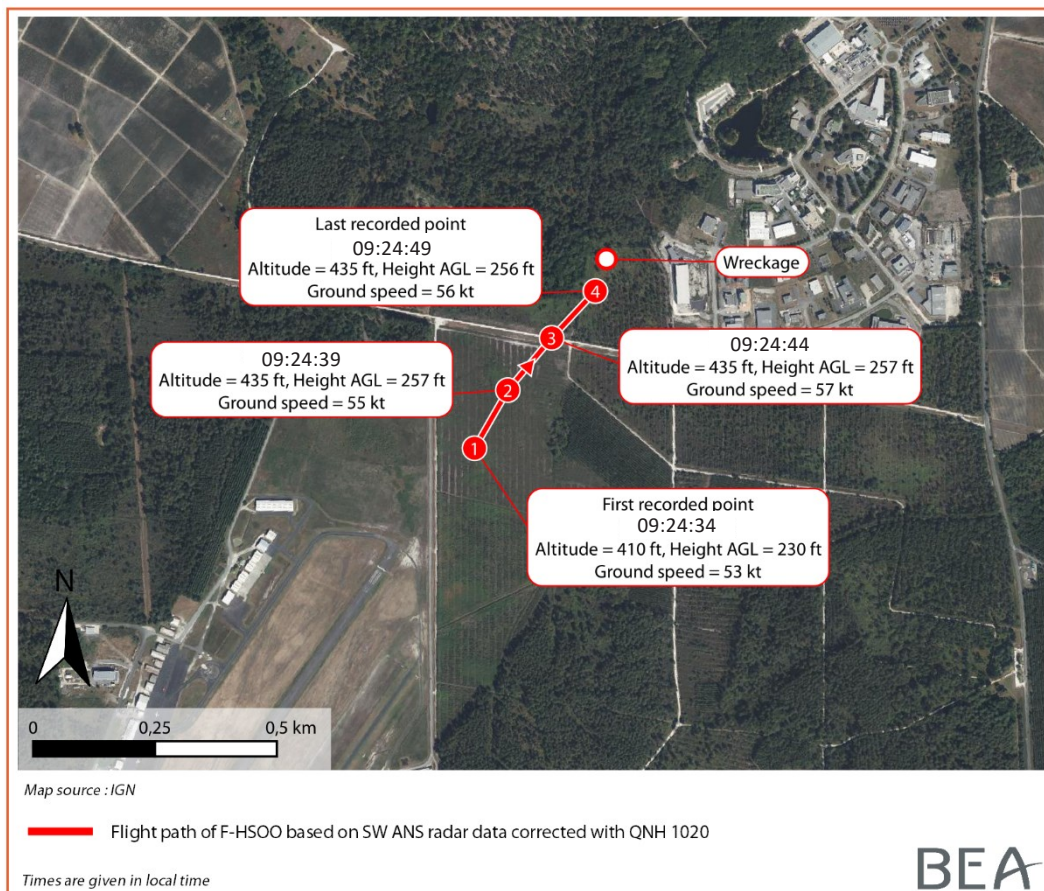
Figure 1: path of F-HSOO based on radar data

The accuracy inherent in radar data limits its analysis. It should be noted, however, that after take-off, the aeroplane's ground speed remained at around 55 kt with no noticeable increase in altitude.

In light winds, the associated airspeed values were lower than those normally observed during the take-off of a DR400/500 Président.
