**Accident** to the TECNAM P2002-JF  
registered **F-HTPS**  
on Wednesday 12 March 2025  
at Plabennec

## Collision with a fence during take-off from a field

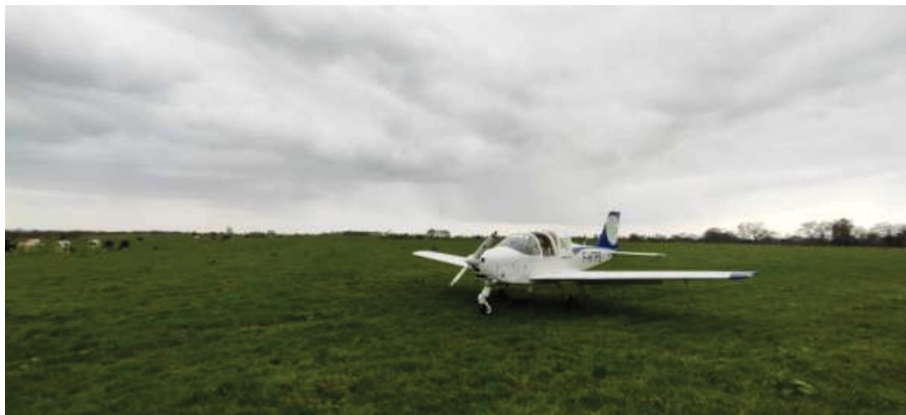
During the fourth runway circuit at a height of 500 ft, the engine misfired before shutting down. The electric pump was already operating. The passenger activated the carburettor heat. The pilot transmitted an emergency message on the frequency<sup>4</sup> and identified a field on his right-hand side to land in. He extended the flaps to the landing position and landed in a field of wet grass. By means of the brakes and a tight right-hand turn, the pilot was able to stop the aeroplane before the various obstacles around the edge of the field. No injury or damage were observed.

*Figure 1: F-HTPS at a standstill in the field (source: Iroise Aéro Formation)*
