Incident to the AIRBUS A350-900
registered **F-HTYO**
operated by Air France
on 28 May 2023
en route from Osaka airport (Japan)

SAFETY INVESTIGATIONS

Failure of weather radar in climb, turn-around, damage to radome, airspeed indicator probes affected and overweight landing

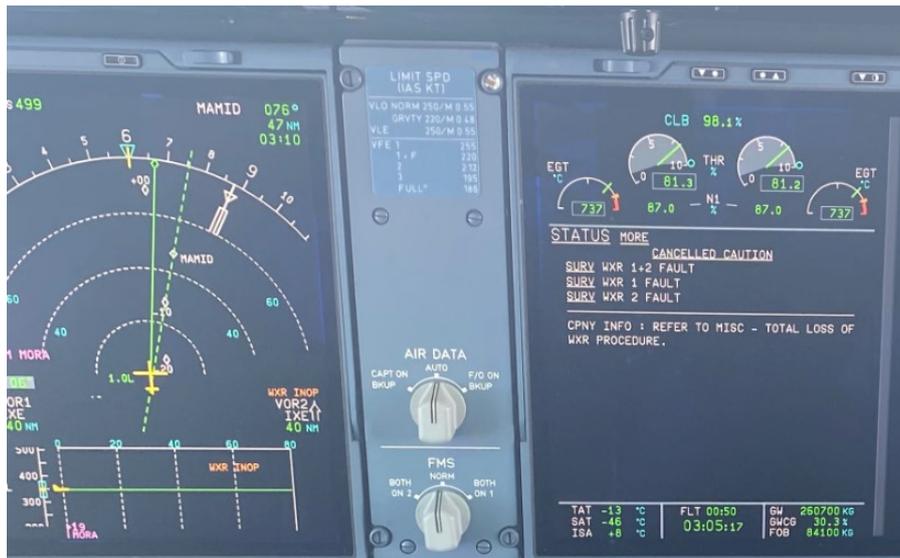
Figure 1: photo of the ECAM taken by the crew at 03:05

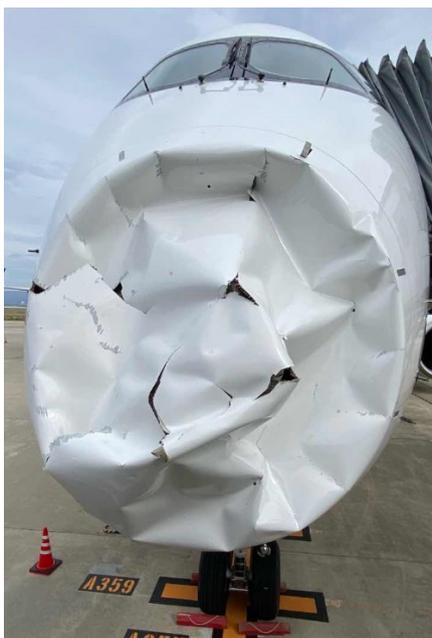
The observations made on the radome found that it was still in place, complete, and substantially damaged (see Figure 4).

Figure 4: damage to the radome (Source: Air France)

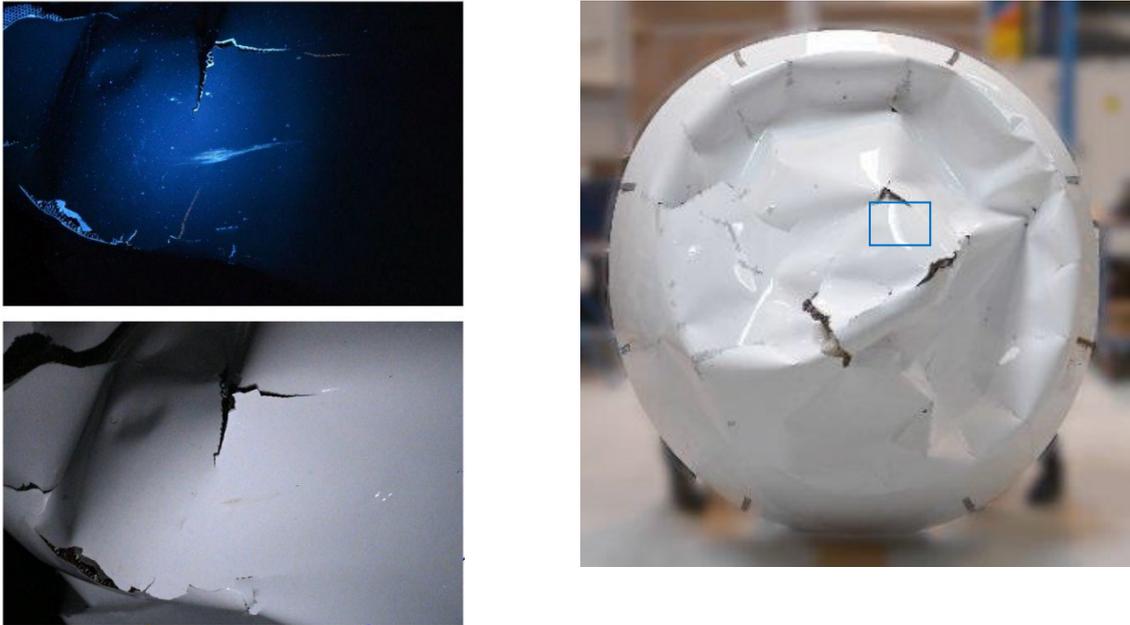
Figure 21: view of mark under UV light (top left) and in visible light (bottom left) - location on the radome (right) (Source: BEA)

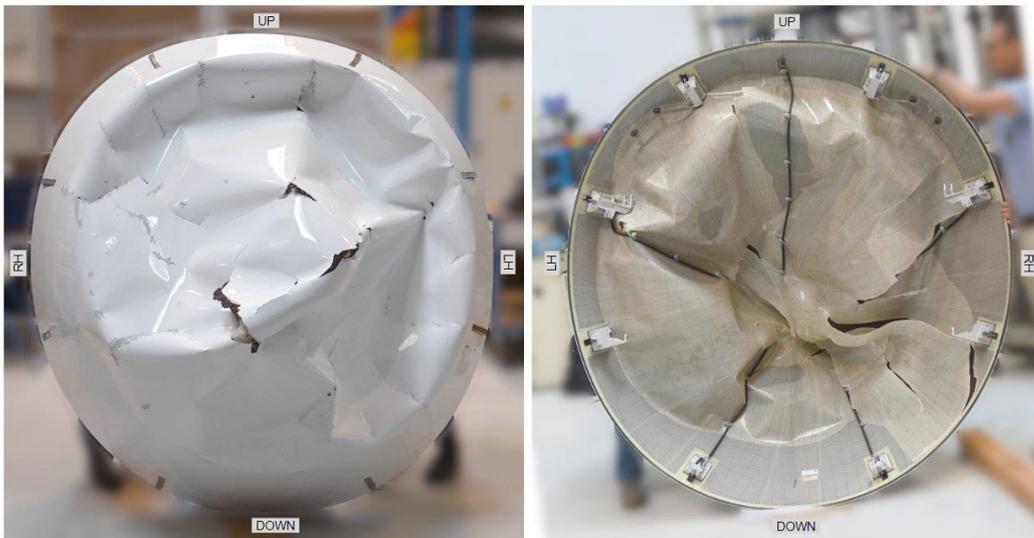
The radome was destroyed by buckling. Its outer surface presented multiple cracks of which some were open and passing through the sandwich structure. The inner skin was detached from the honeycomb over approximately 80% of its surface.

Figure 22: external view (on left) and internal view (on right) of F-HTYO radome

To conclude, it is very likely that the damage observed on the radome was caused by a falcon strike. It is very likely that this strike caused a debonding of the inner skin that spread radially and aftward on the radome until the latter completely collapsed. It was not possible to determine when, nor in which region of the world, the bird strike occurred.

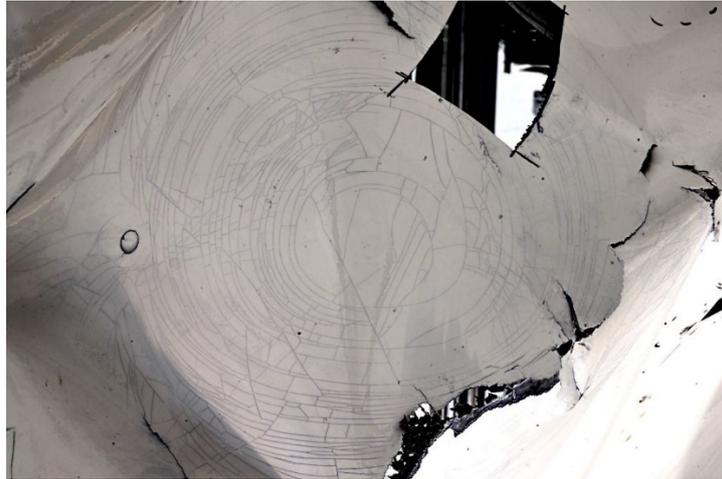
On the outer side, around the edge of the aforementioned organic residue, extended concentric cracks were observed in the paint. A developer powder was used to clearly highlight these.

Figure 23: presence of concentric cracks in the paint (Source: BEA)

On the inner side, localised damage evidenced crushing of the honeycomb and coincided with the centre of the concentric cracks in the paint. These elements were consistent with the occurrence of an external impact in this area.

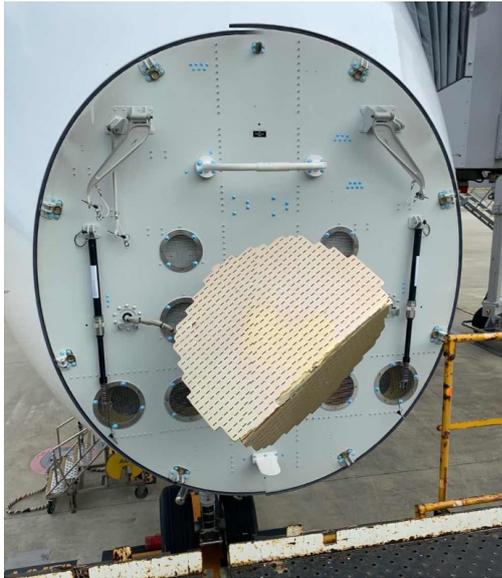
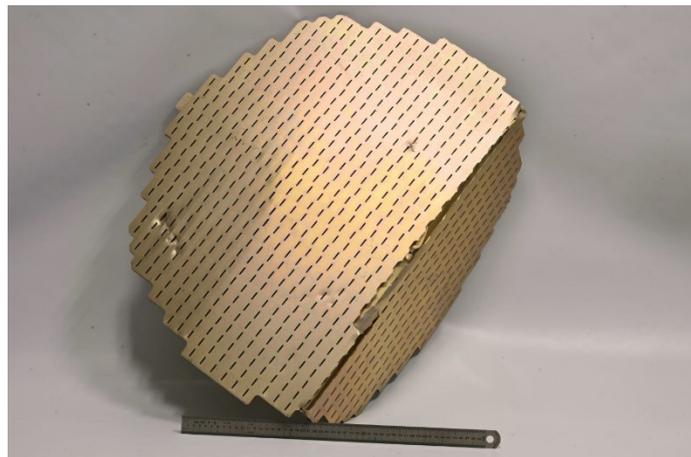
The F-HTYO weather radar antenna was examined at the Airbus failure analysis laboratory in Toulouse, under the supervision of the BEA. It was found folded on the aeroplane, along a line running from the bottom to the upper left edge (antenna viewed from behind), oriented at approximately 30° in relation to the vertical axis.

Figure 24: front face of the weather radar antenna (Source: Airbus)

The damage observed resulted from contact between the antenna and the inner side of the radome. However, it was not possible to determine with certainty whether the damage occurred before or after the radome collapsed.

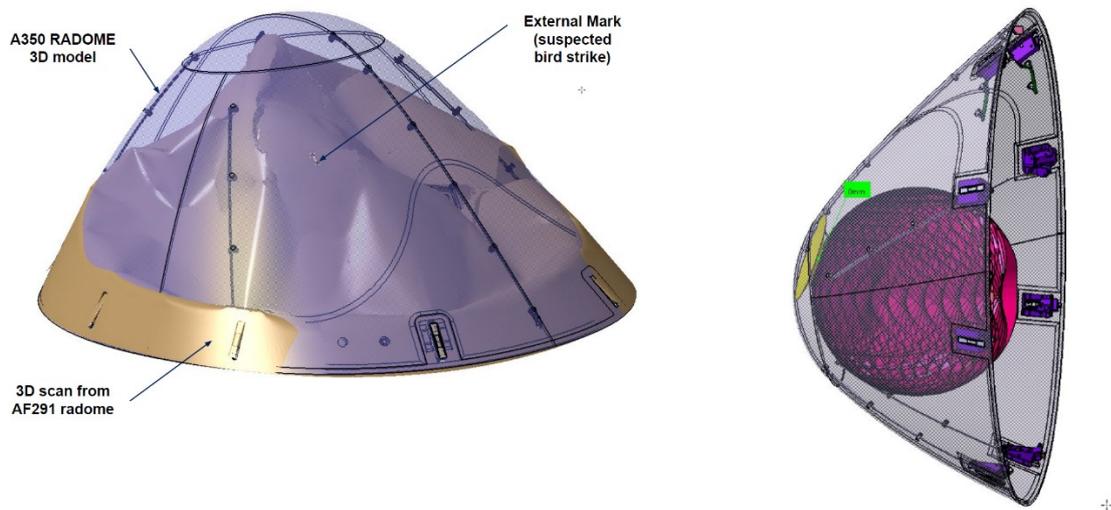
Two conditions were considered: on the ground and in flight. The corresponding aerodynamic loads were applied to the radome in these two situations. In flight, it was shown that a debonding of 380 mm in diameter was required for there to be an interaction between the inner skin and the antenna. On the ground, the required debonding was 390 mm.

In both cases, the extent of the debonding was much greater than the maximum size of acceptable damage as described in the AMM, which is 250 mm in diameter. According to Airbus, a debonding of this extent is clearly visible.

Figure 25: simulation of debonding based on observed damage (Source: Airbus)

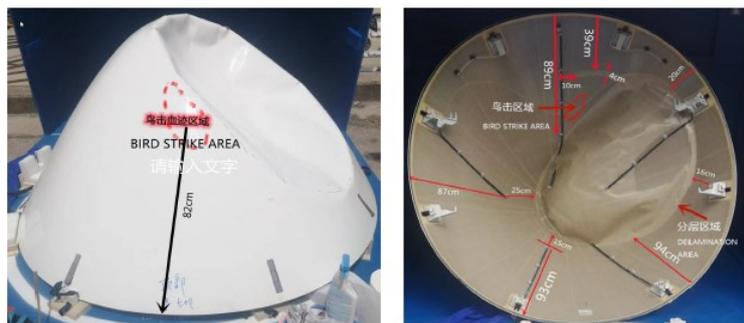
The crew of flight MU7710 (Madrid - Shanghai) reported the appearance of the **SURV WXR 1+2 FAULT** alert after reaching FL 200. As the reinitialization of AESS 1 and AESS 2 was unsuccessful, and after analysing the meteorological conditions, the crew decided to turn back to Madrid. The fault codes recorded in the CMS confirmed the existence of a mechanical blockage of the radar antenna. The radome, the drive-unit, the antenna, the RTU, the AESU and the Control Panel were sent to Airbus for inspection. The crew of the previous flight had reported a bird strike during the flare upon landing in Madrid. No damage was identified during the visual inspection by maintenance (the visual inspection of the inner face of the radome was not, however, confirmed by the operator) and the aeroplane was returned to service.

Figure 36: photographs of the B-324X radome after flight MU7710 (Source: Airbus)

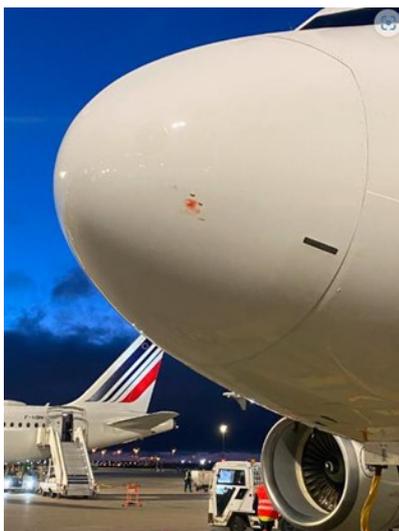
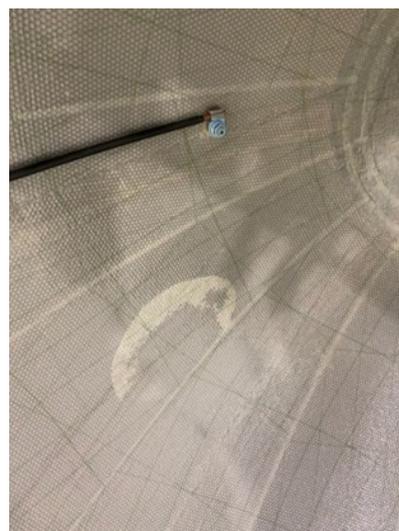
During the investigation, the BEA was informed of the occurrence of a bird strike on an Air France A318 carrying out a scheduled flight from Marseille-Paris Orly. The on-ground personnel observed a blood stain on the left of the radome in addition to traces of blood and feathers in the right engine. The ground mechanic cleaned the blood off the radome before carrying out a tap test on its outer surface. No damage was observed. As the occurrence was FOD, the flight safety coordinator advised the technicians to open the radome. When they opened the radome, a white mark was observed, exceeding the acceptable damage limits.

Figure 37: bird strike and debonding of the inner skin of an A318 radome (Source: Air France)

The radome was removed and sent for repair.
