**Serious incident** to the KUBICEK BB142  
registered **F-HVIO**  
on Tuesday 30 April 2024  
at Rosiers-sur-Loire

**Rejected landing, low flight over a small village, collision  
with a power line**

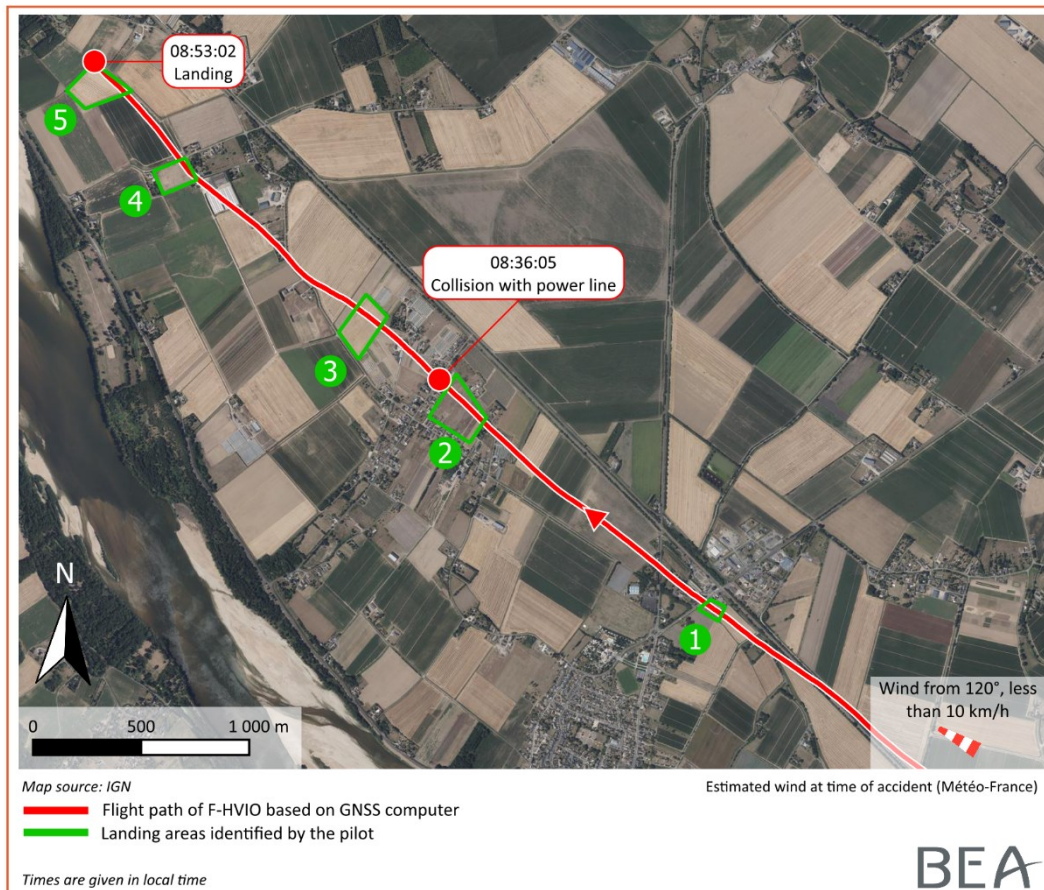
Figure 1: flight path of F-HVIO

At around 08:28, the pilot of F-HVIO identified an area for landing (see **Figure 1**, point ①), but one of the members of the ground team informed him that the area was not easily accessible for the vehicle due to the access limitations installed against travellers. The pilot decided to reject the landing.

At 08:35, 1,500 m further on, the pilot identified a new area for landing (point ②), a field with short grass four hectares in size, just before a small village. The 230 m-long field was bordered by a row of trees at the start of the field. During the approach, the pilot felt a gust. Another pilot nearby also reported gusts over the radio. To avoid a possible uncontrolled collapse of the balloon envelope<sup>4</sup> onto the houses situated behind the field, the pilot rejected this second attempted landing.

During the go-around, the pilot identified a new landing area (point ③) just behind the village but did not perceive a power line situated in the village. The basket struck this line. The pilot did not observe any damage on the basket. Having passed the identified area just after the village, he continued the flight.

A few minutes later, 1,500 m further on, the pilot identified another landing area (point ④). However, the farmer who owned the field was present and asked the pilot to land elsewhere due to recent planting. Finally, the pilot landed 700 m further on (point ⑤).

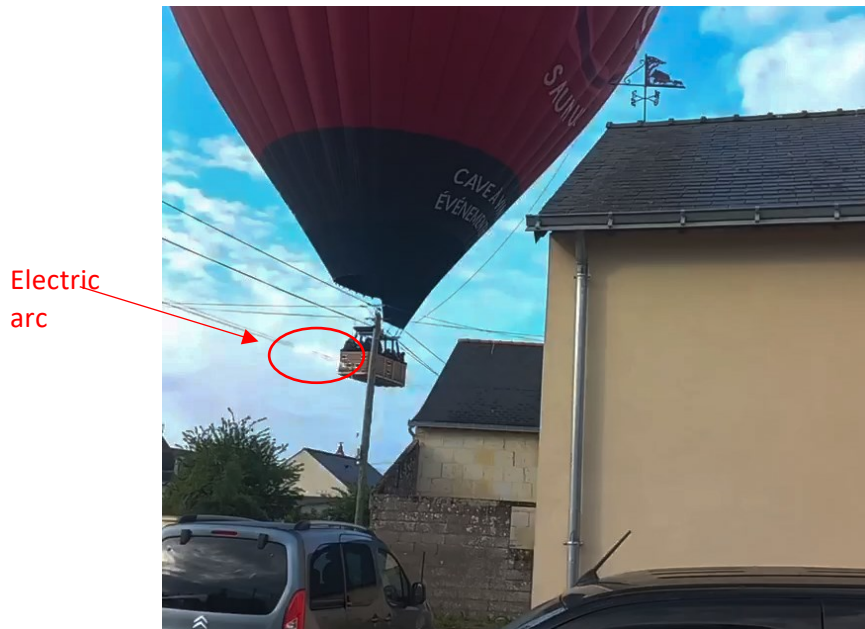
*Figure 2: excerpt from video at time of collision  
(Source: witness on ground, annotated by the BEA)*

The basket hit a medium-voltage (MV) power line<sup>5</sup> about 10 m high, running alongside the road that crosses the village and perpendicular to the balloon's flight path. The line is made up of three 7.5 mm-diameter, twisted, unsheathed steel cables. The concrete poles carrying the line are spaced about 100 m apart in the village. The collision area was situated around 15 m from one of the poles.

- activation of the network protection circuit breaker following a short-circuit on the line;
- extensive damage to the base of a concrete pole, requiring its replacement.

A video<sup>6</sup> of the collision, taken by a local resident, was provided to the BEA and analysed. The images show that the balloon's basket caught the first power line cable and brought it into contact with a second, creating an electric arc and a detonation.

Following the serious incident, the operator updated its risk assessment table as part of its SMS. It amended the sheet relating to the risk of "Late perception of a power line" and added two new sheets, "Sudden or one-off wind acceleration: gusts" and "Electric arc under the basket". Pilots and crew were also reminded of the procedures to be complied with in such situations.
