Accident to the CESSNA 208 registered F-HVPC on Thursday 1 August 2024 at Vannes

Time	Around 14:05 ¹
Operator	École de Parachutisme Sportif de Vannes Bretagne (EPSVB)
Type of flight	Parachute drop
Persons on board	Pilot and 14 skydivers
Consequences and damage	Aeroplane slightly damaged, one skydiver injured
This is a courtesy translation by the BEA of the Final Report on the Safety Investigation. As accurate as the translation may be, the original text in French is the work of reference.

Untimely deployment of a parachute at aeroplane door, in climb, during a parachute drop flight

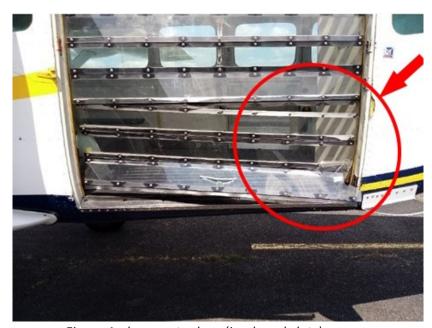
- the three lower slats of the vertical sliding door were damaged and had come out of the rear slide guiding the sliding door. The connection between the third and fourth slat was partially torn off;
- the aeroplane's skin at the rear door jamb was deformed over around 8 cm and around 50 cm above the aeroplane floor;

Figure 1: damage to door (jamb and slats) (source: skydiving school)

As the skydiver was pulled to the rear, the right-hand riser caught on and deformed the skin of the aeroplane. On snagging, the system connecting the riser to the parachute was severed while the skydiver was pulled outside the aeroplane through the door. The separation of the riser caused the deployment of the reserve canopy which came into contact with the aeroplane's left-hand horizontal stabilizer.

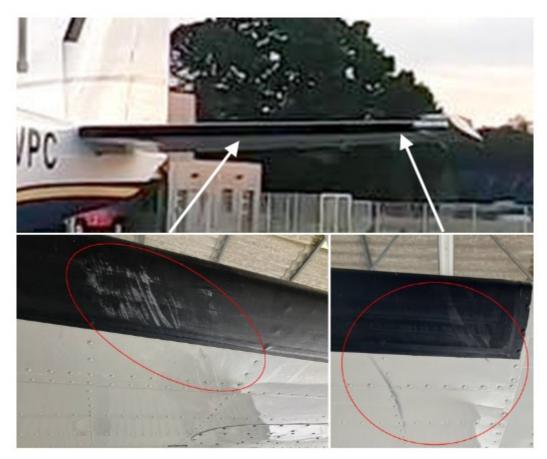
• two areas of rub marks were visible on the leading edge and lower surface of the aeroplane's left-hand horizontal stabilizer. The white marks were situated in the middle of the horizontal stabilizer and the black marks close to the tip.

Figure 2: marks on leading edge and lower surface of left-hand horizontal stabilizer. (source: BEA)

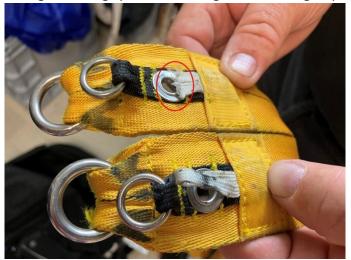
• the textile loop securing the 3-ring system⁵ of the right-hand riser group was severed;

Figure 3: view of the left (bottom) and right (top) risers with the broken textile loop (source: BEA)

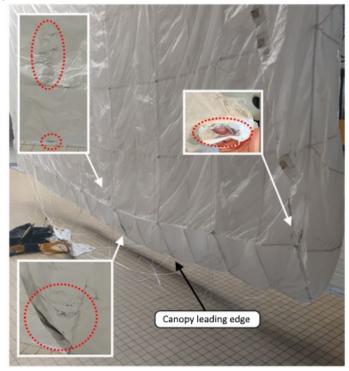
• the white reserve canopy showed rub marks (transfer of black colour from the leading edge of the left-hand horizontal stabilizer of the aeroplane), burns and tears on its leading edge and right-hand tip.

Figure 4: damage to leading edge and right-hand tip of reserve canopy (source: BEA)

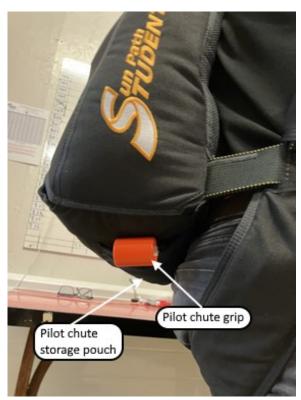
The pilot chute pouch located under the parachute showed no anomalies and was in satisfactory condition.

Figure 5: position of pilot chute storage pouch on a parachute of the same type (source: BEA)

The orifice in the pouch allowing the pilot chute to be extracted from its housing is situated on the right-hand side of the parachute. The position of a skydiver in line with the aeroplane door and according to the direction in which they are sat and the side on which the aeroplane door is situated, may directly expose the pilot chute to the airflow generated by the partially open door. The risk of an undesirable occurrence is thus increased.

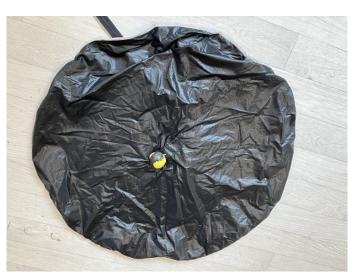
Figure 6: pilot chute and its leather ball (source: BEA)

The pilot chute handle generally consists of a piece of plastic tube or a plastic or leather ball. Most skydivers prefer a leather ball because it offers better grip and is not so fragile as a plastic ball. However, when it comes into contact with a surface, leather slides less easily with the risk of partially dragging the pilot chute out of its pouch.

During these chest movements, as the parachute harness is a close fit, the parachute had followed these actions. The leather ball of the pilot chute of the skydiver sat next to the door was probably squashed between the floor of the aeroplane and the parachute. This rubbing against the aeroplane floor probably led to the pilot chute partially coming out of its housing. The airflow then caused it to completely come out of its housing and dragged it to the outside of the aeroplane, thus activating the deployment sequence of the main canopy.

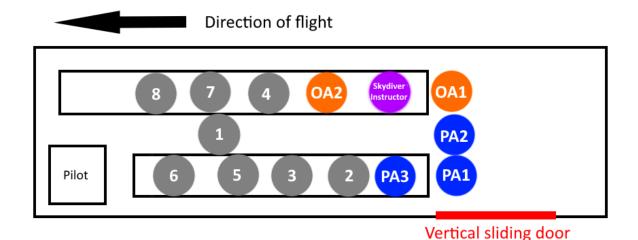
Figure 8: position of skydivers on board the aeroplane (source: BEA)

During the climb, after the door had been partially opened, the skydiver instructor started checking the equipment of the two students who were to be dropped when passing 1,200 m for the first time. The skydiver sat in the middle, on the right-hand side of the first student, moved to the right-hand side and was then touching the skydiver sat next to the partially-open door. The latter, although he had not moved to one side, had moved his chest by bending sideways and turning.

Following this occurrence, the skydiving centre has prohibited the opening or partial opening of the door during the flight, outside of the drop phases.
