**Accident** to the PIPER - PA46- 350P  
registered **F-HYGA**  
on 6 August 2021  
at Courchevel (Savoie)

<b>Time</b>	11:44 <sup>1</sup>
<b>Operator</b>	Private
<b>Type of flight</b>	Cross-country
<b>Persons on board</b>	Pilot and two passengers
<b>Consequences and damage</b>	One passenger fatally injured, aeroplane destroyed

**Approach at low height, collision with a bank below  
runway threshold, fire**

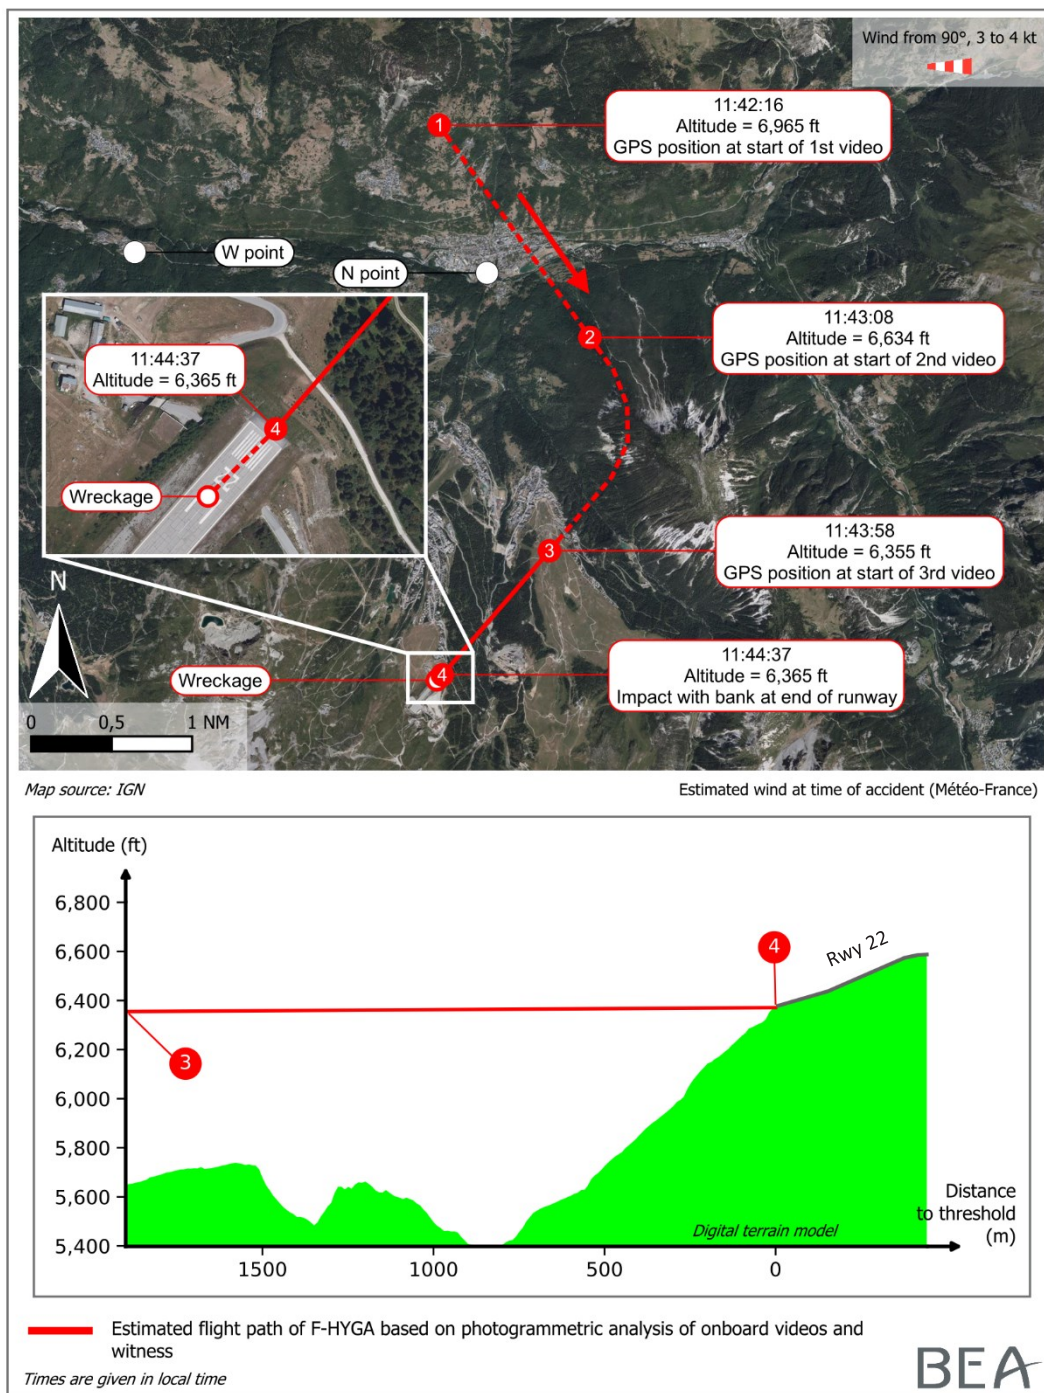
Figure 3: estimated path of the end of the flight

The reconstruction of the aeroplane's path was possible based on crossing points determined using the GPS metadata available at the beginning of the three videos taken with the rear passenger's mobile phone (see **Figure 3**, points ①, ② and ③). A photogrammetric analysis of the last video taken by the passenger provided a more accurate path of the end of the final approach up to the collision (see **Figure 3**, between points ③ and ④). This video recording also showed the Garmin 1000 display located at the centre of the instrument panel.

- from reporting point N to the last turn, the approach path was slightly offset to the north compared with the path described on the VAC chart;
- the pilot made the last turn at an altitude below 6,635 ft;
- on final, the aeroplane was in the runway centreline;
- at 11:43:58 (see **Figure 3**, point 3), i.e. approximately 40 s before the collision with the bank, the aeroplane was at an altitude of 6,355 ft and at a distance of approximately 1,900 m from the runway threshold. The ground speed was 93 kt;
- the pilot then maintained level flight until he collided with the bank;

- between 11:44:15 and 11:44:32, the ground speed decreased from 90 kt to 78 kt<sup>2</sup>;
- the stall warning triggered when the ground speed reached 78 kt;
- the passenger put his hand on the throttle lever immediately after that. An increase in engine speed could be heard, immediately followed by a decrease in engine speed and then the collision with the bank. This collision occurred at 11:44:37 (see **Figure 3**, point 4).
