Accident to the amphibious PIPER - PA18 “Super Cub”
registered **F-HYHB**
on 7 March 2023
at Biscarrosse - Parentis seaplane base (Landes)

Time	Around 15:10 ¹
Operator	Aquitaine Hydravions
Type of flight	Local instruction flight
Persons on board	Pilot in training and instructor
Consequences and damage	Landing gear structure and floats damaged, engine submerged

**Rupture of forward float interconnecting strut during
water landing, in instruction**

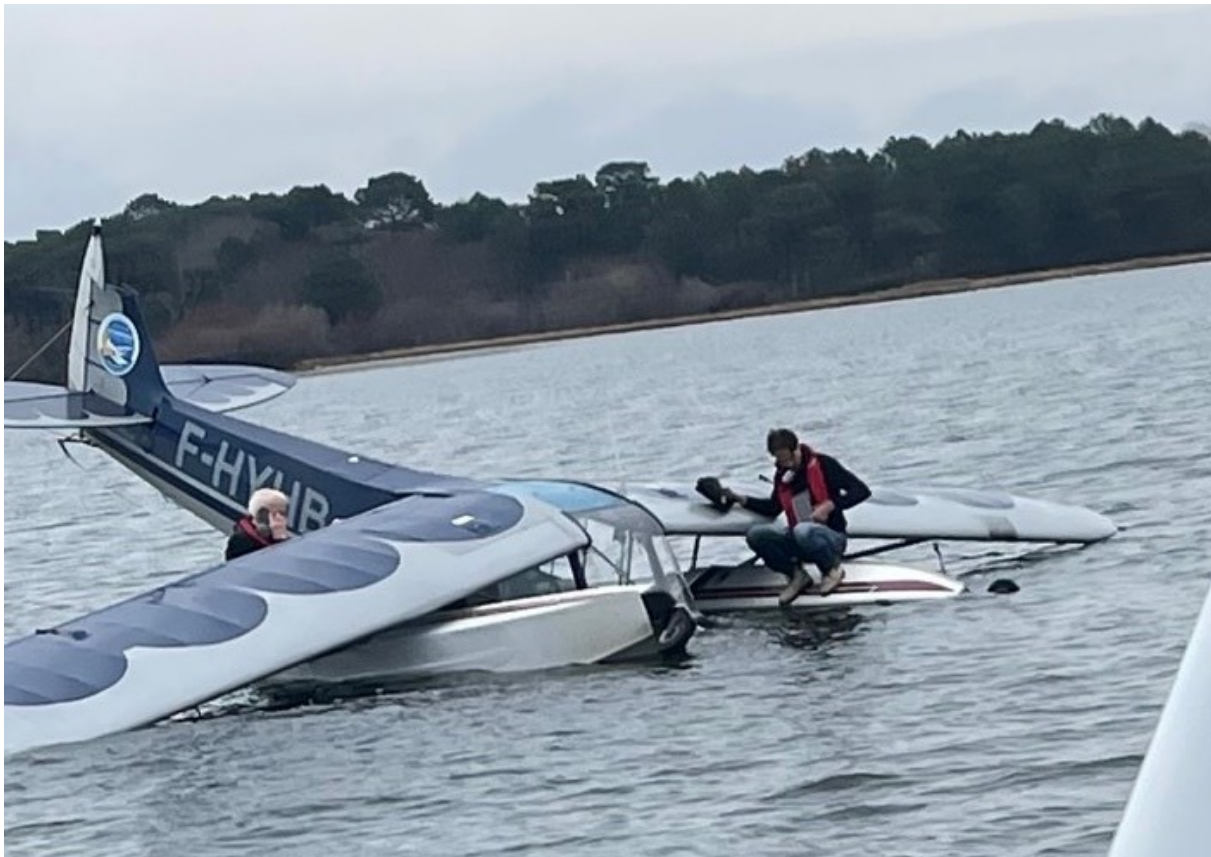
Figure 1: occupants waiting for emergency services (source: Aquitaine Hydravions)

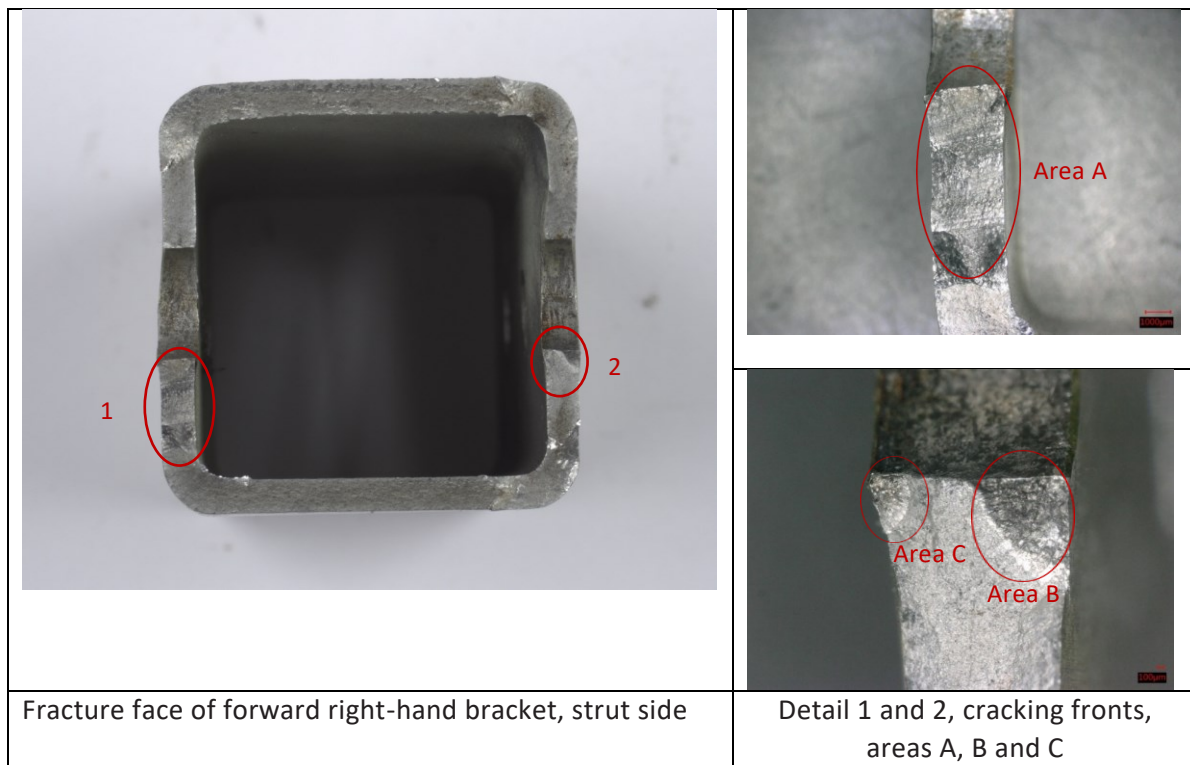
Optical microscopy observations of the forward right-hand bracket rupture found several oxidised and matted cracking fronts (areas A, B and C). There were also several radial secondary cracks initiated in line with the ruptured bore hole. The ruptured bore hole was out-of-round and showed signs of fretting⁵.

Figure 3: observations of bracket rupture with optical microscope (source: BEA)

The examinations revealed micro fatigue striations on the cracking fronts of both faces. Away from these fronts, dimples were found, which are characteristic of a ductile failure process due to overloading.

The comparative examination of the forward left-hand and right-hand brackets showed a similar development of fatigue destruction.

The asymmetry between the upper and lower rupture of the forward right-hand bracket suggests a succession of upward bending-type loadings. These loads can be observed during high-speed manoeuvres on a choppy water surface.

The out-of-round of the upper bore hole of the forward right-hand bracket may be associated with upward bending (as suggested above) combined with forward to aft loading of the bracket. These loads are mainly encountered when navigating on rough water, on the step⁶ or in a turn.

The rupture of the right-hand bracket of the forward float interconnecting strut was initiated by fatigue cracking. The cracking had spread slowly and progressively from the bore hole during in-service use of the assembly. The part finally ruptured when the remaining section of the bracket, not consumed by the cracking, had become insufficient to withstand the applied load, probably during the previous water landing. During the last water landing, the three other mounting brackets experienced ductile failure due to the overload stresses from the sudden deceleration caused by the right, then left, floats moving apart on contact with the water.

Based on the information provided in the scope of this investigation, Wipaire plans to ask for an additional inspection for aeroplanes principally used by training organisations. It is planned that this inspection will include the removal of the float interconnecting strut and the search for out-of-round or cracking in the bolt attaching holes. If damage is observed, the mounting bracket will have to be replaced. Wipaire also plans to warn operators (or maintenance organisations) of the importance of the securing tension of the cross braces, as they transmit the loads to the brackets. All of the structure may be affected if the cross braces are too tight or too slack.

The club, whose main activity is training for and issuing the SEP(H) rating makes intensive use of its seaplanes by accumulating numerous water landing cycles. At a meeting of the club's board, its directors decided to amend the maintenance programme to adapt it to the particular use of the PA18s, anticipating the manufacturer's future instructions.
