**REPORT of the accident to the Falcon 20 E registered F-GHLN
operated by LEADAIR UNIJET on January 20th 1995 at Le Bourget airport**

F-LN950120EN

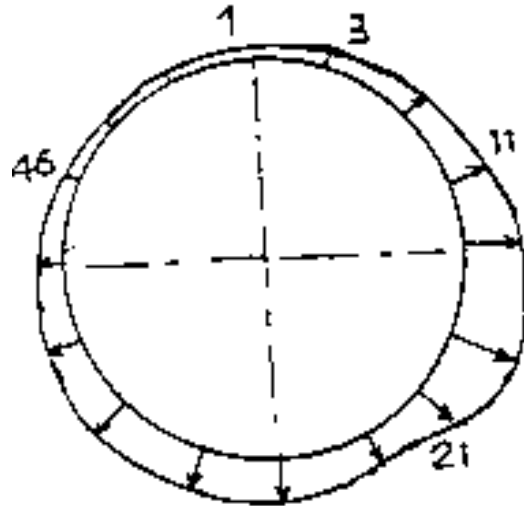
In addition, these distortions are not uniform. The maximum distortion occurred in the sector of the disk corresponding to blades 11 to 21, and to attachment holes 5 to 8.

The minimum distortion is found in a sector which is not exactly opposite (blades 46 to 3 and attachment holes 18 to 2), as shown in the simplified drawing below.

A dye check indicated that the disk showed no signs of cracks or incipient failure.

Hardness tests carried out showed that the material's characteristics were in conformity with the manufacturer's specification, this being between 34 and 44 Rockwell C.
