**Serious incident** to the De Havilland - DHC-6 Twin Otter  
Series - 300  
registered **F-OCQZ**  
operated by Aircalin  
on Tuesday 4 May 2021  
at Futuna Pointe Vélé (Wallis and Futuna islands)

## Loss of engine power during final approach

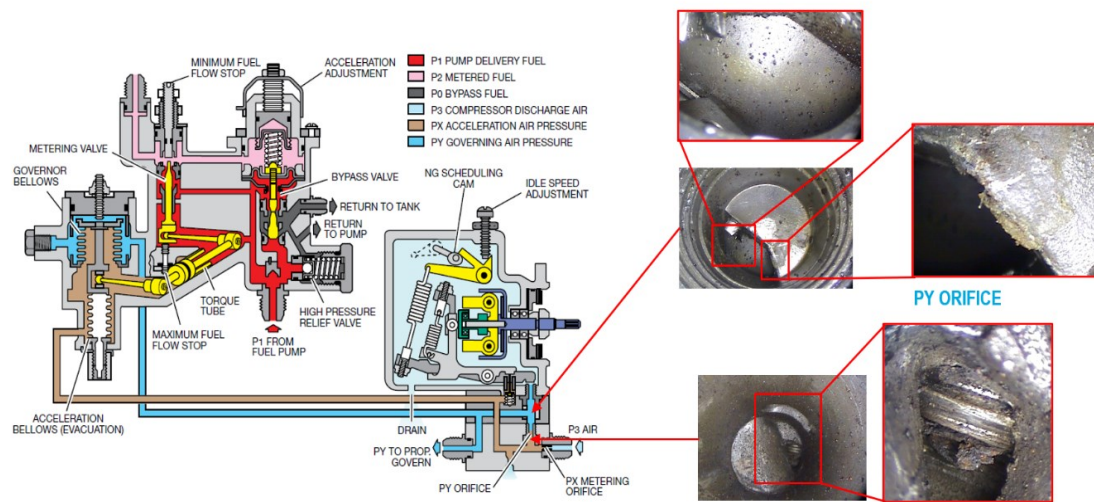
Figure 3: examination of FCU # 1 (source: PRATT & WHITNEY)

The borescope inspection carried out on the P3 and PY air inlets of LH FCU #1 revealed the presence of flaky debris, black granular deposits, fibres, yellowish particles and signs of corrosion.

Black debris was found in the Px and Py air passages, as well as black, flaky debris in the Px bleed cavity, comparable to the debris found in the Py orifice inlet during the borescope inspection. The Py port was contaminated with black debris.

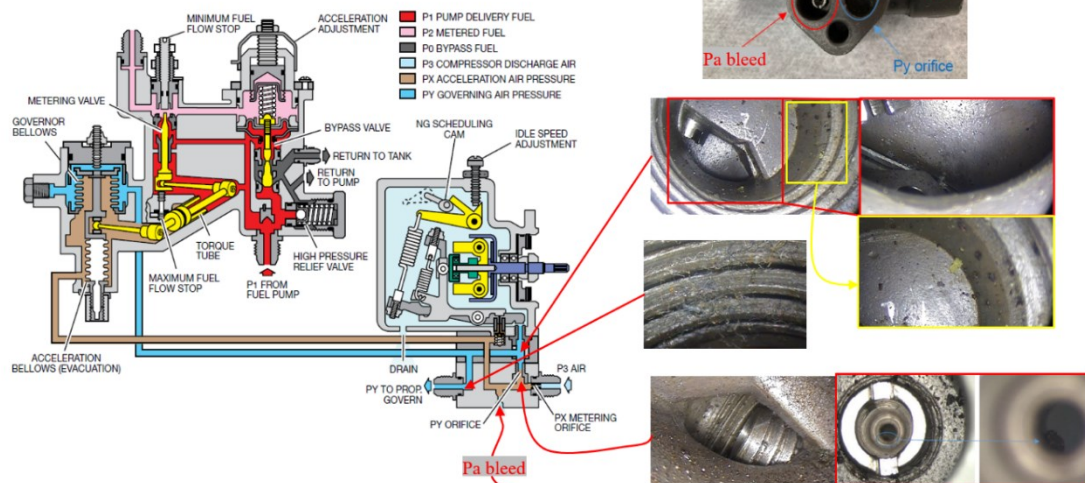
Figure 4: examination of RH FCU #2 (source: PRATT & WHITNEY)

The borescope inspection carried out on the P3 and PY air inlets of RH FCU #2 revealed the presence of black granular deposits, yellowish crystals and fibres.

According to PRATT & WHITNEY, the debris found during the examination of RH FCU #2, in the location where it was found, would not have had a direct impact on the operation of the FCU. However, PRATT & WHITNEY highlighted the fact that this debris could have migrated into the air section and could have momentarily altered the operation of the FCU.

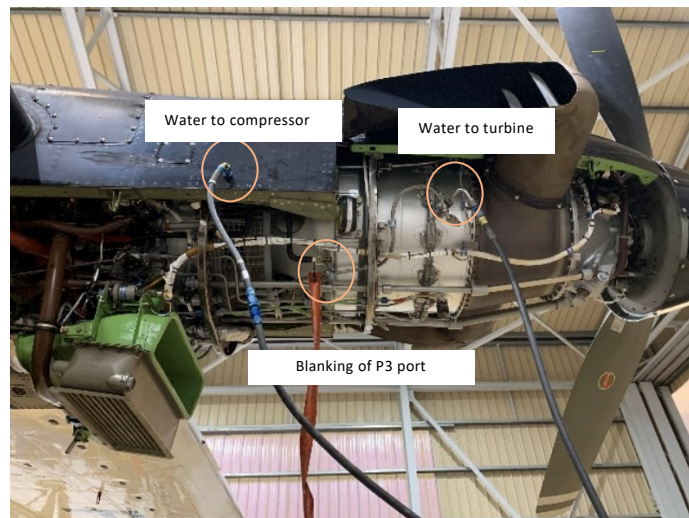
*Figure 5: installation of compressor washing equipment (compressor and turbine sections)  
(Source: Aircalin)*

According to PRATT & WHITNEY, washing the compressor and turbine at the same time can lead to a build-up of water between the compressor and turbine, which might not be evacuated when drying the engine during the engine power-up. This water can be evacuated gradually. It can also find its way into the air section and, in contact with some metals, this water can lead to corrosion.
