Accident to the PIPER - PA32 registered F-OJSN

on 28 November 2018
in the Baie des Saintes (Guadeloupe)

Vibrations in flight, diversion, engine failure on final, water landing

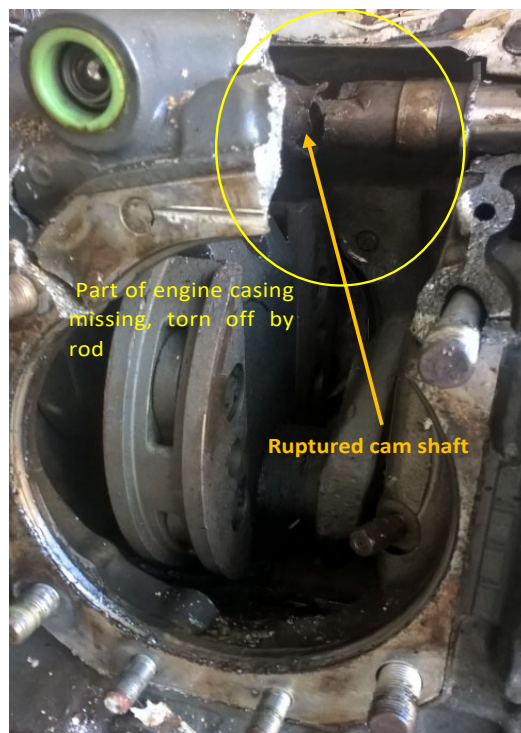
- a piece of the engine casing had come away in line with its rear left attachment point;
- the cam shaft had failed;
- the rod head and the rod of cylinder 6 had failed.

Figure 4: engine casing and damaged cam shaft

The damage observed on the casing and on the cam shaft seemed to be the result of the failure of the head of the cylinder 6 rod. The damage seemed to be consistent with the pilot’s statement, the hole in the casing having resulted in oil spreading over the airframe and the failure of a rod causing intense engine vibrations.

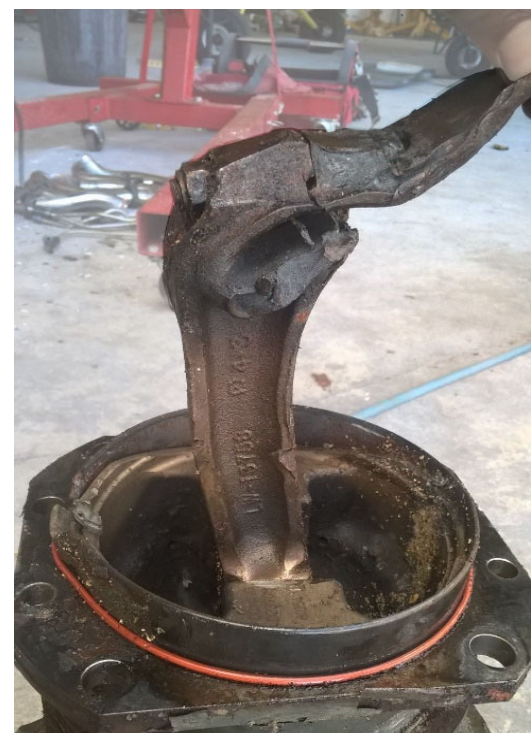
Figure 5: cylinder 6 and its failed rod at head end

The cause of the rod failure was not determined.
