**Accident** to the De Havilland DHC-6 400 “Twin Otter”  
registered **F-OMYS**  
operated by CAIRE  
on Thursday 24 August 2023  
at Saint-Barthélemy airport

This is a courtesy translation by the BEA of the Final Report on the Safety Investigation. As accurate as the translation may be, the original text in French is the work of reference.

**Runway veer-off on landing, collision with a parked helicopter**

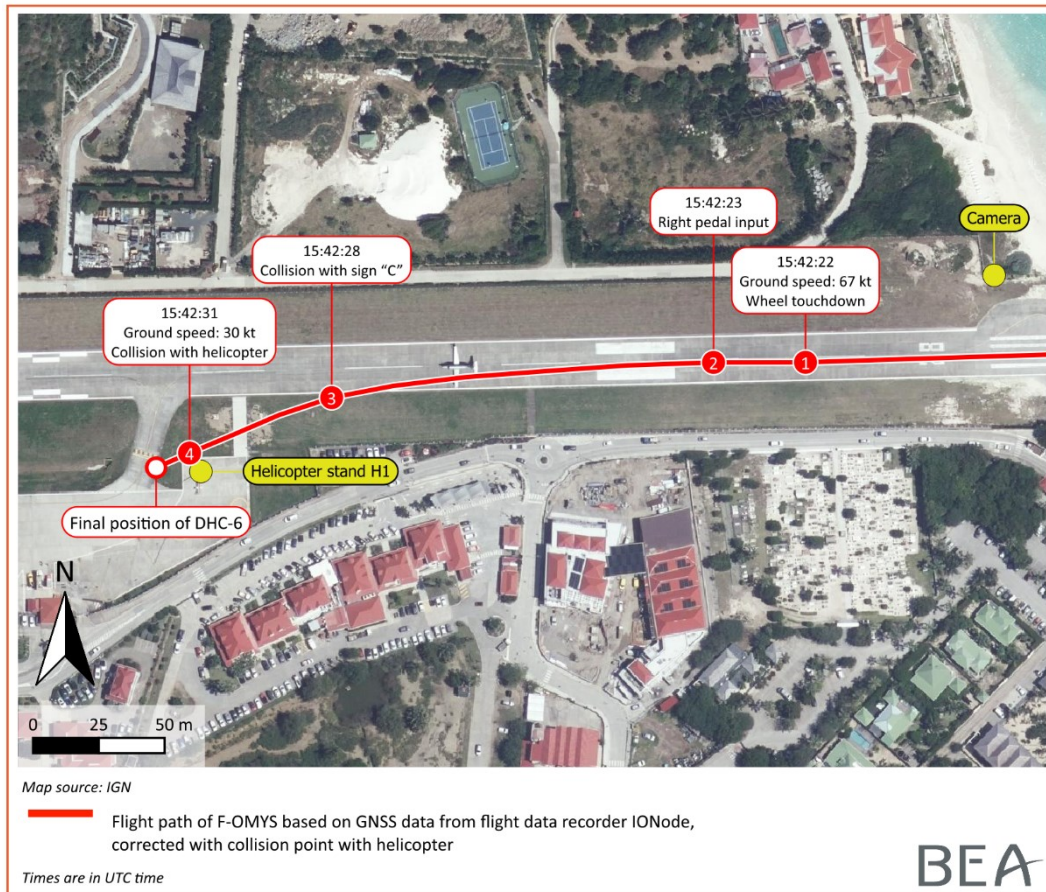
Figure 1: path

to correct the phenomenon. The aeroplane then ran over the runway's grass shoulder. It struck the sign indicating the junction with taxiway C. The captain then decided to use the nose wheel lever by pushing it with all his force to turn right.

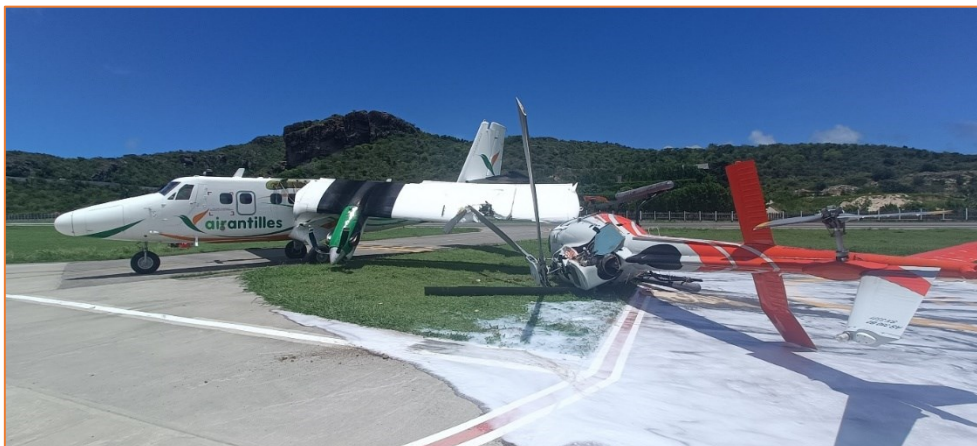
Figure 2: position of aircraft after accident (source: Gendarmerie)

The left-hand wing of the aeroplane struck an AS350 helicopter parked on stand H1. The aeroplane pivoted violently and then came to a halt.

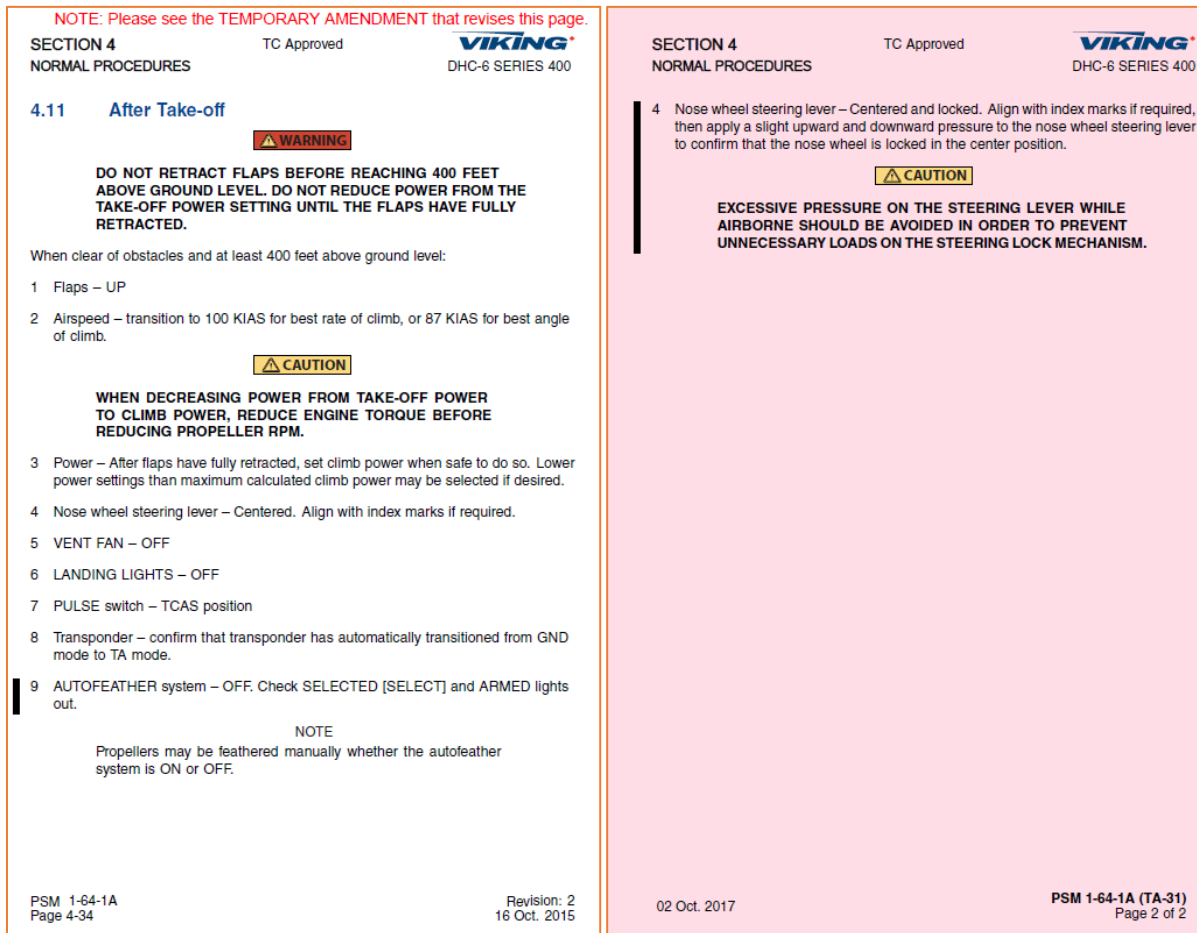
Figure 6: after-take-off procedure taken from the POH and its amendment (source: De Havilland)

This procedure is described in a temporary amendment (referenced TA-31), dated 2 October 2017<sup>9</sup>. The previous procedure consisted solely of checking that the NWS lever was centred by aligning the marks if necessary.

This amendment had not been incorporated into the normal procedures of the CAIRE operating manual for the DHC-6. In this manual, the after take-off procedure only states that the pilot in the left-hand seat must ensure that the NWS is centred and locked by checking that the NWS marks are aligned.

No explanation was provided for the failure to incorporate temporary amendments TA-31 and TA-32 into the operator's manual. Factors such as personnel changes in the years following the publication of these amendments, as well as changes in the regulatory watch processes in response to these personnel changes, were mentioned.

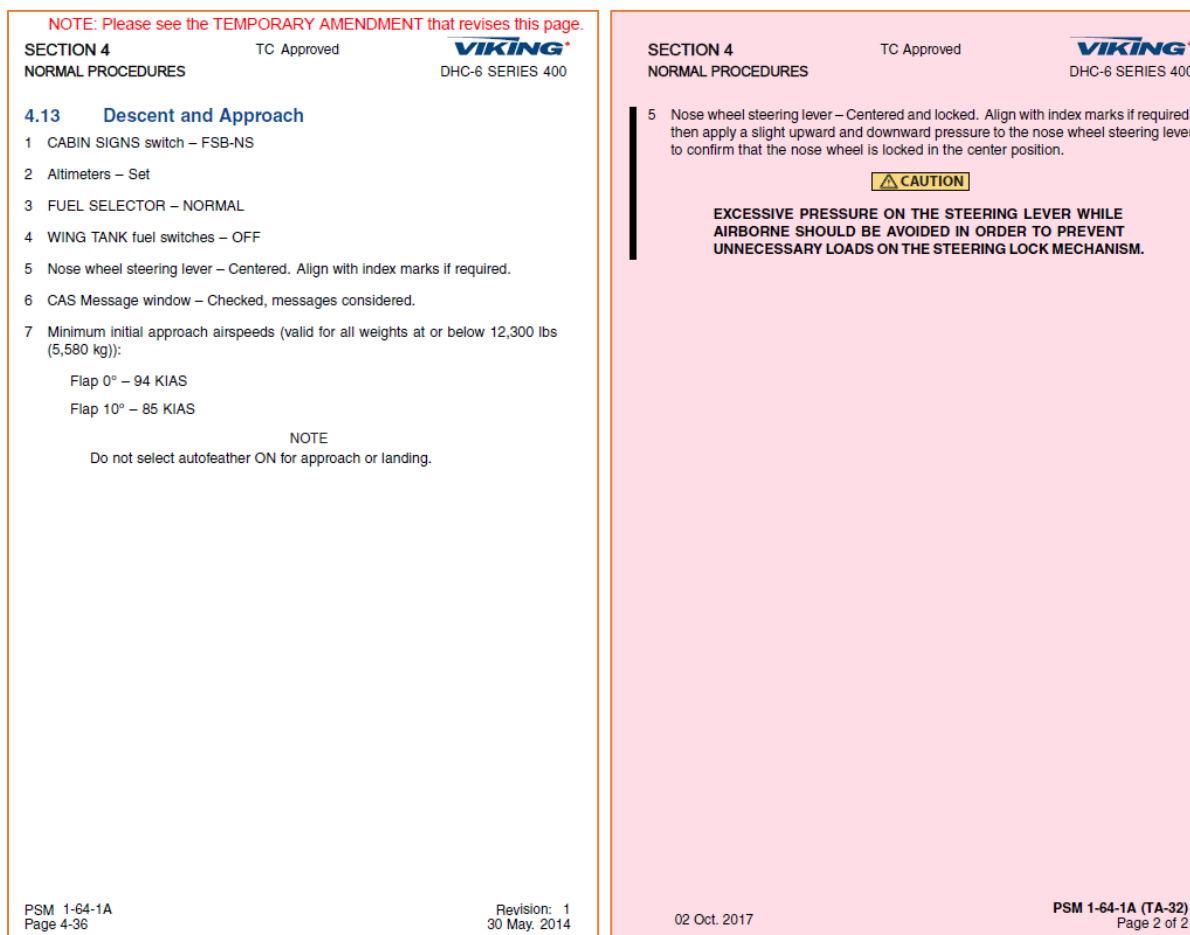
Figure 8: Descent/Approach procedure taken from the POH and its amendment (source: De Havilland)

During the approach, according to the “Normal Procedures” section of the POH, the pilot must ensure that the nose wheel is centred and locked using a method similar to that used after take-off. This procedure is also described in a temporary amendment (referenced TA-32), dated 2 October 2017.

The normal procedures in the CAIRE operating manual for the DHC-6 do not contain any actions relating to the NWS during the descent or approach. The before landing checklist includes the verification item, “STEERING...CENTERED”.

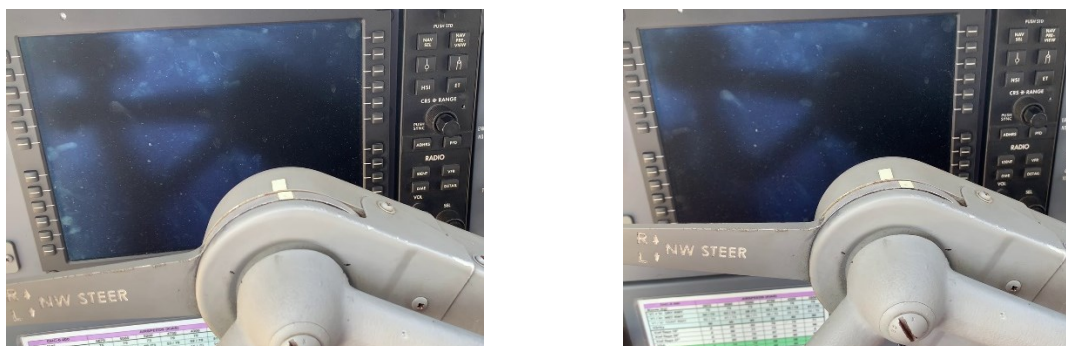
- the alignment marks could be offset to varying degrees although the gear was locked in the centred position by the spring latch (Figure 9);
- the marks could be aligned although the nose gear was not locked in the centred position by the spring latch (Figure 10).

Figure 9: photos of NWS lever when the gear is locked in the centred position (source: BEA)

During these tests, it was observed that the tension of the connecting cable between the NWS lever and the actuator was insufficient<sup>13</sup>. It was not possible to determine the cause of this insufficient tension level.

According to De Havilland, an insufficient NWS cable tension can lead to the offset described above, with the marks aligned although the gear is not centred. In this case, if locking is not checked in accordance with the amended procedures, the orientation of the wheel can change during the flight.

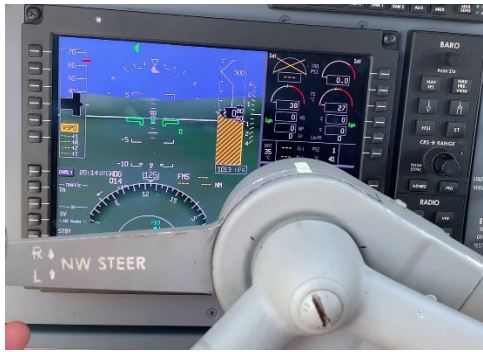
Figure 10: photo of NWS lever aligned although the gear is not locked in the centred position  
(source: BEA)

The tension in the NWS control cable was insufficient. It was not possible to determine the cause of this incorrect adjustment. The probable consequences of this was a situation where, on take-off, the NWS marks were aligned although the NWS was not locked in the centred position. As it was not locked, the nose wheel probably pivoted during the flight.

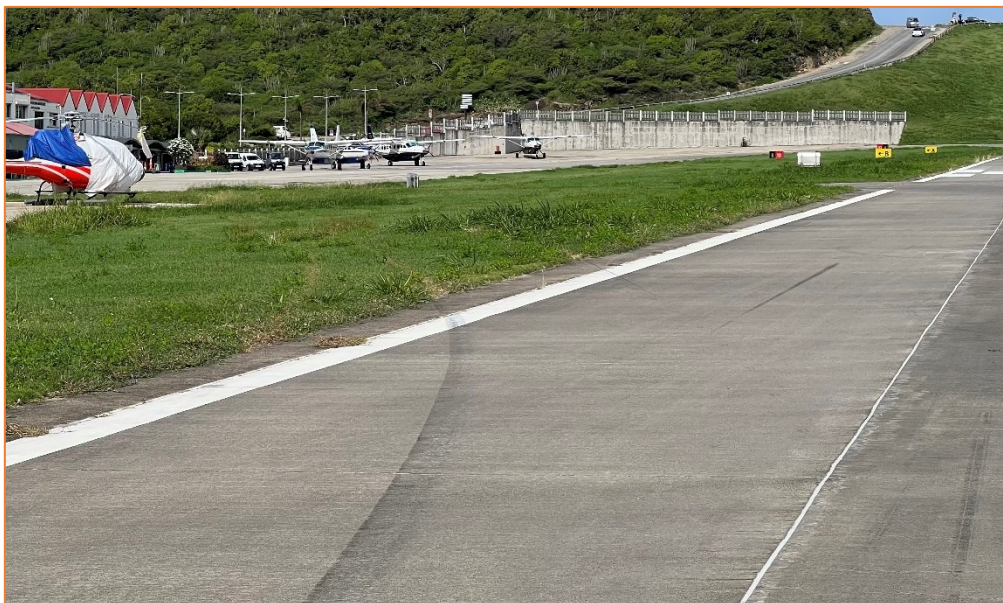
The marks left by the aeroplane's wheels on the ground, as soon as the aeroplane touched down, included a pronounced nose wheel mark. This is consistent with the nose wheel being out of line with the path and skidding. No similar particularity was observed on the marks left by the wheels of the main landing gear.

Figure 12: mark left by nose wheel (source: BEA)

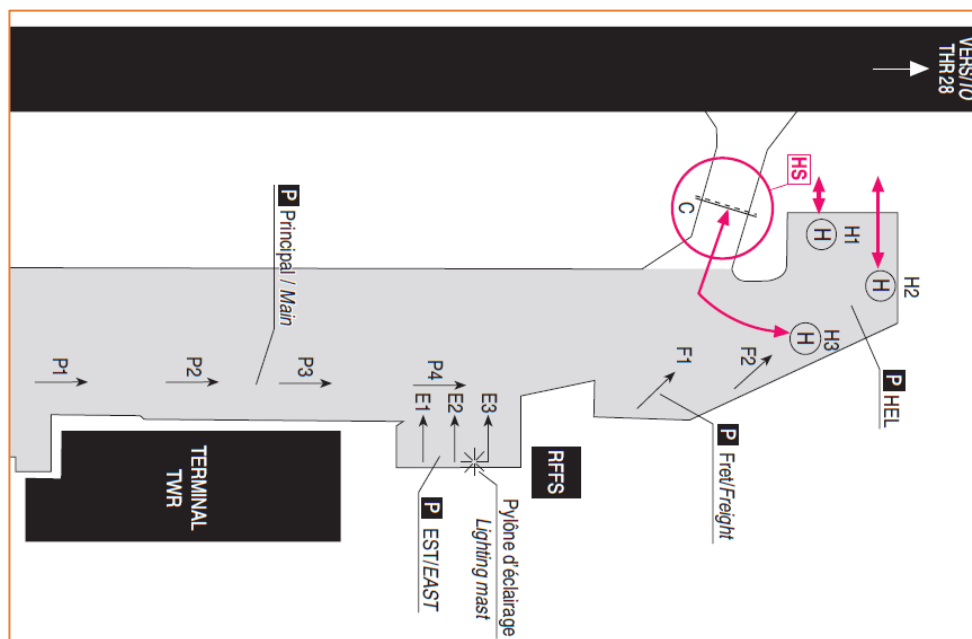
Figure 13: excerpt from ramp drawing (source: AIP)

A helicopter stand area is situated at the eastern end of the ramp (indicated by “P HEL” on Figure 13).

Being 30 m from the runway axis, the position of this stand complies with the aerodrome certification standards applicable<sup>14</sup> to Saint-Barthélemy airport, as it does not encroach on the runway safety area<sup>15</sup> which has a minimum width of 60 m. The position of the direction sign indicating the junction with the taxiway was also compatible with the standards relating to the presence of objects in this safety area.
